Structural damages of L'Aquila (Italy) earthquake

H. Kaplan¹, H. Bilgin¹, S. Yilmaz², H. Binici¹, and A. Öztas¹

Abstract. On 6 April 2009 an earthquake of magnitude 6.3 occurred in L'Aquila city, Italy. In the city center and surrounding villages many masonry and reinforced concrete (RC) buildings were heavily damaged or collapsed. After the earthquake, the inspection carried out in the region provided relevant results concerning the quality of the materials, method of construction and the performance of the structures. The region was initially inhabited in the 13th century and has many historic structures. The main structural materials are unreinforced masonry (URM) composed of rubble stone, brick, and hollow clay tile. Masonry units suffered the worst damage. Wood flooring systems and corrugated steel roofs are common in URM buildings. Moreover, unconfined gable walls, excessive wall thicknesses without connection with each other are among the most common deficiencies of poorly constructed masonry structures. These walls caused an increase in earthquake loads. The quality of the materials and the construction were not in accordance with the standards. On the other hand, several

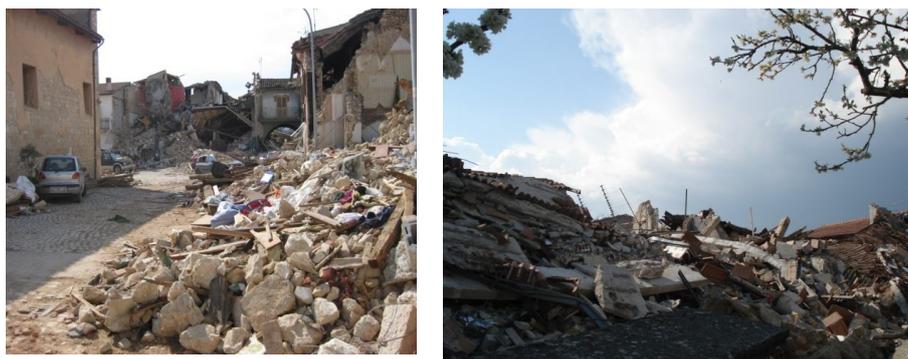
Fig. 2. A general view of building damage in Onna; collapsed and severely damaged residential buildings.

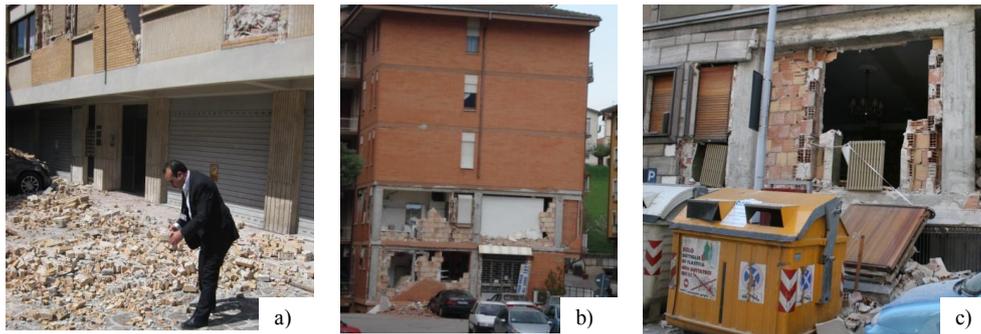
purposes. Although it is a good solution to prevent heat bridges, unrestrained walls had low out-of-plane resistance. Many such walls collapsed and caused important damages (Fig. 6).

Isolating side walls were not anchored to the structural framing with masonry ties. Infill walls were built in contact with the structural framing and increase the base shear capacity of the framing system. Damage to infill masonry walls was concentrated in the lower stories of buildings because of higher demands on the story shear forces of the moment-frame-infill wall system. Figure 6b and c illustrates typical damage to infill walls in two buildings in the center of L'Aquila.

Fig. 6. (a) Typical hollow clay tile used in infill walls, (b–c) severe infill wall damages.

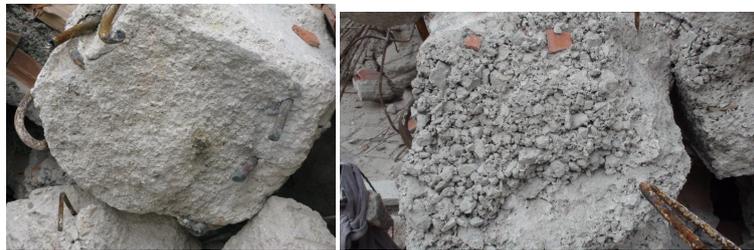
Poor quality of concrete was observed many RC buildings (Fig. 7). Poor detailing of RC sections and joints have caused structural elements to behave in a brittle manner and end up with shear type failures. Figure 8a depicts shear failure in beam-column joints and column shear failures. Besides, longitudinal reinforcements also buckled due to the lack of transverse reinforcement in the joint. On the other hand, transverse reinforcement spacing was measured to be up to 40 cm in columns in the damaged RC buildings. No transverse reinforcement was used in column-beam connection joints of many buildings. Shear failures caused by inadequate transverse reinforcement can be seen in Fig. 8b. Inadequate detailing of transverse reinforcement caused not only shear failures but also buckling of longitudinal reinforcement in plastic hinge regions. This also led to a brittle mode of failure. Such a typical damage is shown in Fig. 9.

Fig. 7. Aggregate used in concrete having no particle size distribution.

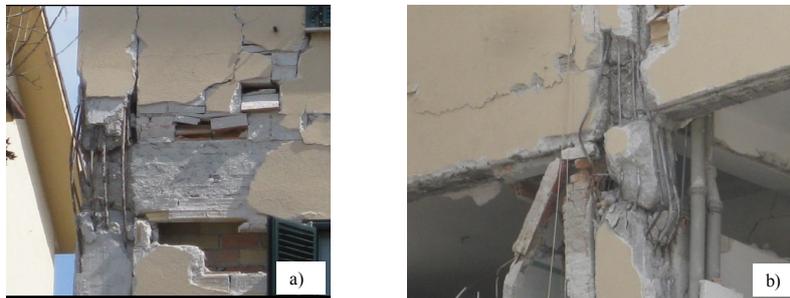
Fig. 8. (a) Shear failure in beam-column joints. (b) Shear failure of column and beam-column joint.

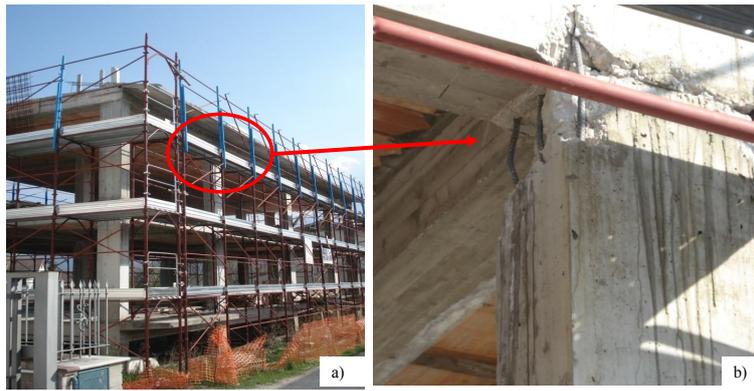
Fig. 9. (a) Moment frame under construction. (b) Buckling of the reinforcement in plastic hinge regions.

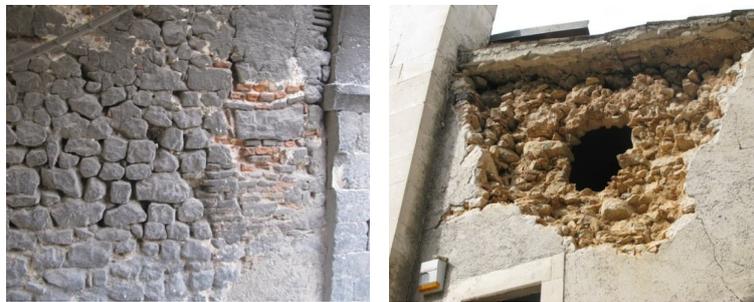
L'Aquila earthquake served as a good open-laboratory for damaged masonry buildings. Some of those buildings had historical characteristics. Many of the damaged historical monumental buildings were stone and rubble stone masonry having low construction quality. Similarly, other masonry buildings in rural settlement areas of L'Aquila were also usually constructed by rubble stone and heavy blocks usually, which can be easily available around settlement areas (Fig. 10). Many of these masonry buildings were non-engineered and were not earthquake resistant.

Fig. 10. Bad profile of a damaged wall.

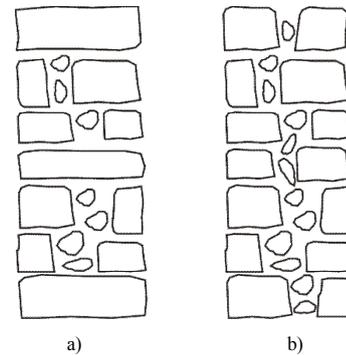
Unconnected outer and inner wythes are given in Fig. 11. These types of deficiencies lead to out-of-plane failures. Typical wall section observed at many damaged walls is compared with an earthquake resistant section in Fig. 11, where lack of connection between outer and inner wythes can be seen.

Fig. 11. (a) Proper and (b) improper details.

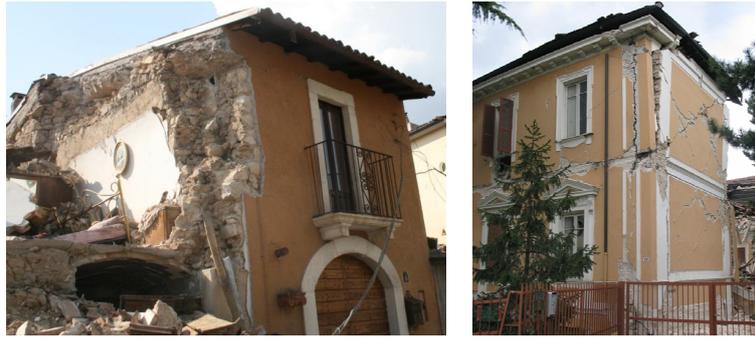
Another reason for out-of-plane failures are poorly connected crossing walls. In many cases, at corner points of the buildings, masonry units did not properly overlap to ensure an earthquake-resistant connection. This causes walls to be separated at initial stages of the quake. After that, out-of-plane failures were initiated due to poor restraining conditions. These types of damages are shown in Fig. 12.

Fig. 12. Badly connected crossing walls causing out-of-plane failures.

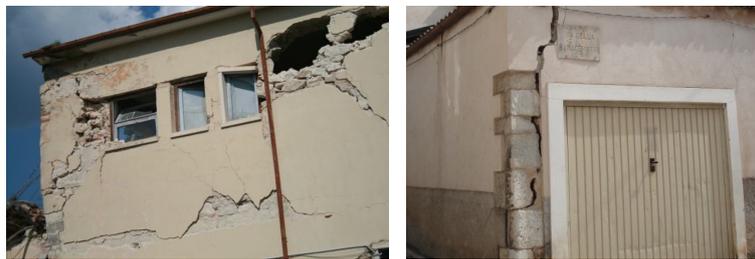
Restraining effect of crossing walls was reduced by wall openings placed to close to the building corner. Such damages are given in Fig. 13. Window and door openings weaken the connection of crossing walls. If there was a greater ground-shake, next expected steps would be out-of-plane failure of those walls like in many other cases in L'Aquila.

Fig. 13. Damages observed at connection of crossing walls.

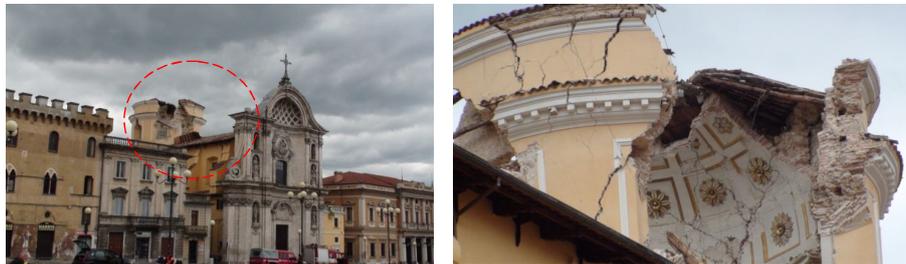
Beside relatively new buildings, many historical churches collapsed or heavily damaged (Fig. 14). The Church of Santa Maria del Suffragio in L'Aquila was seriously damaged but

the remains of Pope Celestino V that were kept inside were recovered from the basilica shortly after the earthquake. The dome of the Duomo of the Amine Sante also collapsed. The dome of this church was made of heavy rubble stone and wall thickness was excessive and improper.

Fig. 14. Damages observed at connection of crossing walls.
