Structural damages observed in state buildings after Simav/Turkey earthquake occurred on 19 May 2011

Abstract. Different levels of damages occurred in state buildings, especially in educational facilities, during the Simav earthquake ($M_L = 5.7$) on 19 May 2011. A site survey was carried out in the area after the earthquake, where six state buildings were examined in detail. The results of the survey showed that main reasons for the formation of damages in these buildings are the use of low strength concrete, insufficient reinforcement, inappropriate detailing, and low-quality workmanship. The investigated buildings were also evaluated by P25-rapid assessment method. The method demonstrates that two of the buildings in question are in “high risk band”; the other two fall into “detailed evaluation band”, and the rest are in the “low risk band”. This figure also matches with the damages observed in the site survey.

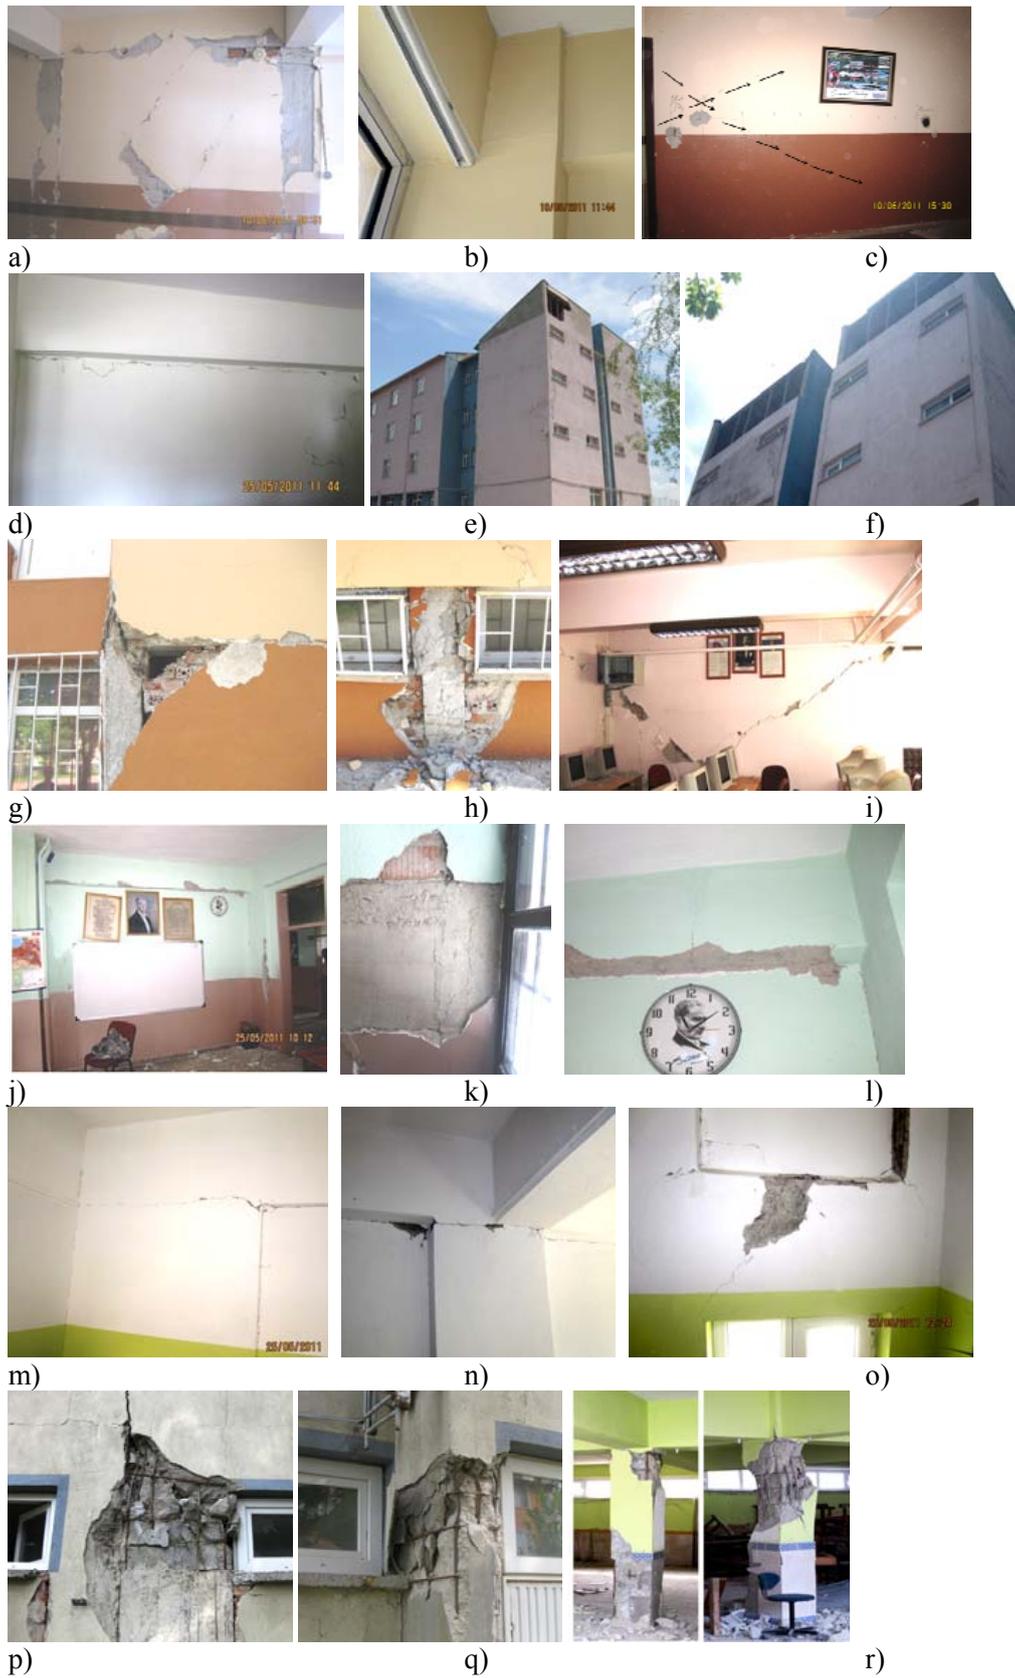
Fig. 5. Observed typical damages at investigated buildings.

- In the Simav Government House (SHK), load bearing elements and infill walls were damaged (Fig. 5a). As seen from Fig. 5b and c, damages in load bearing systems are sliding shear damages on the upper edges of the column and shear cracks at shear walls.

- On the ground floor of the 75th Year Cumhuriyet Dormitory (CLP), there are minor infill wall damages and separation between frame and infill walls (see Fig. 5d). Moreover, the end wall on the roof of the structure collapsed in the out-of-plane direction because of the earthquake (Fig. 5e, f). The reasons for this damage were identified as the excessive unsupported wall length and lack of horizontal and vertical bond beams at the end walls.

- In the B block of the Cumhuriyet High School (CL), shear damages occurred on the columns neighbouring the band-type windows due to short column mechanisms (Fig. 5g, h). Meanwhile, extensive infill wall damages occurred throughout the structure (Fig. 5i).

- In Osmanbey Primary School (OBI), walls crushed, plaster fell and infill wall-frame separations occurred (Fig. 5j). In some beams, cracks formed due to lap splice (Fig. 5k) and flexural forces were identified (Fig. 5l).

- In the Public Education Center (HEM), mainly infill wall damages occurred. Additionally, it was detected that there are sliding shear damages on the shear walls and columns of the ground floor (Fig. 5m, n).

Meanwhile, there are shear damages at the short beams connecting to the shear walls (Fig. 5o).

- In Anadolu Vocational High School (AEM), significant damages occurred on the infill walls and other structural members during the earthquake that occurred on 17 February 2009 with magnitude of $M_L = 5.0$ and thereby the building had been evacuated. As there were no partition walls on the ground floor, which was used as a cafeteria, “weak storey” formed and damages concentrated on this floor. In this two-block building, blocks collided with each other during the 2009 Earthquake as there was no sufficient joint length between them. As a result of this, significant damages occurred on the columns of the pounding parts of the building. In fact, these pounding damages proceeded and the concrete crushed during the recent earthquake that occurred on 19 May 2011 (see Fig. 5p). Meanwhile, due to band-type windows, the ground floor of the structure suffers from short column damages. Apart from these, during the earthquake with magnitude of $M_L = 5.0$, shear damages occurred on the short columns. In the recent earthquake, more severe damages occurred in the building such that crushing of covering concrete and buckling of the longitudinal reinforcements were observed (Fig. 5q). Meanwhile, it was detected that, in the 2009 earthquake, bending and shear damages occurred on the columns present in the central part of the ground floor. In this recent earthquake with magnitude of $M_L = 5.7$, these damages proceeded further (shown in Fig. 5r).

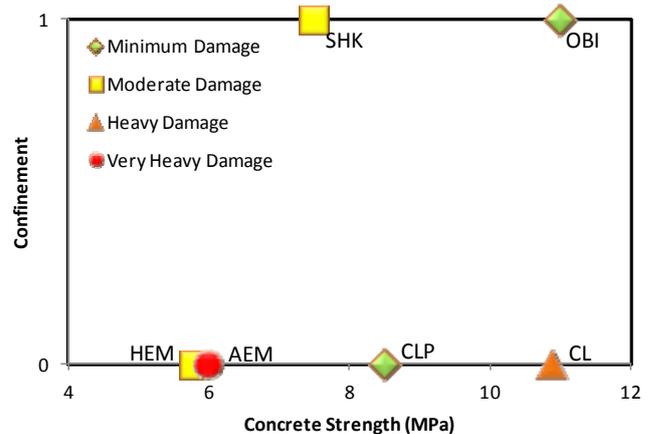
Fig. 6. Effect of concrete strength and confinement on damage level.

For the buildings surveyed, the observed level of damages, concrete strength and the confinement of the ground floor in each building are given in Fig. 6. For a structure, it is expected that the increase in the confinement and concrete strength decreases the level of damage. However, the investigated buildings point out that such a direct relation between the level of damage and confinement, as well as the concrete strength, is not reliable. For example, it was detected that, in Cumhuriyet High School (CL), while the concrete strength is higher compared to the other structures in question, the damage is more severe. The main reasons for these problems are the presence of short columns and soft storey in this building. In contrast to Cumhuriyet High School (CL) in Public Education Center building (HEM), there is a moderate level of damage while it has the lowest concrete strength compared to the other buildings. This higher performance of the building could be attributed to presence of a regular frame structural system with no weak/soft storey. Meanwhile, higher concrete strength of the upper storeys compared to the ground storey also contributed to this result. Due to short columns and soft storey effect, Anadolu Vocational High School building (AEM), having similar concrete strength to Public Education Center (HEM), was heavily damaged during the earthquake with magnitude of $M_L = 5.7$.
