Effects of soil settlement and deformed geometry on a historical structure

Y. Yardım and E. Mustafaraj

Department of Civil Engineering, Epoka University, Tirana, Albania

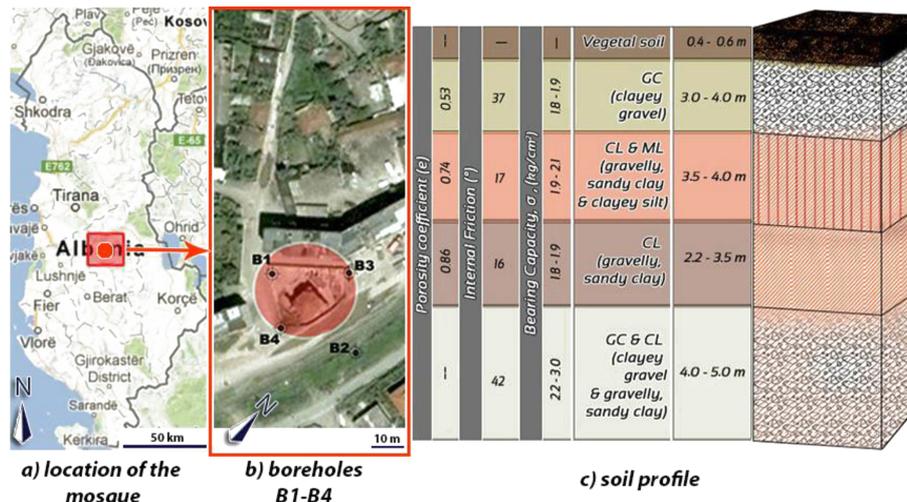
The structure sits on alluvial deposits of the first terrace of the Shkumbini River (Fig. 1). The area is flat with an inclination of 1–2° and the deposits consist of silts and clay intercalated by sand layers (upper part) and gravels in the lower

Figure 1. Location of the mosque (a), boreholes B1–B4 (b) and soil profile under the mosque (c).

part of the lithological profile. Field tests of boreholes, pits and ditch works were performed around the building. The boreholes depth varies from 10 to 20 m (see boreholes B1–B4 in Fig. 1). Several tests were conducted to obtain general properties of soil under the structure. The laboratory works include grain size analysis, natural water content, bulk density, strength parameters, internal friction angle and cohesion based on ASTM. The underground water table is located 18.5–19.0 m below the surface level. In total, five geotechnical layers were seen from the field test (Table 1).

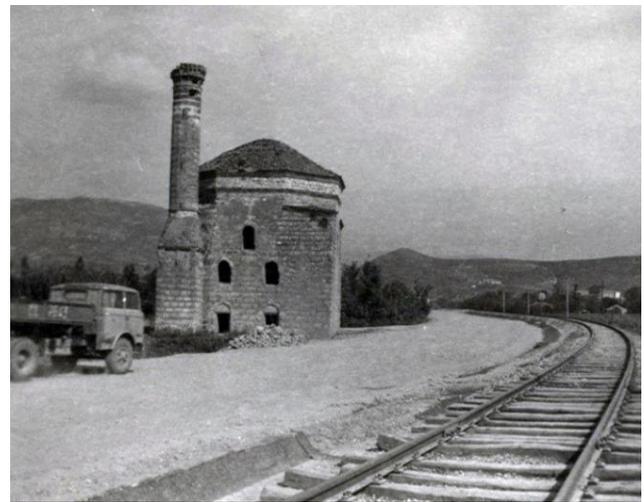
Other influences on the structural conditions created by human intervention are the roads and the railway next to the structure. The railway which lies 6 m away from the structure was built in 1960 to connect the cities of Durrës and Korça. It is located 1 m a.g.l., and it is used 4 times a day with heavily loaded trains. In addition, a motorway was put in place just next to the structure (as shown in Fig. 3). Studies show that the presence of a railway at such a close distance to an unreinforced masonry structure may cause significant damage.

Figure 3. Motorway and rail way built next to structure 1950s, (obtained from Albanian National Archive).

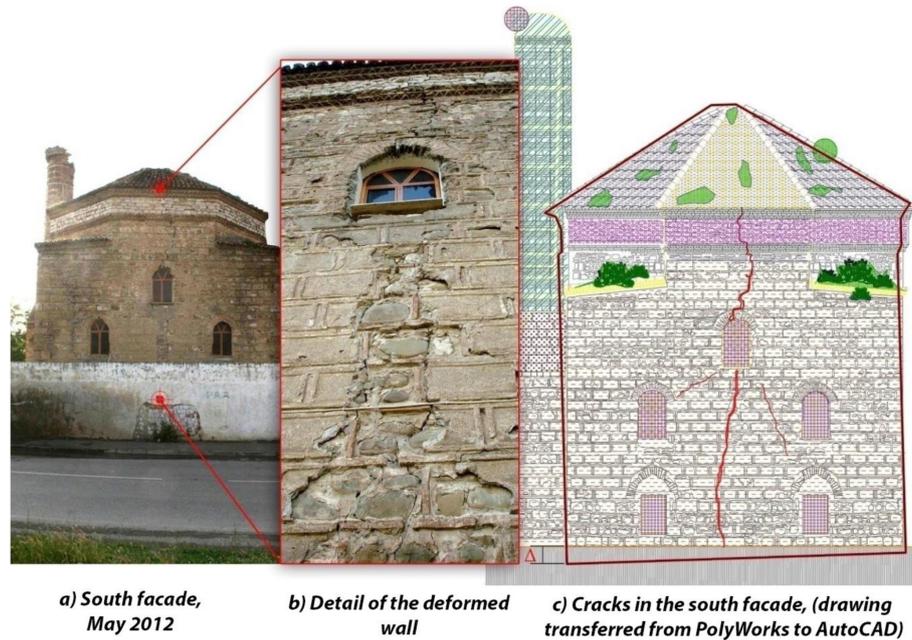
Figure 5. Cracks due to differential settlement ($\Delta = 18$ cm) in the south façade (May 2012).

The main reasons for this complexity rise from a variety of internal and external influences. Based on the field study, the measured geometric imperfection of the structure is primarily caused by differential settlement of the foundation due to the soil profile. The soil layers are very suitable to produce internal erosion with its different void ratio and particle size along the vertical. This type of settlement is triggered by earthquakes, frequent changes in underground water level caused by the river base change, changes of ground water level due to surrounding drainage system and constant vibrations created by the adjacent motorway and railway. In addition to the above-mentioned factors, the maintenance that had been carried out at different times during the lifespan of the mosque with different materials whose characteristics do not match the original materials could be a secondary or an additional cause of imperfect geometry.

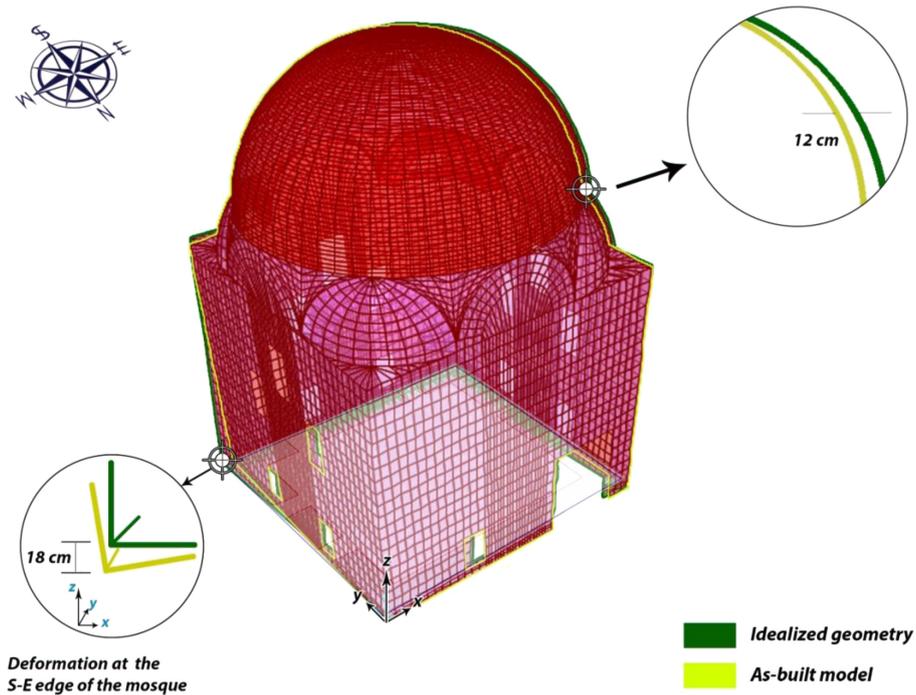
Representation of geometric imperfections is not uniform along the structure; therefore, it is not easy to describe all effects of such deformations. The recorded deformation has been progressing for centuries. The morphological features of the site and soil profile have been playing a key role for this imperfection in geometry. Seismic activities and constant vibration because of external impact accelerate and form this deformation. Final shapes are formed with a combination of these events with material characteristics. However, the soil profile and general crack formation together with the TSL measurement proves that the structure is deformed toward the south façade of the mosque where the railway and motorway are also located.

Figure 6. Deformation of the structure at the southeastern corner and east of the dome.

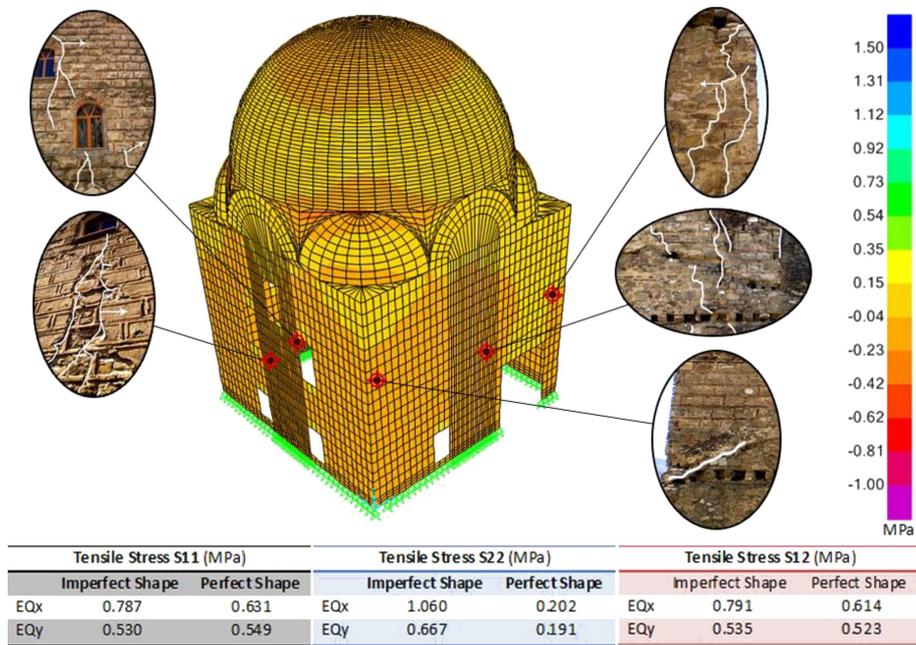
With the help of a laser scanner acquisition, the obtained geometric imperfection results in an increase in stress concentrations under seismic load. This imperfection changes the possible failure mechanisms and threatens the historical monument if an earthquake were to occur in the area. With respect to the corresponding models with more accurate geometry, the maximum tensile stress that occurs in the structure is 0.361 MPa under static load, 0.801 MPa under seismic load and 0.144 s for the first mode. On the other hand, the actual geometric model gives 0.774 MPa under static load, 1.4 MPa under seismic load and 0.174 s for the first mode. The existing structural defects associated with the stress results are shown in Fig. 7; as expected, stress concentrations were recorded at the corners of openings and wall connection locations.

The cracks on the existing structure and stress concentration in the model verify this method. The key findings from a comparison of stress concentrations due to response spectrum analysis are given in Fig. 7. The imperfect geometry due to settlement directly affects stress concentration values

Figure 7. Stress difference for accurate and imperfect geometric model under combined dead and earthquake loading (stress values obtained from SAP2000).

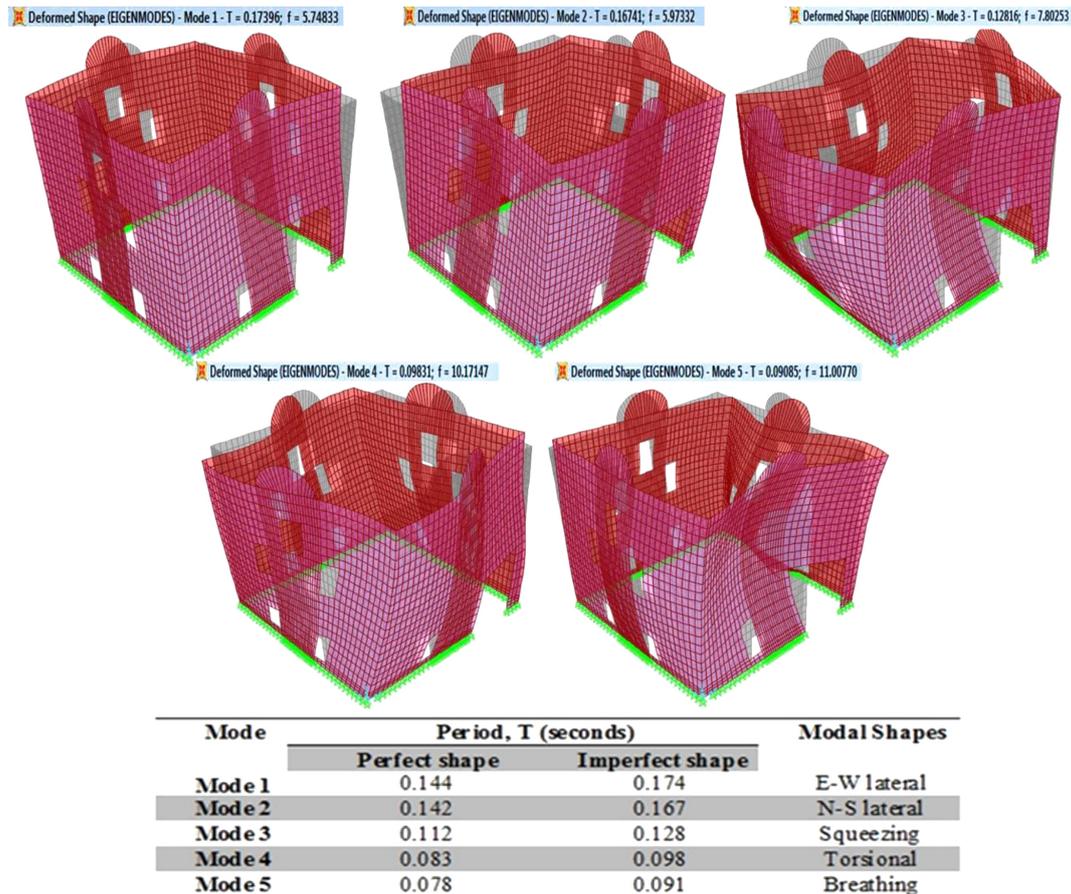
which are the key values to drawing retrofitting strategies for the historical monument. The comparison between the modes shows that the imperfect geometry has considerable influence on modes as well. The periods for every mode are summarized in Fig. 8. Stress concentration and the mode pe-

Figure 8. First five modes for as-built and assumed perfect geometry (SAP2000).
