# Field survey report and satellite image interpretation of the 2013 Super Typhoon Haiyan in the Philippines

E. Mas, J. Bricker, S. Kure, B. Adriano, C. Yi, A. Suppasri, and S. Koshimura

International Research Institute of Disaster Science (IRIDeS), Tohoku University, Miyagi, Sendai, 980-0845, Japan

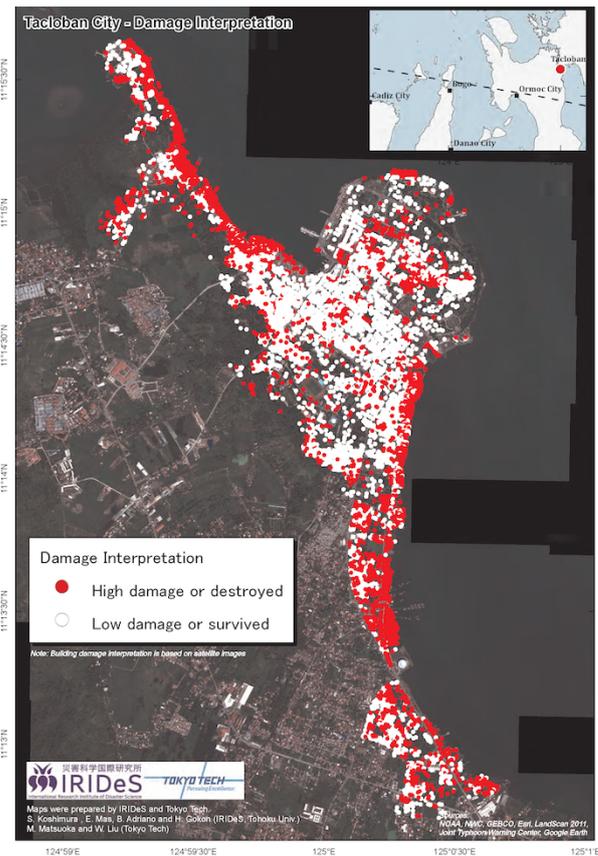
**Figure 3.** The results of the visual damage assessment using pre- and post-event satellite images and two classification criteria. (i) High damage or destroyed in red and (ii) low damage or survived in white.

The results of this assessment are shown in Fig. 3. Significant damage was interpreted on the coasts to the north and south of downtown Tacloban. During our field survey, we visually confirmed the extensive damage in these areas. The verification of our interpretation is, at this moment, qualitative due to the difficulties experienced during the field survey in gathering detailed information at a house-by-house resolution (Fig. 4). The extensive damage interpreted to the north and south of the downtown was confirmed to be due to the high vulnerability of the structures in these areas and to the presence of stranded ships, which caused most of the damage near the Anibong area (Fig. 5). In addition, areas interpreted as having high damage in Fig. 3 are correlated to high

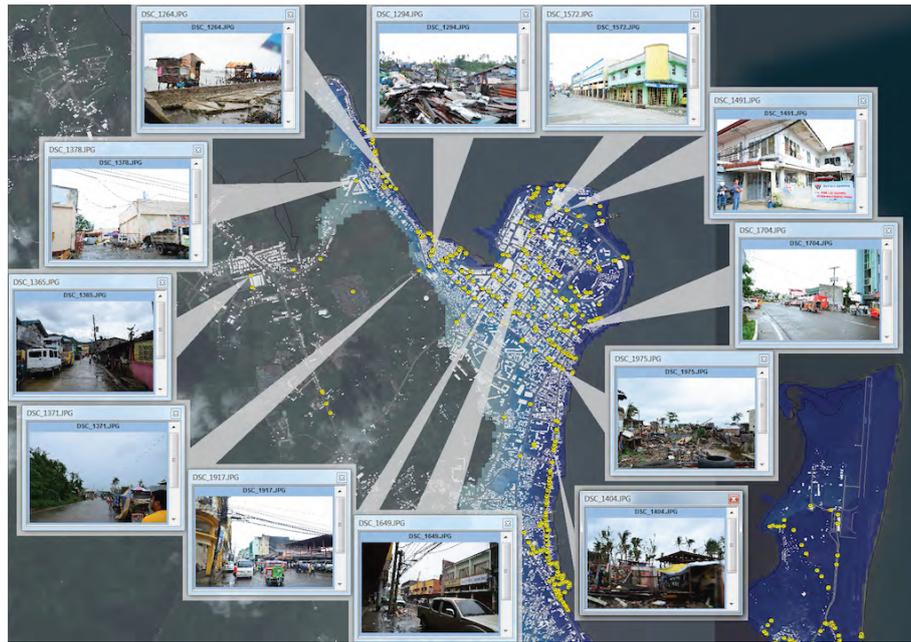
**Figure 4.** Photos taken during the field survey at the areas assessed through visual inspection of satellite images. The damage conditions and distribution confirm the interpretation that higher damages existed to the north and south of the downtown area in Tacloban city, the Philippines.

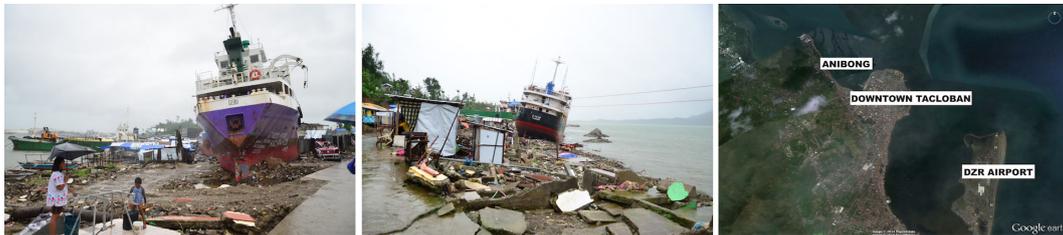
**Figure 5.** Stranded ships near the coast of Anibong to the north of the Tacloban downtown area. The storm surge was measured at approximately 6 m, and extensive damage was confirmed.

in the area (Fig. 5). Behind Anibong, a steep hill functioned as a barrier to the surge; however, the hill remains unstable due to the erosion of its slopes. Figure 11 shows the damage to concrete frame structures; a local landslide and soil erosion were deep enough to uncover house foundations and tree roots. Pile dwellings, or palafittes, are the main type of house found in this area. Due to these houses' lightweight building materials and their wooden piles not being deep enough in the sandy soil, this was one of the most vulnerable places in the Tacloban city area.

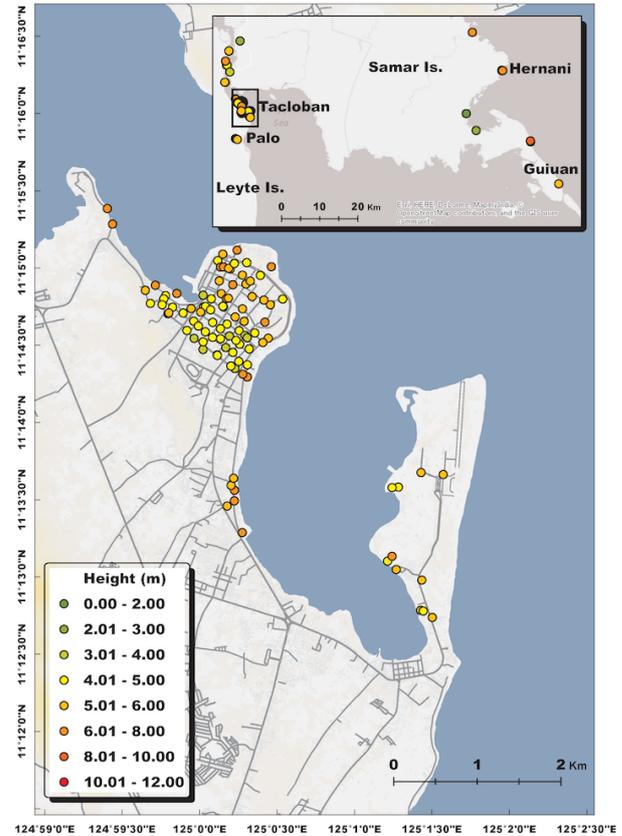
**Figure 7.** Storm surge inundation (Leyte Island and western Samar Island) and surface wave heights (eastern Samar Island) with respect to the local mean sea level.

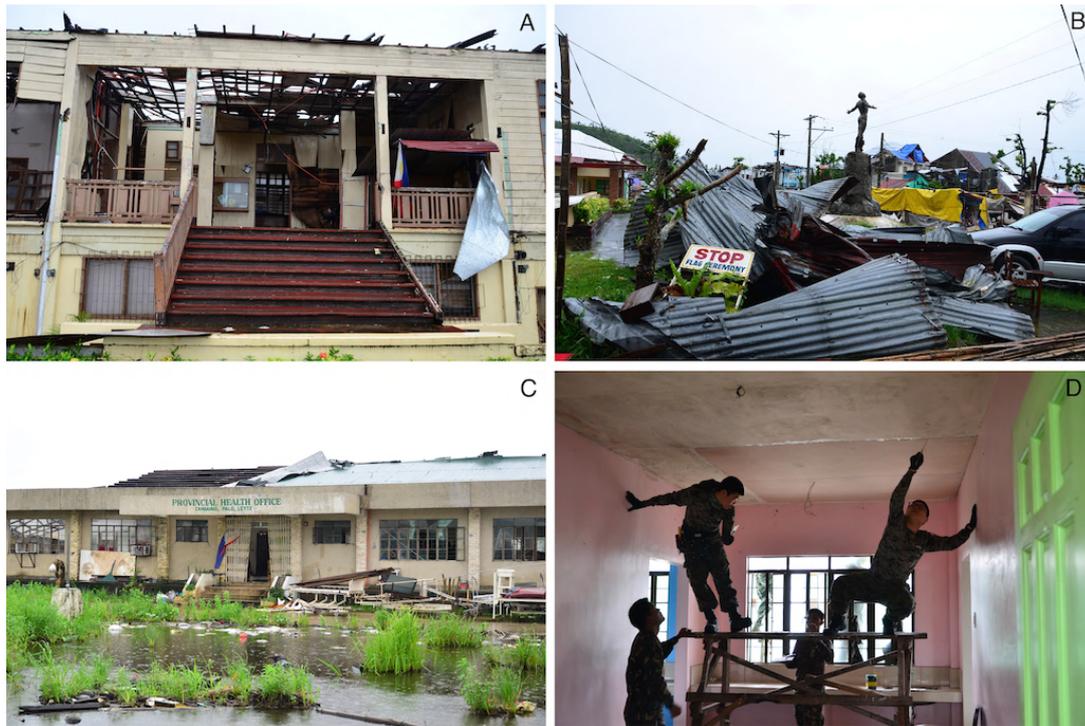
**Figure 8.** (a, b) Damage observed at the School of Health Science at the University of the Philippines, Manila. (c) Damage to the Provincial Health Office building in Palo. (d) The South Korean army helping with the restoration of a local hospital in Palo.

Palo is a neighbor to Tacloban city, in the south of Leyte, the Philippines. It was also heavily damaged, with several residents killed during the typhoon. The survey team visited the School of Health Science at the University of the Philippines, Manila, and found extensive damage to its infrastructure. In addition, hospitals in the area suffered from winds and the surge. Significant structural damage was not observed other than to roofs; however, equipment, medical supplies and windows were destroyed (Fig. 8).

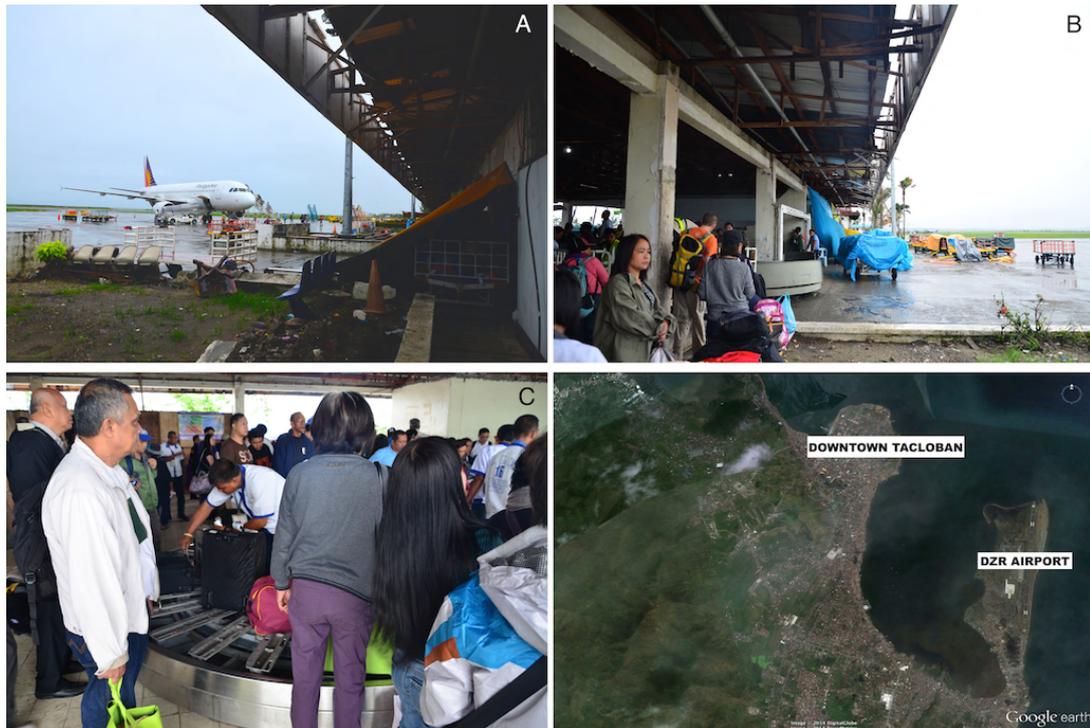
DZR Airport is located on the edge of the eastern peninsula of the Tacloban city area. This is a domestic airport with flights from Manila and Cebu. It was effectively destroyed by winds and storm surge inundations of, at most, 6 m in height. Walls, the roof and equipment were damaged. It was reopened for emergency relief 3 days after the disaster and, later, for limited commercial flights. At the time of

**Figure 9.** (a, b) Damage to the walls and roof of a gate to the side of the runway. (c) Passengers arriving and baggage claim belt out of service due to damage.

the field survey, no electricity, water, walls or baggage claim belts were available, as shown in Fig. 9.

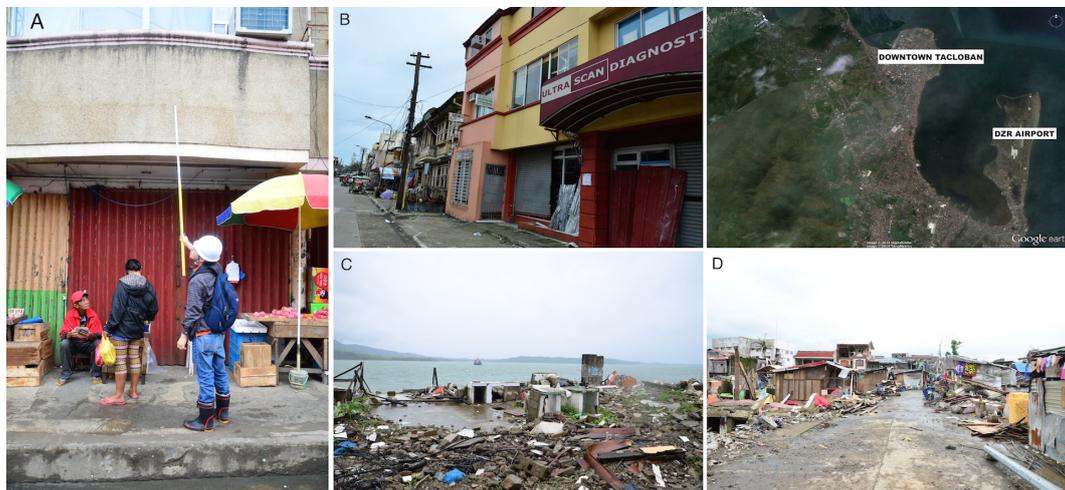
**Figure 10.** (a) Watermark in the inland downtown area, where no structural damage was observed. (b) Inland downtown, damage to doors due to flooding. (c, d) Extensive damage at the coastline near downtown Tacloban.

ings were dirtied by the storm surge and by rain falling in through roofs that had been blown away. Some soft walls and windows were broken, and equipment, furniture and architectural elements inside these buildings were ruined. However, structural damage (other than to roofs) was not severe (Fig. 10). Conversely, the coastal areas of Tacloban, some near downtown, were struck by wind, the storm surge and surface waves on top of the surge. The complete collapse

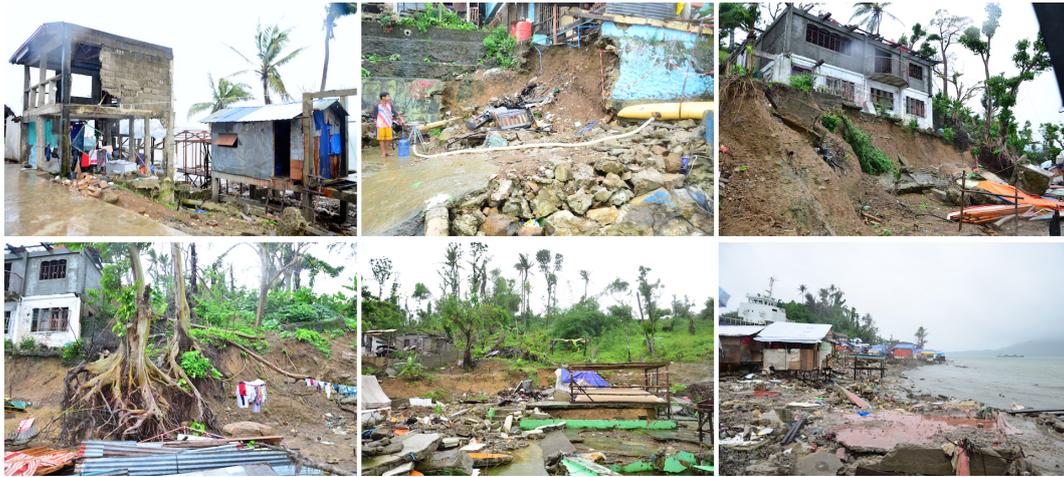
**Figure 11.** Damage observed at the Anibong area, north of downtown Tacloban. Destruction of wooden pile dwellings, erosion and local instability of slopes.

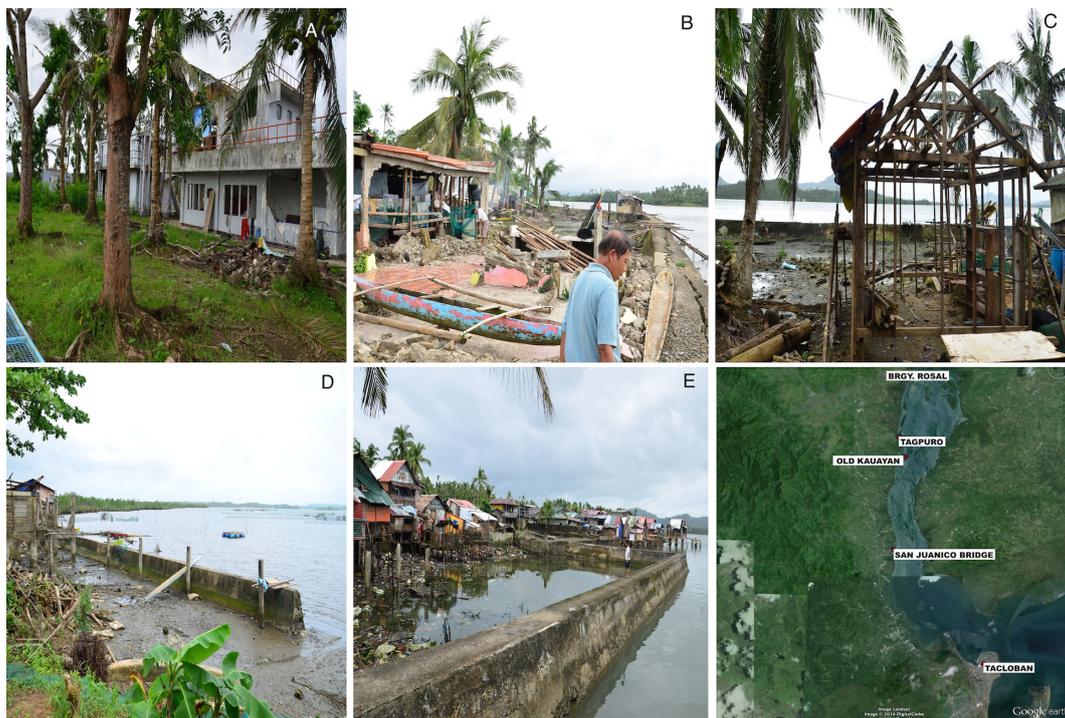
**Figure 12.** Damage at the northern part of Leyte Island. (a) Structure near the San Juanico Bridge. Inundation height was measured at 5.9 m. (b, c) Coastal village of Old Kauayan, where a small sea wall was overtopped and damaged. Surge flooding of 4.4 m was measured here. (d) Sea wall damage at Tagpuo. The run-up height was 6.9 m. (e) Barangay Rosal area with a 5.0 m storm surge inundation and damage to houses behind the 3.0 m sea wall.

Driving north from Tacloban city, Leyte Island is connected to Samar Island by the San Juanico Bridge. We surveyed the area and found flooding heights up to 5.9 m with damage to equipment and furniture inside concrete structures. No significant structural damage was reported in these areas. Farther to the north, along the San Juanico Strait, villages such as Old Kauayan and Tagpuro were affected by surge inundations between 4 m and 6 m high and by a measured run-up on the hill of Tagpuro of 6.9 m in height. In Old Kauayan, there was extensive damage to coastal wooden houses and to the community school. A seawall of 3 m was overtopped, and the flow generated scour at the wall's landward side. The northern part of the area visited by the team was Barangay Rosal, where the local mayor described the event and reported heights up to 5 m. Significant damage was observed

to pile dwellings located behind a 3 m high seawall, which was overtopped by the storm surge, and roofs were ripped off by the winds. The storm surge mainly affected the west side of the San Juanico Strait, from the bridge up to the north (Fig. 12).

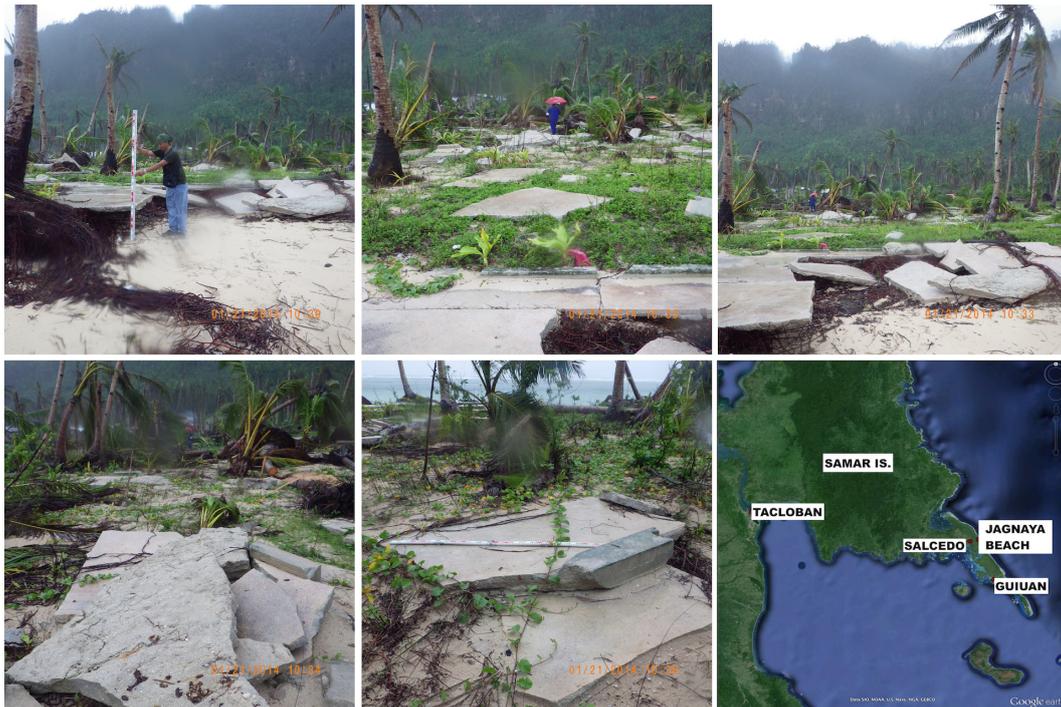
**Figure 13.** Guiuan village, one of the areas most affected by storm surge and superimposed storm waves. Sand erosion, vegetation damage and destroyed concrete structures were observed.

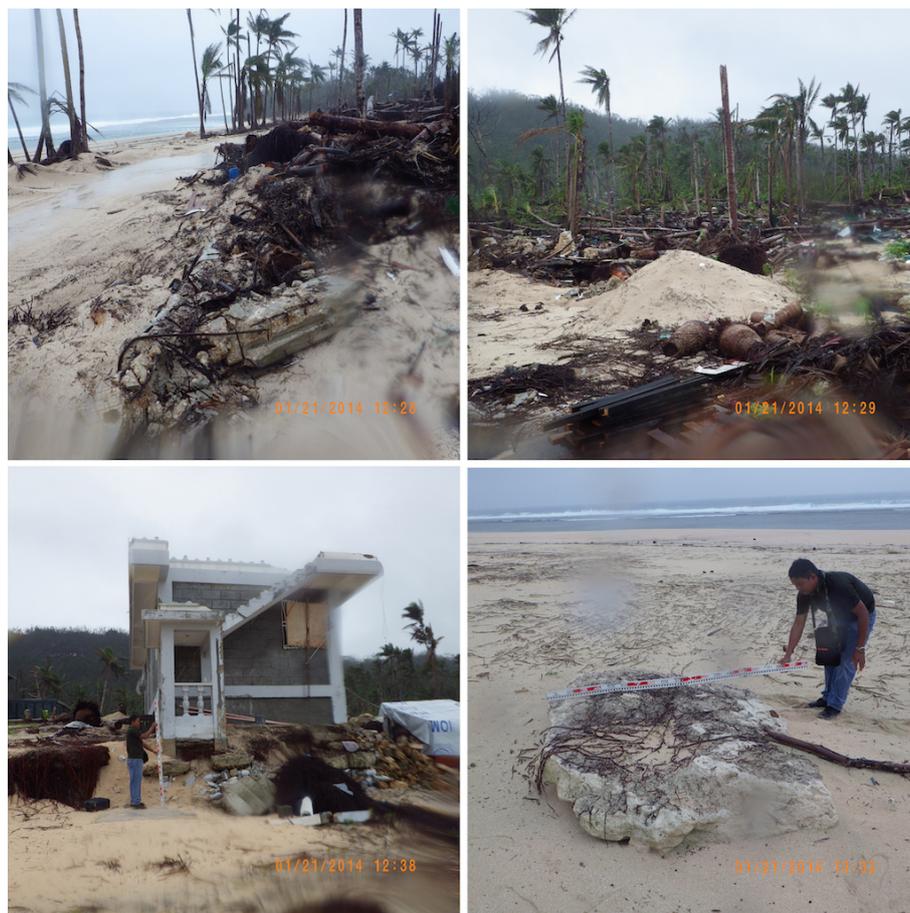
**Figure 14.** Jagnaya Beach area, east of Salcedo village. Extensive sand erosion and deposition to inland was observed. In addition, coral boulders were observed on the beach, which were possibly carried inland by the waves.
