The Stava mudflow of 19 July 1985 (Northern Italy): a disaster that effective regulation might have prevented

F. Luino¹ and J. V. De Graff²

Abstract. The disaster occurring in the Eastern Italian Alps in the summer of 1985 was caused by the failure of two tailings dams located just upstream from the village of Stava in the municipality of Tesero (Trento province, Italy). The structure comprised two small storage basins for the deposition of tailings from the separation process of the Prestavel fluorite mine. On their downstream sides, the basins were contained by steep earth embankments, whereas upstream they rested directly on the natural slope. The total height from the base of the lower dam to the crest of the upper dam was over 50 m.

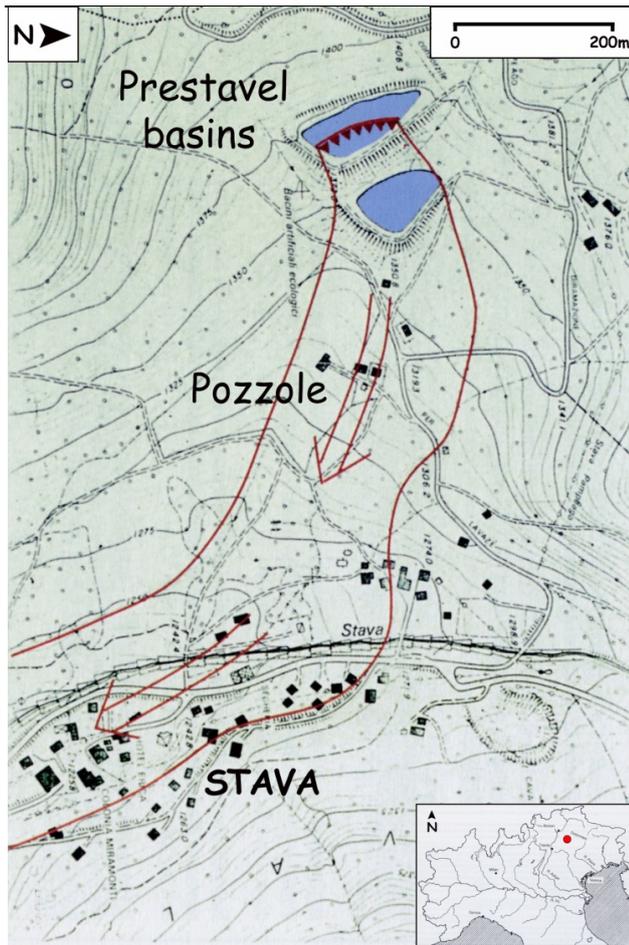
Fig. 1. Stava village and the Prestavel basins in the official map before the collapse. Red lines show failure and the path of the mudflow (courtesy of Fondazione Stava, 1985).

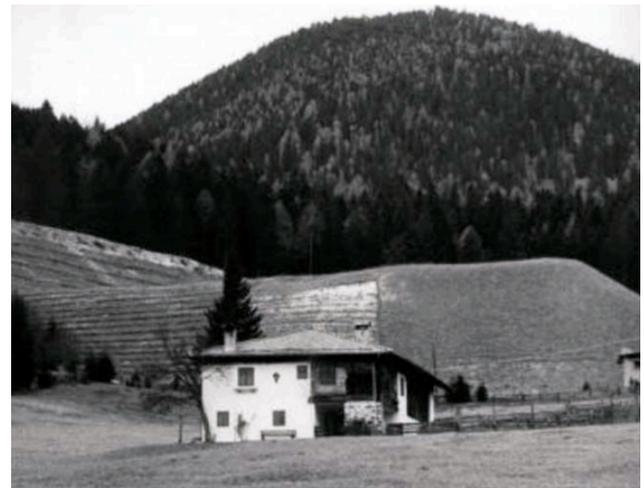
The elevation of the lower impoundment was 1350.80 m, or a maximum dam height over ground level of about 22–23 m. At the time of the disaster, the maximum elevation of the dam crest was 1378.83 m, or a maximum dam height of about 28 m. Viewed as a single section, with one dam face directly above the other, the structure was presented as a loose earth embankment over 50 m high (Fig. 3).

Fig. 3. 1981–1982: bottom view of the two basins almost completely replanted. It is possible to notice the progressive levels of growth achieved by hydrocyclone and the caretaker's house in the foreground (courtesy of Fondazione Stava, 1985).

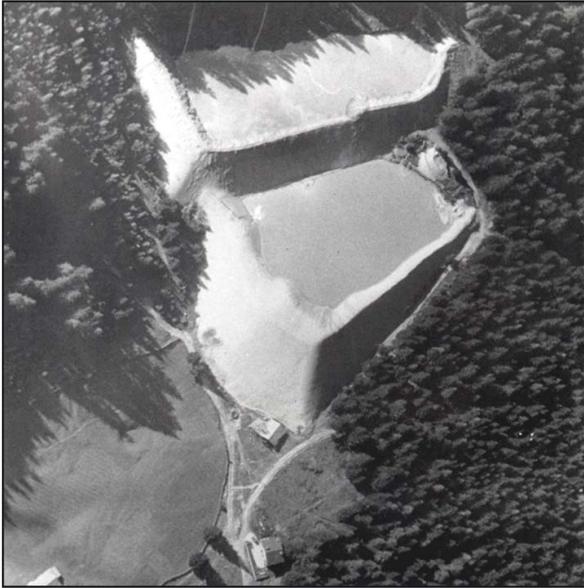
Fig. 5. Aerial view of the basins in October 1973, nearly two years after the construction of upper basin; in this one is in progress the raising of the embankment from the orographic left side (photo Impresa Rossi, Brescia).

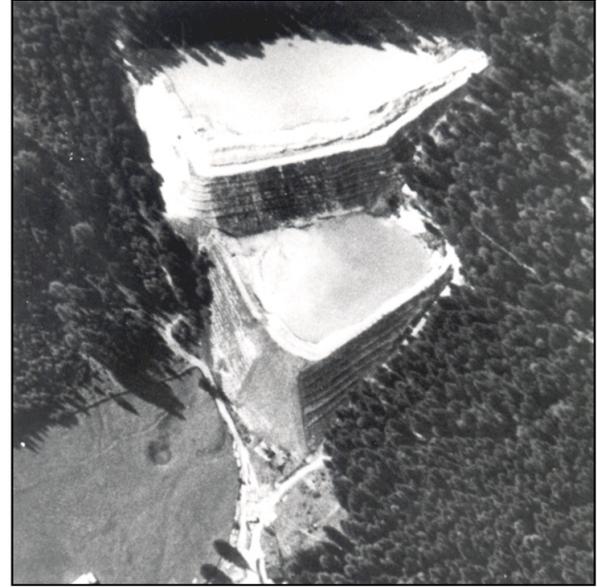
Fig. 6. The decantation basins photographed in September 1978. The geometry of the upper basin seems altered with respect to the previous photo: works to raise the embankment according to the scheme “upstream” are clearly in progress (photo Impresa Rossi, Brescia).

An aerial photograph taken in September 1978 (Fig. 6) shows that while the geometry of the lower basin had remained basically unchanged, that of the upper basin appears planimetrically and altimetrically different from previous photographs. The crest of the embankment was estimated to be at 1373 m or about 10 m higher than in 1973. A few meters further down, a berm, built to break the steep gradient of the external face (39°), ran along the entire perimeter of the embankment at an average elevation of 1371 m. Also in this photograph, evidence of dam raising can be clearly observed on the left side, starting from its northern end. The basin appears slightly extended, forming a triangle towards its northern end and reaching further upstream.

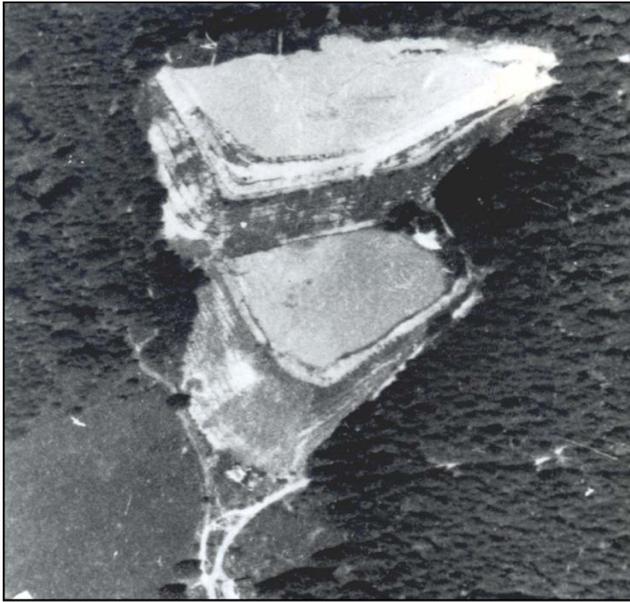
Fig. 7. The Pozzole basins in the summer 1983. The top of the upper embankment appears amply broadened and leveled. Also noticeable is the development of the delta deposit at the left end of the upper basin, next to the place of cyclone operation (photo Impresa Rossi, Brescia).

An aerial photograph taken in 1983 (Fig. 7) reveals the later changes mainly involving the upper impoundment. It demonstrates more or less completed banking of the entire embankment. By this time it had reached an altitude of 1376 m, about 3 m higher than in 1978 and about 13 m higher than in 1973. In both basins, the water appears whitish and very murky. The upper impoundment is more significantly enlarged by the deposit at “delta” fed by the cyclone installed at the basin’s northern end. Along the south side and frontally, water touches the internal face of the embankment.

The aerial photograph taken in 1983 shows very noticeable lighter, elongated patches on the external face and the right side of both embankments. Almost all the embankment of the upper basin appears raised in comparison with the previous image and the height was realized using the “upstream” construction method.

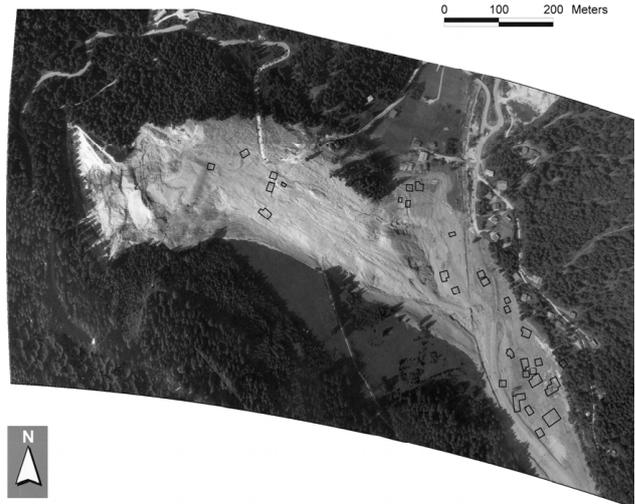
Fig. 8. The Pozzole basins and the upper part of the mudflow a few hours after the disaster. The large displacement of dam material is observable in the frontal sector of the upper embankment and the tracks of the scarps for the detachment and outflow of the materials deposited in the basin. On the left side, the sandy-silty deltaic deposit has remained almost completely in place. The remains of the lower embankment appear slightly in relief under the muddy covering. The photograph, processed using ArcView GIS and thus slightly deformed due to the collimation with the elements of the Regional Technical Map, shows the traces of the external walls of the destroyed buildings (photo Aeron. Mil., conc. S.M.A. no. 623, 19 July 1985).

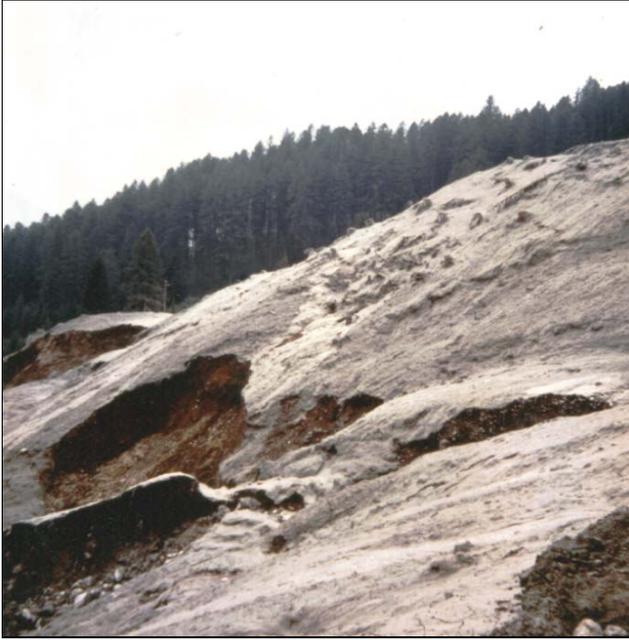
Fig. 9. A slope sector at the foot of the Pozzole basins, just upstream the Stava village. The photograph shows a thin layer of mud left behind as the mudflow moved downstream. The effects on the ground and the destructive effects on forest cover are also visible (photograph CNR-IRPI Torino, 20 July 1985).

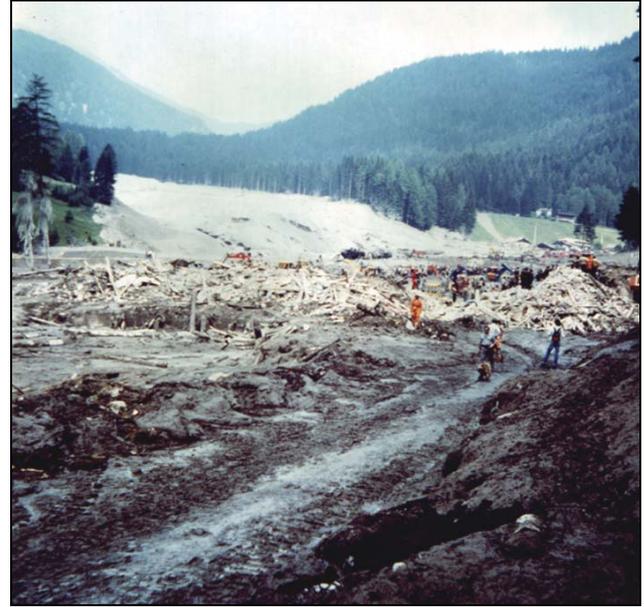
Fig. 10. Area where Stava village once stood. The mudflow in this urbanized sector reached a maximum height of 14 m in the middle of the valley bottom; all buildings were destroyed at the ground level. The mud-covered Pozzole slope (Fig. 6) is visible in the upper left side of the picture (photograph CNR-IRPI Torino, 20 July 1985).

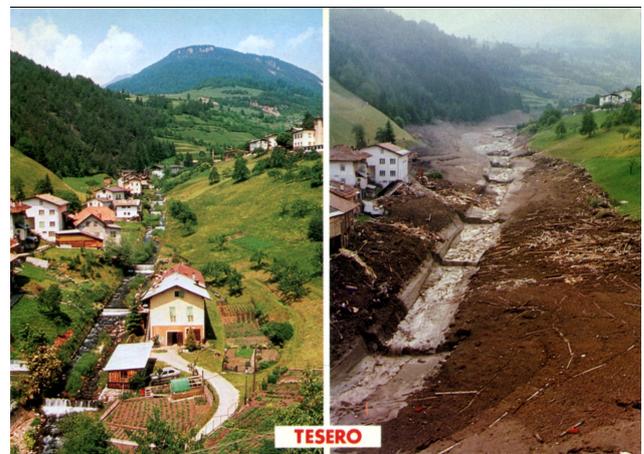
Fig. 13. Before and after the passage of the mudflow in the Tesero village at section 20 in Fig. 8 (postcard – Foto Trettel, P., edited by: Artesan, Tesero).

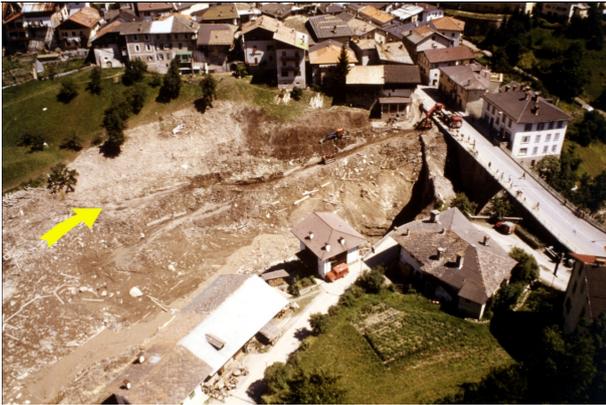
the fluid mass overflowed the older bridge and partially removed the roadway. In this section the mud track on the left side was 10 m higher than those observed on the right side, with a maximum height on the left of about 18 m above the valley bottom (Fig. 14).

Fig. 14. The effects produced by the mudflow in Tesero, upstream of the two bridges. For the curvature of the axis to the right valley, the mass raised considerably on the left side to 10 m more than the right bank (photo CNR-IRPI Torino, 20 July 1985).

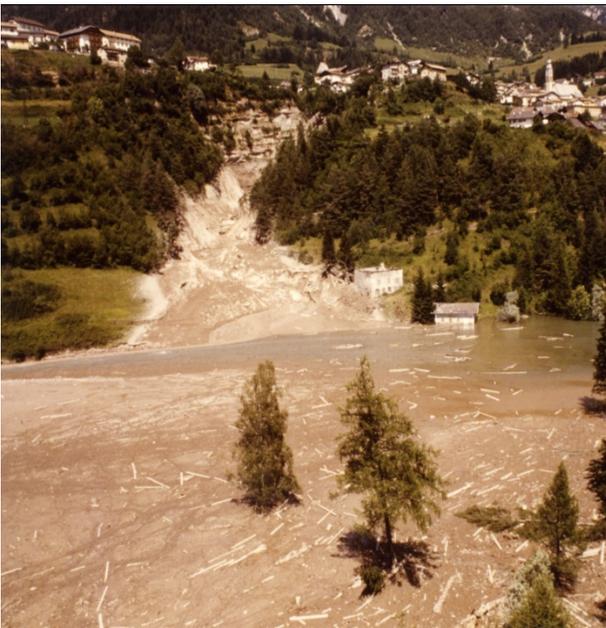
Channeled into the deep incision downstream from the two bridges, the mass rapidly reached the area of confluence of the Stava and Avisio rivers, where the mudflow gradually came to rest. The wide, fairly flat valley bottom allowed the mud materials to deposit over an area of approximately 100 000 m². The flat, displaced mass that accumulated in the Avisio riverbed formed a dam upstream from the confluence and formed a lake 500 m long (Fig. 15).

Fig. 15. Stava creek at the confluence with the Avisio River. In its final confined stretch, the mudflow triggered significant erosion of both sides of the valley and the valley bottom. Along the path, all the trees were removed. On the margins, mud marks reached the tops of trees up to 25 m height above the valley floor. In the river bed of the Avisio River, a basin was created that extended about 10 ha in total (deposit forming the dam plus the lake behind it) (photo CNR-IRPI Torino, 20 July 1985).

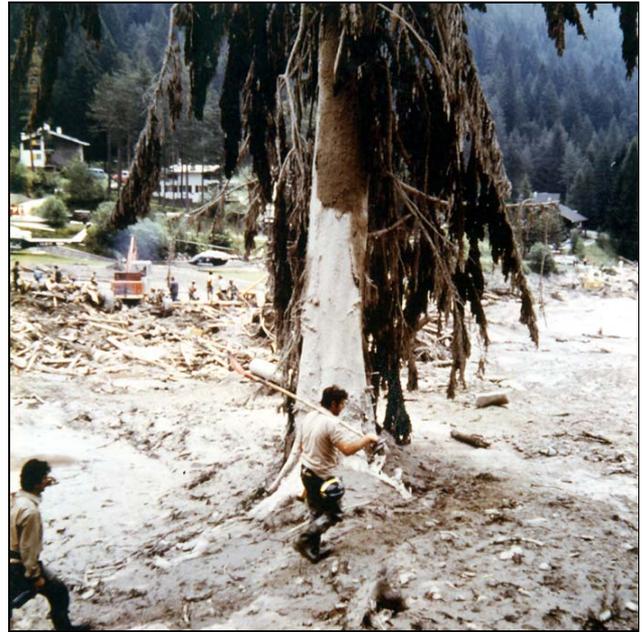
including the destruction of buildings and uprooting of hundreds of trees along the mudflow path until reaching the Avisio River. Of note is that numerous tree trunks were deposited in long levees on both sides of the mudflow, together with the coarser and heavier materials the mass movement had picked up and carried with it (Fig. 16).

Fig. 16. Just upstream from Stava village, the mudflow had a remarkable height despite its obvious width. This is evident by signs of barking on the tree (by abrasion of the densest part of the mudflow) and by the apparent heaviness of the foliage widely covered by mud (as a result of the higher and smoother of the mudflow). Some of the trees and coarser material deposited as levees along the track are visible in the background (photograph CNR-IRPI Torino, 20 July 1985).
