Site investigation of masonry buildings damaged during the 23 October and 9 November 2011 Van Earthquakes in Turkey

F. Piroglu and K. Ozakgul

Dept. of Civil Engineering, Istanbul Technical University, 34469 Maslak, Istanbul, Turkey

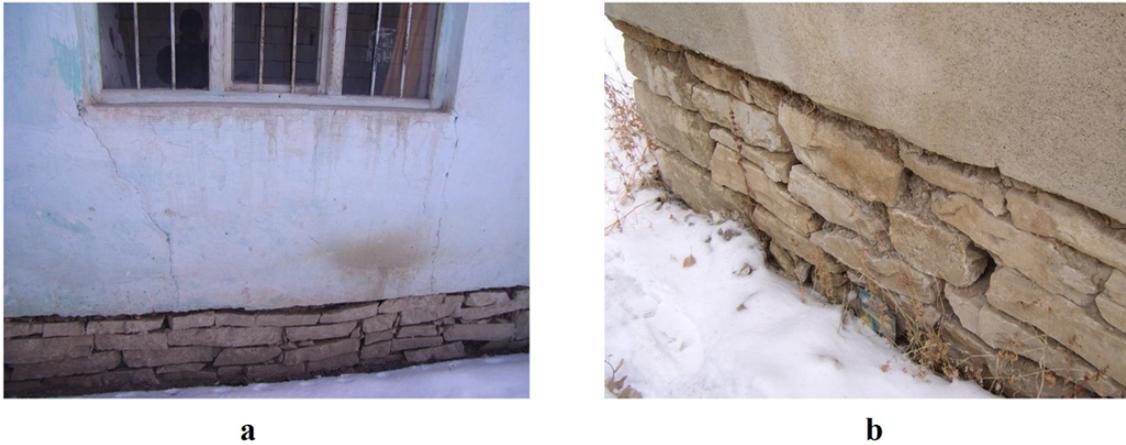
The foundations of these buildings were mostly constructed at about 30 cm to 50 cm depths directly on the ground surface, as shown in Figs. 12 and 13, and the masonry walls were apparently built without using any plinth band beams and proper connections or anchorages on the top of the foundation. The plinth band beams should be built to prevent settlement of the building and also to provide lateral resistance and integrity to these buildings (Furukawa and Ohta, 2009). The foundations were generally laid in courses formed by intermingling of stones having non-uniform sizes and shapes and sometimes without using any mortar.

Fig. 13. Views for the typical foundation of a masonry building.

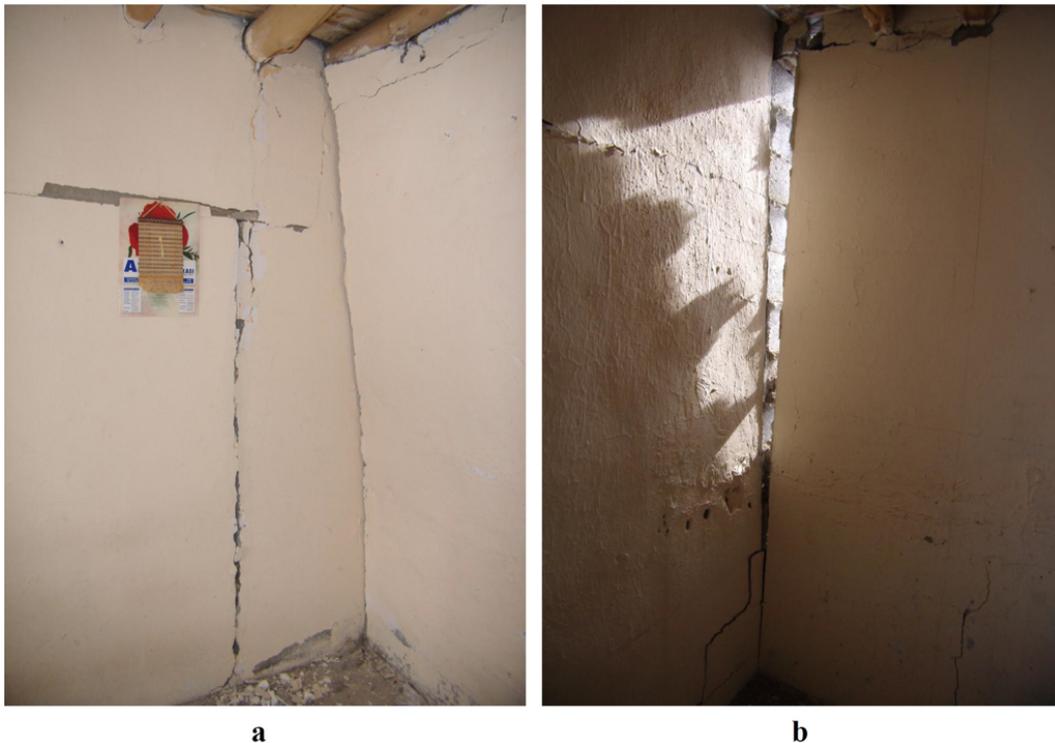
had frequently developed and propagated along the height of the bearing wall intersections, as seen in Figs. 14 and 15. Gaps of up to 10 cm were measured at the top of these walls due to the lack or inadequate anchorage of the wall-to-wall connections.

Fig. 14. Severe damages due to overturning moments and developed gaps at the intersections of the bearing walls.

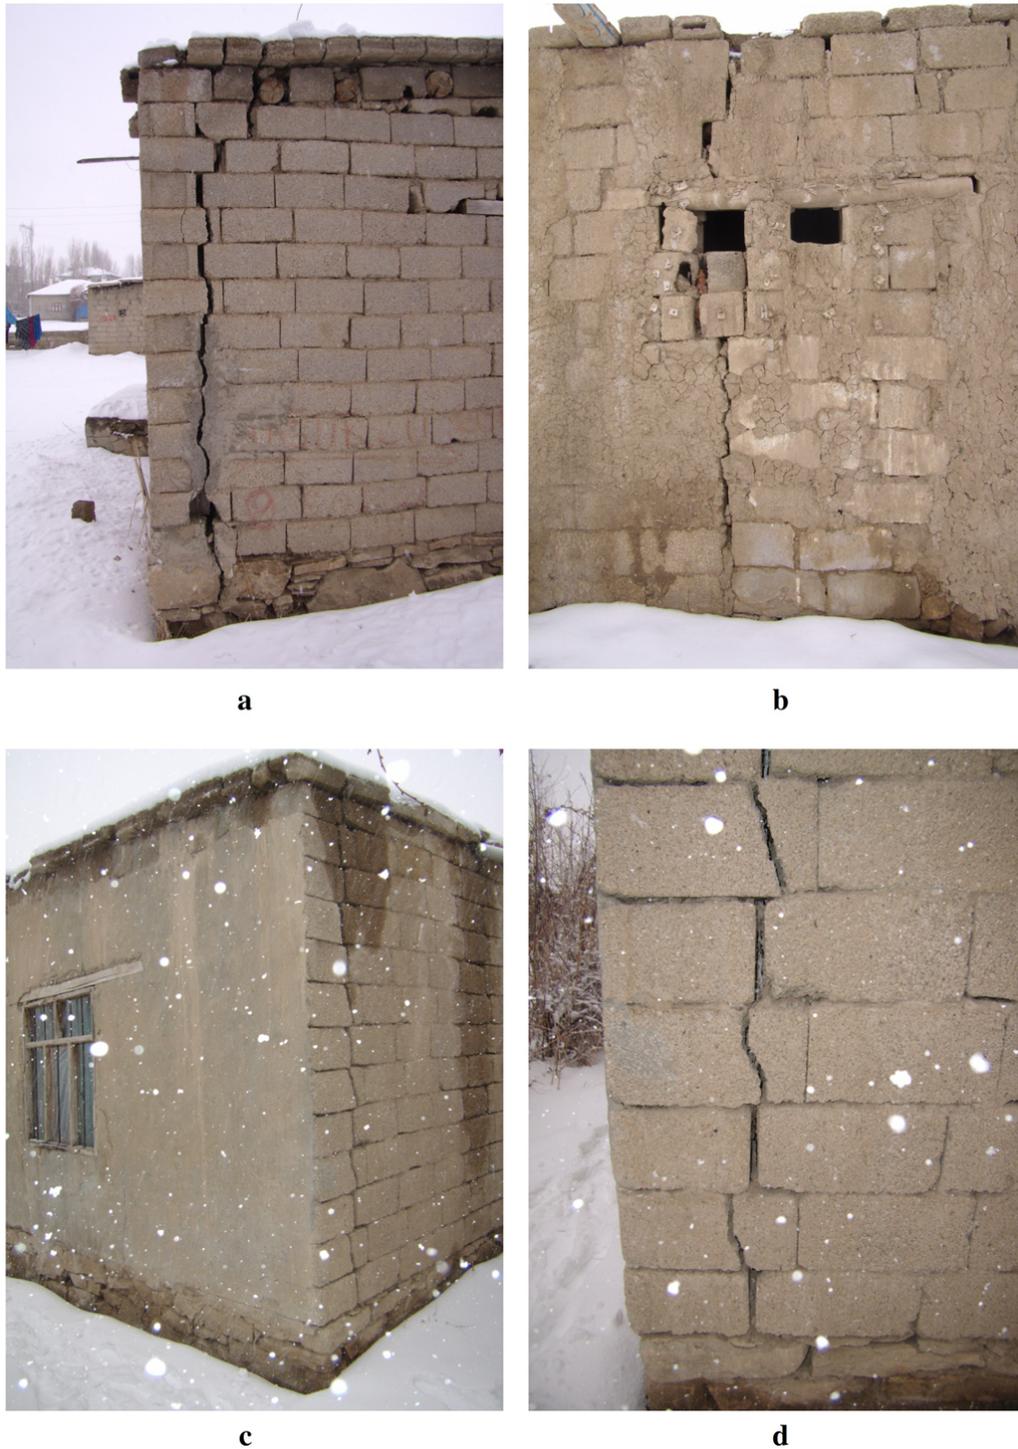
Fig. 15. Serious vertical crack propagations in the walls.

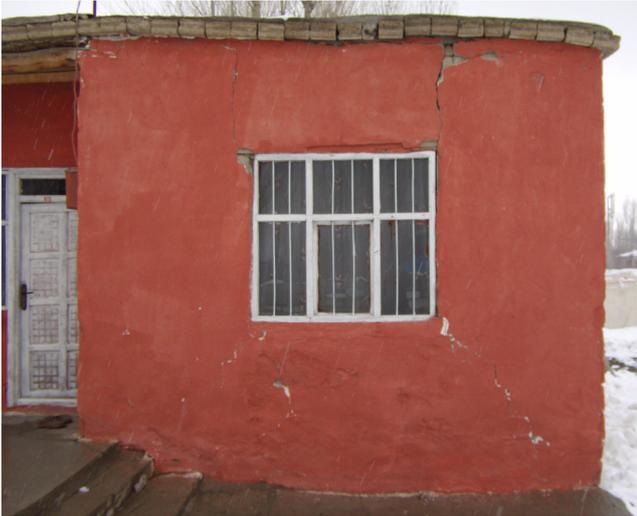
The most common damage observed in the unconfined masonry buildings was the inclined cracks that developed at the bearing wall portions above and below the window openings and above the door openings. It was observed that the cracks propagated from the corners of the openings where high stress concentrations exist occurred due to the lack of lintel and sill beams which should be constructed above and below the openings in the bearing walls, as seen in Figs. 16 and 17. Timber beams were mostly used as the lintel-beams for the door and window openings of the masonry walls in the Hacibekir district as well as in rural areas of Turkey.

Fig. 16. The cracks developed at the sill and spandrel parts of a masonry wall with a window opening.

Furthermore, confining tie columns constructed on both sides of these openings could also prevent the propagation of the inclined cracks in this part of the bearing wall,

as recommended in Turkish earthquake codes (TEC, 1998, 2007). Additionally, these tie columns should improve the stability of these walls by the means of their slenderness ratios.

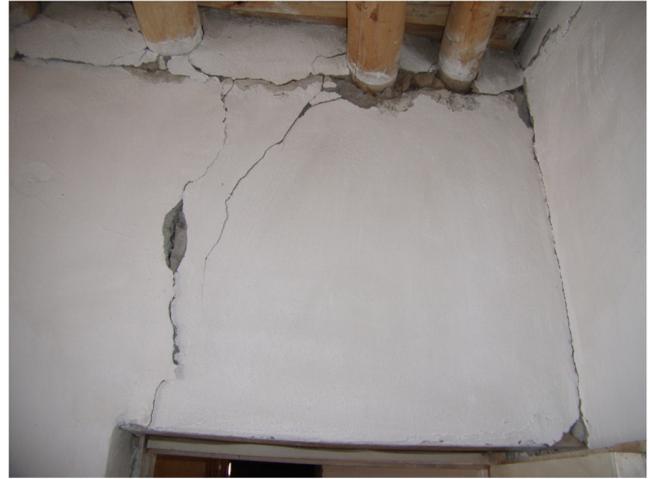
Fig. 17. Plaster spalling and the cracks developed at the spandrel part of a masonry wall above the door opening.

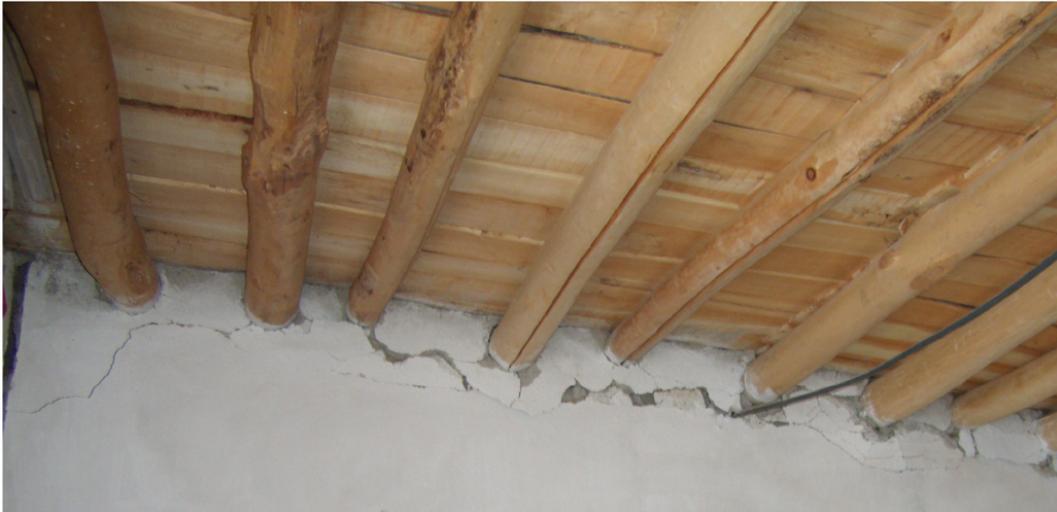
The wooden logs supported on the masonry walls led to plaster spalling and vertical cracks starting under the log ends and developing along the top of the wall because of the compressive stresses. It is clear that due to this, a decrease or even loss of strength of the bearing wall can be expected, as seen in Figs. 17 and 18. During the field study, it was observed that some of the logs were previously weakened by the severe cracks naturally occurred along their lengths during their lifetime (see Fig. 18). Sometimes it was seen that the exterior or interior plaster was partially or totally spalled along the adobe walls and gaps had developed at the intersection of the bearing walls, as seen in Figs. 19 and 20. It is possible to expect that these walls should collapse due to the effects of the strong future aftershocks. Based on the field observations, heavy flat roofs of the adobe buildings supported

Fig. 18. The plaster spalling under the log ends and longitudinal cracks in some logs.

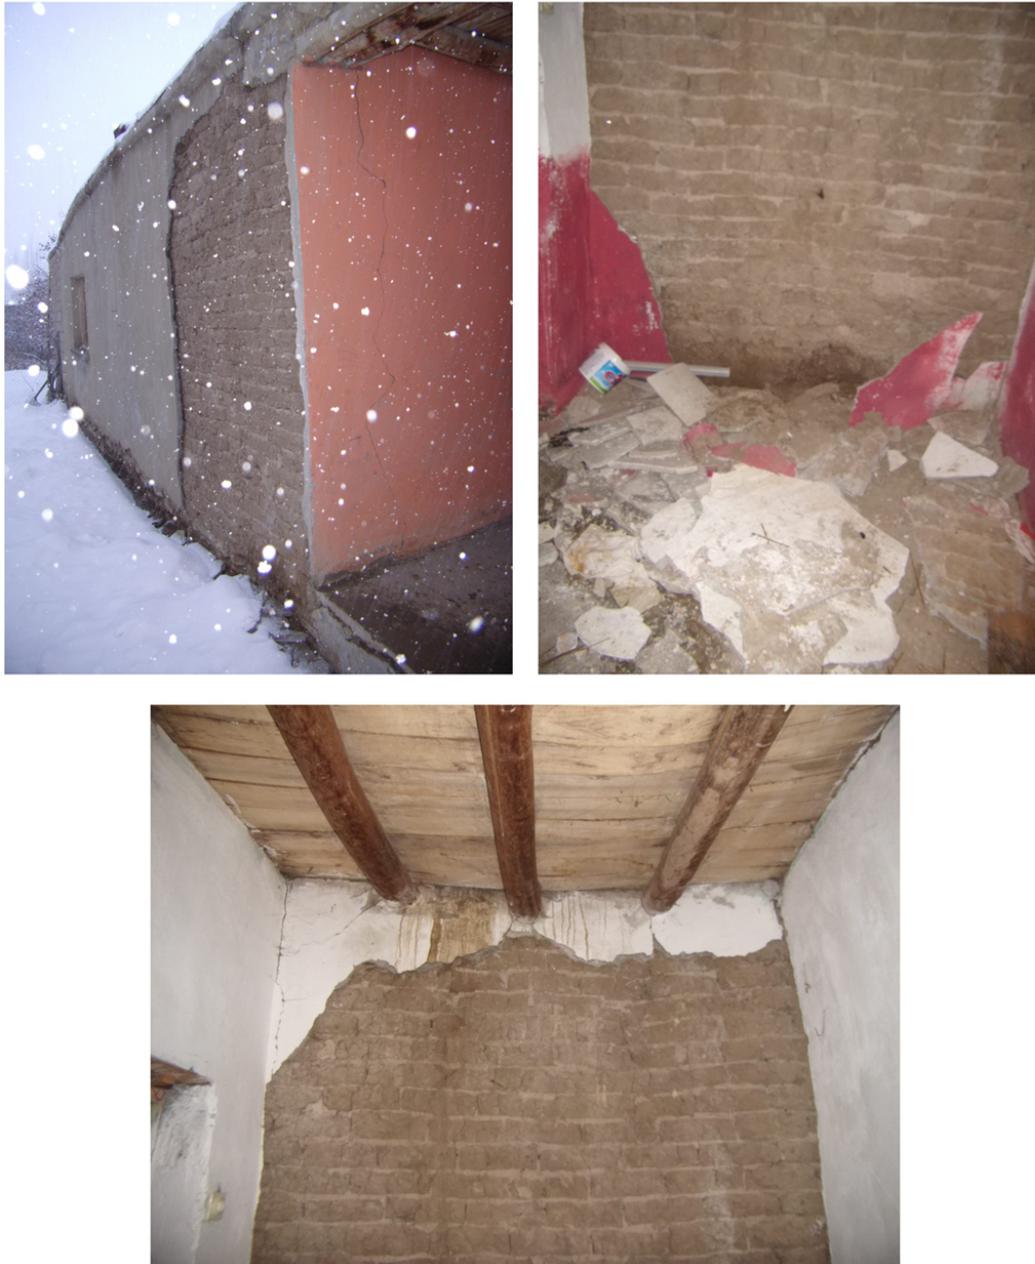
Fig. 19. The exterior and the interior plaster spalling at the adobe walls.

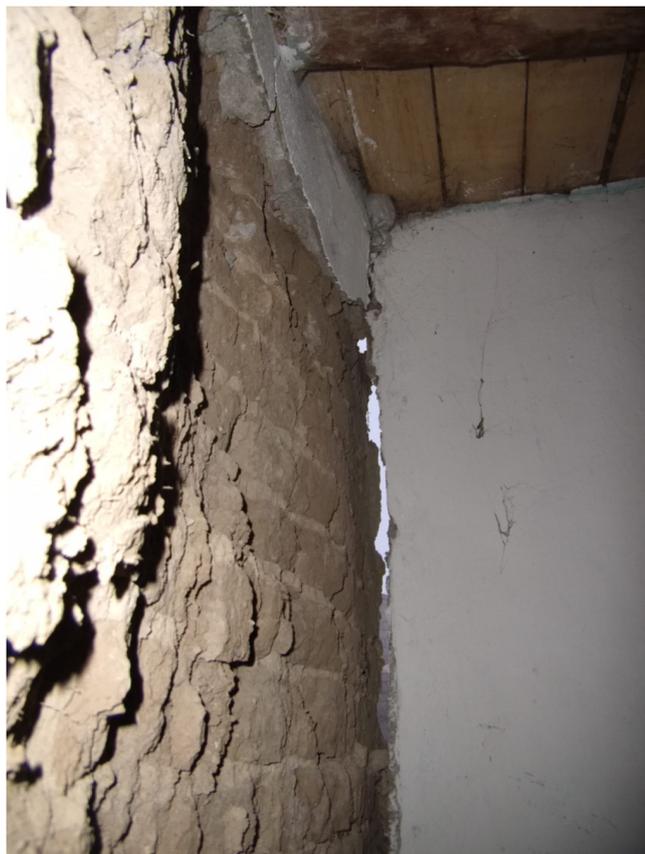
Fig. 20. The interior plaster spalling and severe separation that occurred in the intersection of the walls in an adobe building.

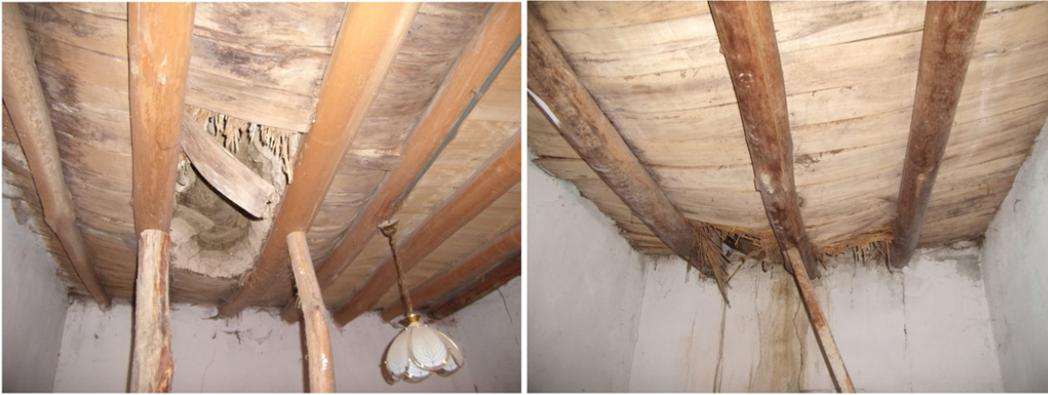
by wooden logs were severely affected by the earthquake-induced inertia forces due to their weight, and as a result of this roofs and bearing walls had partially collapsed. To prevent the total collapse of these roofs, the logs were supported by using wooden posts, as seen in Fig. 21. Occasionally, the debris of the partially collapsed buildings was removed by the homeowners, as shown in Fig. 22.

Fig. 21. Partially damages observed in a heavy flat roof system.

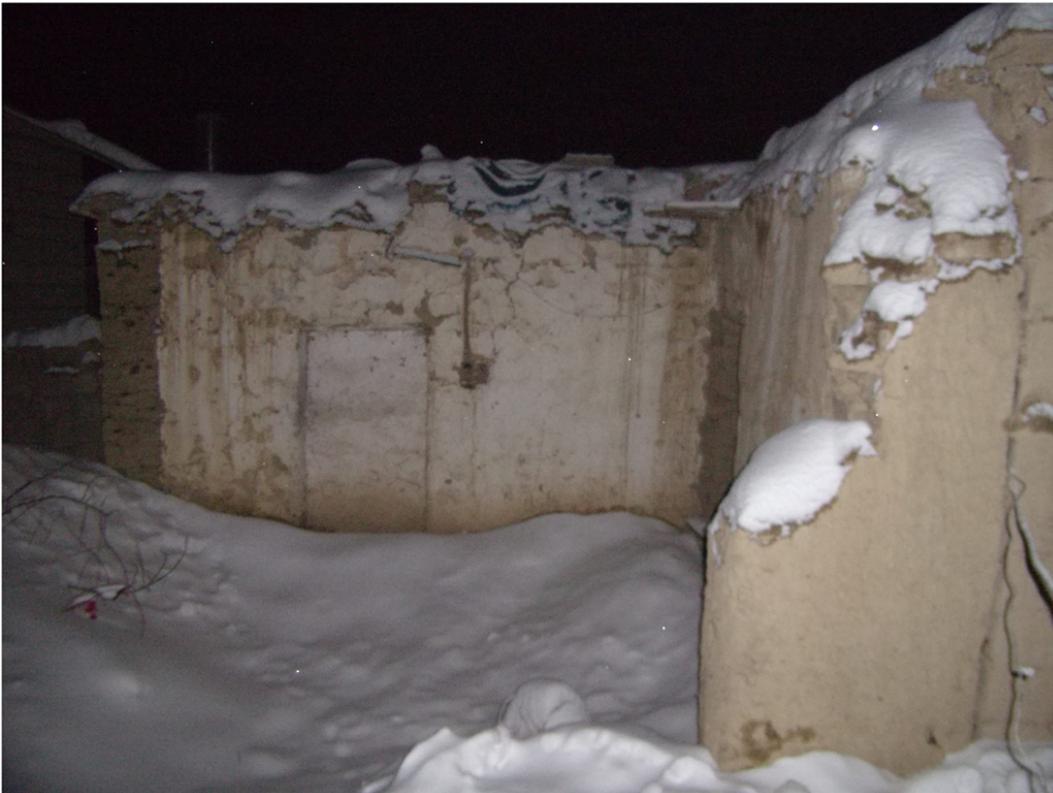
Fig. 22. A partially collapsed adobe building where the debris was removed.

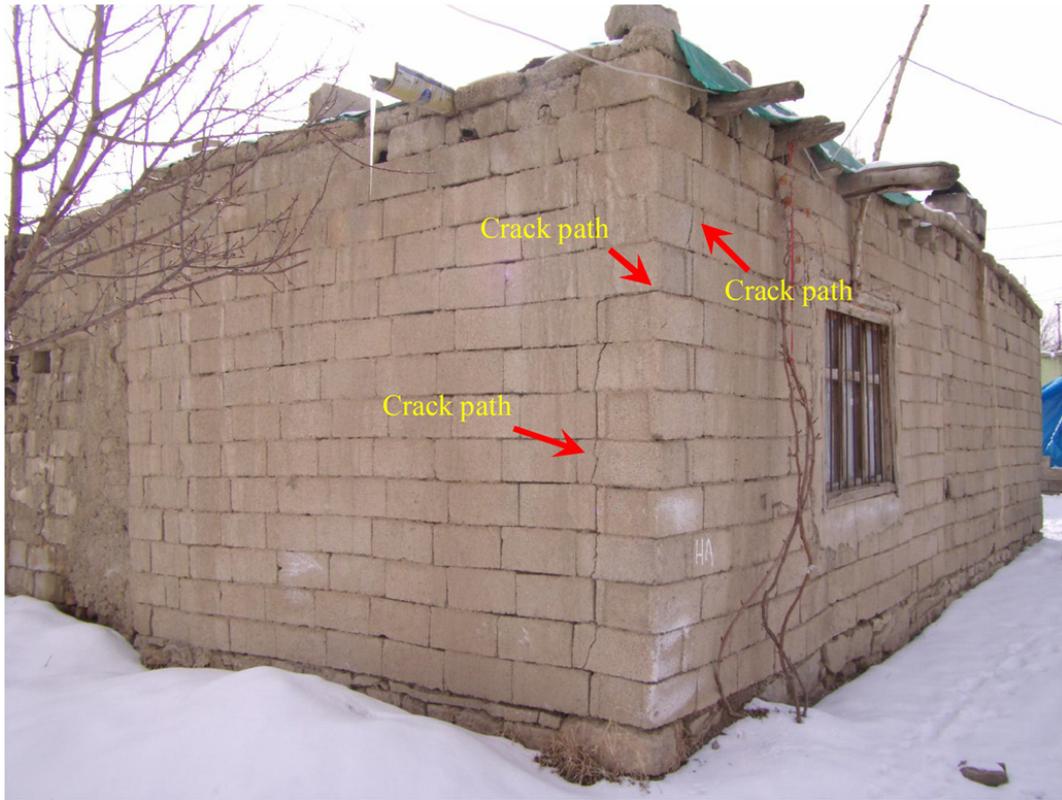
another requirement is defined for the arrangements of the bearing walls in plan. It is recommended to arrange these walls regularly and symmetrically or nearly symmetrically with respect to the main axes in order to prevent development of torsional moments and cracks (Klingner, 2006), as seen in

Fig. 23. In the field it was mostly observed that symmetry of the buildings was mainly present in one direction, but in the other orthogonal direction this requirement was nearly satisfied. The continuity of the bearing walls in vertical direction is another important restriction of the Turkish earthquake

Fig. 23. Crack propagated from one wall to the other in perpendicular direction at the building corner.

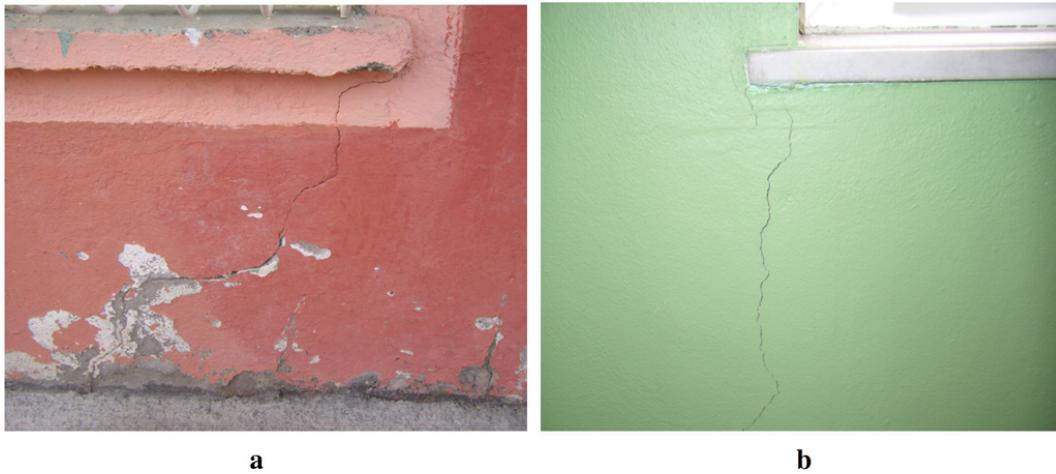
Based on the site investigations, the confined masonry buildings in this region had usually shown good performance during the two consecutive earthquakes. The large number of these buildings only suffered minor crack damages, particularly between the masonry walls and the confining members, at the spandrel or sill parts and at the corners of the openings, as given in Figs. 27 and 28.

Fig. 27. Slight cracks at sill parts of window openings.

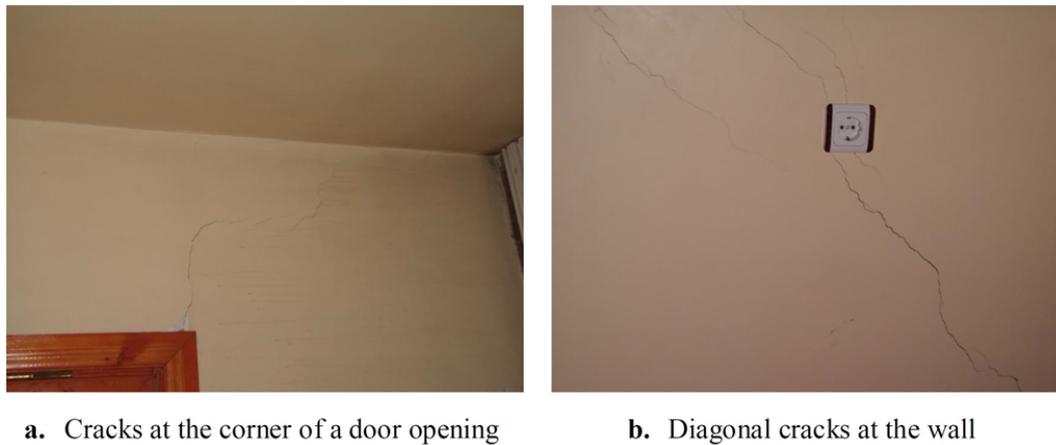
According to the Turkish earthquake codes, all the rules mentioned in the previous section are also valid for the confined masonry buildings. Additionally, maximum unsupported length of a load-bearing wall could be extended from 5.5 m to 15 m (TEC, 1975) or even to 16 m (TEC, 1998, 2007) in the first seismic zones, if tie columns could be constructed at the corners as well as in the walls each having plan lengths of no more than 4 m. The same extension is also valid for the other seismic zones. It was observed that in some of the confined masonry buildings, the unsupported lengths of the bearing walls without any openings were measured as a maximum of 5 or 6 m, and minor diagonal cracks were detected on these walls, as seen in Fig. 28b.

Fig. 28. Slight damages in a confined masonry building.
