The 27 May 1937 catastrophic flow failure of gold tailings at Tlalpujahua, Michoacán, Mexico

Abstract. On 27 May 1937, after one week of sustained heavy rainfall, a voluminous flood caused the death of at least 300 people and the destruction of the historic El Carmen church and several neighborhoods in the mining region of Tlalpujahua, Michoacán, central Mexico. This destructive flood was triggered by the breaching of the impoundment of the Los Cedros tailings and the sudden release of circa 16 Mt of water-saturated waste materials. The muddy silty flood, moving at estimated speeds of 20–25 m s⁻¹, was channelized along the Dos Estrellas and Tlalpujahua drainages and devastated everything along its flow path. After advancing 2.5 km downstream, the flood slammed into El Carmen church and surrounding houses at estimated speeds of ~7 m s⁻¹, destroying many construction walls and covering the church floor with ~2 m of mud and debris. Revision of eyewitness accounts and newspaper articles, together with analysis of archived photographic materials, indicated that the flood consisted of three muddy pulses. Stratigraphic relations and granulometric data for selected proximal and distal sam

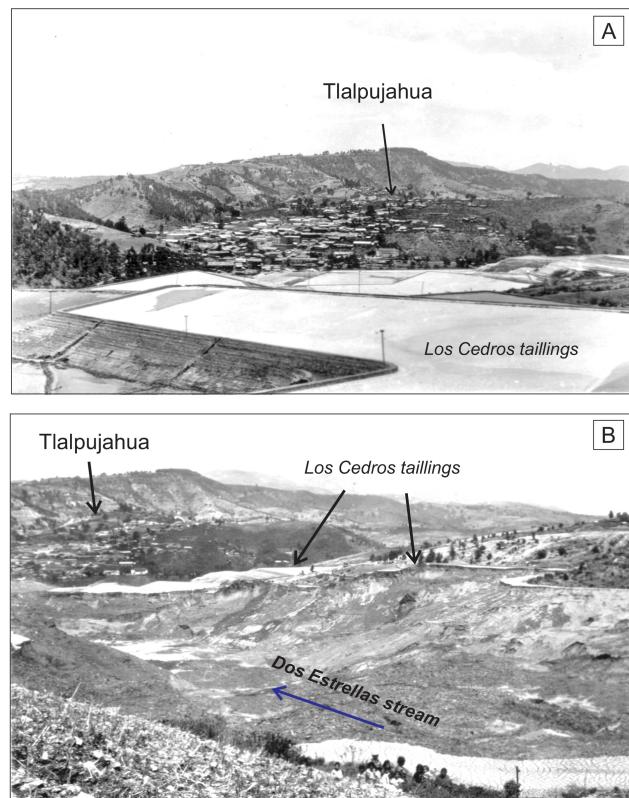
Figure 4. Panoramic views in 1937 from the southeast that show (a) Los Cedros tailings dam with a platform-like form prior to the collapse and (b) The tailings and the Dos Estrellas stream scoured by the flood after the collapse. See people standing on the hill in the foreground.

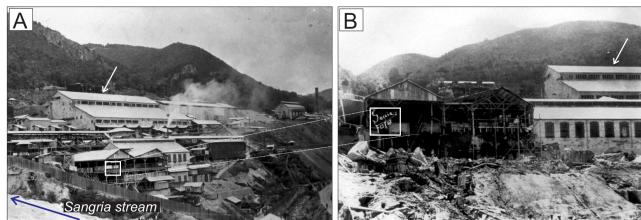
Figure 5. Aspects of Los Cedros Metallurgical plant of “Las Dos Estrellas” mining company at the Sangria stream, (a) before and (b) after the collapse. The white squares show the same location in both images, and an undisturbed roof of the Metallurgical plant (white arrows).

the base of the impoundment had softened due to the persistent rains and a permanent stream that existed at the base of the gully. In fact, on 26 May at 17:30 LT a ~4 t block detached from the lower part of the impoundment, leaving a 30 m wide hole. After this small landslide, mine dam caretakers warned villagers downstream to leave their homes because a large landslide may occur. Unfortunately, only a few paid any attention and this warning went unheeded. That same day, at around 23:20, another block detached from the impoundment, flooding the road to the Los Cedros metallurgical plant and the Juarez bridge. Intense rain accompanied by lightning persisted throughout the night.

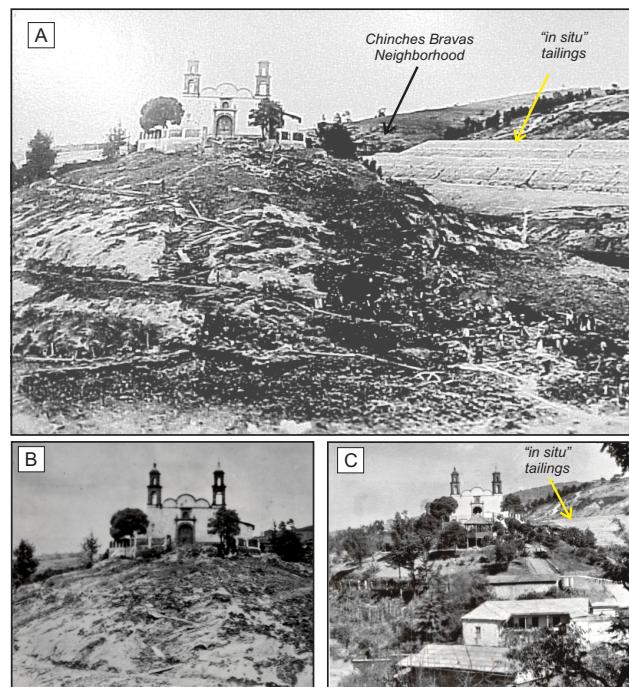
Figure 6. (a) Panoramic and (b) close-up view from the southwest of San Jesus del Monte hill and church after the 27 May 1937 flood with rubble, and wood planks dispersed on the surface and the striped slopes of the hill. (c) View of the same hill prior to the flood that shows houses on its southern slope.

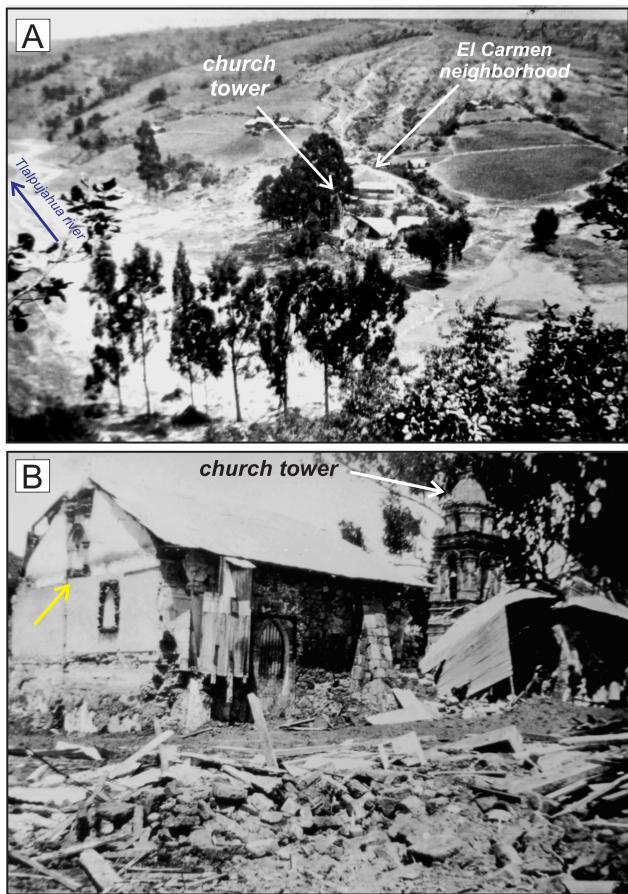
Figure 7. Photographs of El Carmen church after the 1937 flood and extent of the deposit along the Tlalpujahua River (white arrows) (a), and rubble and high-mud marks (yellow arrow) (b).

The flood buried the church with 2.5 m of debris and mud. Behind the church, the flood was able to move and tilt grave markers as they are exposed nowadays. High-mud marks 5 m above the deposit that partially buried the church corroborated that the flood was moving as a hyperconcentrated flow. The flood was able to incorporate chunks of church walls as large as 30 cm. Flow dynamics suggest that these blocks were suspended and rolled downstream.

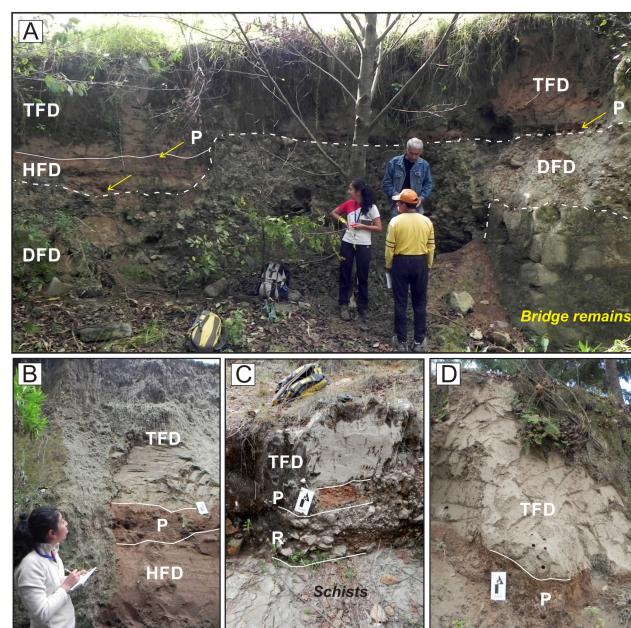
a debris flow deposit with rounded to angular block pieces of broken glass in a coarse-sand matrix, and the underlying schists (Fig. 10a). All this sequence stands beside or atop the remains of an old bridge wall. This stratigraphic column suggests that other historical fluvial debris flows have occurred at Tlalpujahua.

**Figure 10.** Aspects of the tailings flood deposit (TFD) at three sections along its path. (a) At section TL-14, the TFD rests over a paleosol, a thin hyperconcentrated flood deposit (HFD), another paleosol, and a basal debris flood deposit (DFD) that contains pieces of bottle glass. The TFD forms a paleo-channel that stands against the remains of an old stone bridge. (b) View of the TFD at section 17 overlying a paleosol and a lower brown hyperconcentrated flood deposit (HFD) rich in sand-size particles. (c) At section TL-18 the TFD overlies a poorly developed paleosol, a reworked bed with gravel-sized fragments and schists from the local basement. (d) At section TL-19 the deposits rest directly on top of a thicker paleosol.

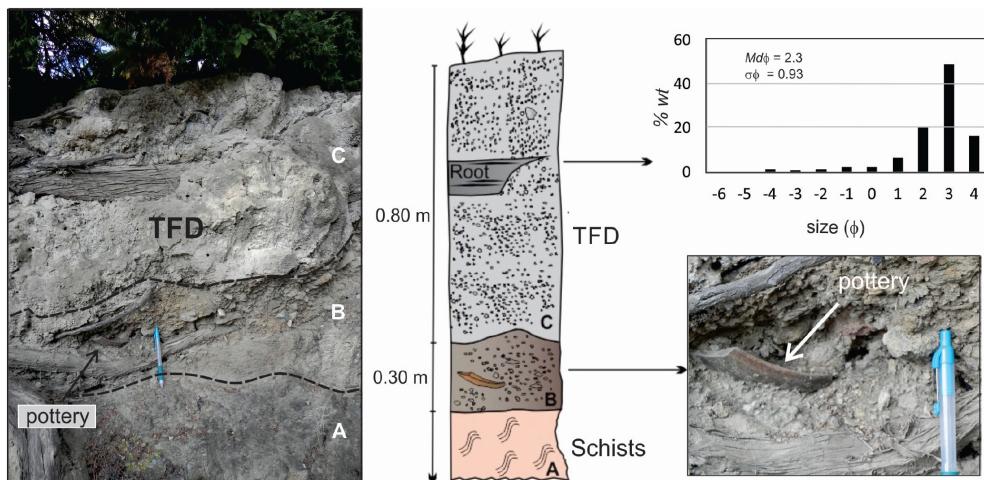
At site TL13, along the steps of the San Jesus del Monte church, the TFD varies in thickness from 80 to 40 cm. It overlies an anthropogenic layer rich in pottery shards, charcoal and other remains, and older debris flow and the basement green schists (Fig. 11).

Figure 11. Section TL13 looking to the west at the steps of San Jesus del Monte hill. The section shows from the base schists a debris flow deposit that turns into a pottery-rich soil and the whitish TFD atop grading into the modern soil cover with trees.

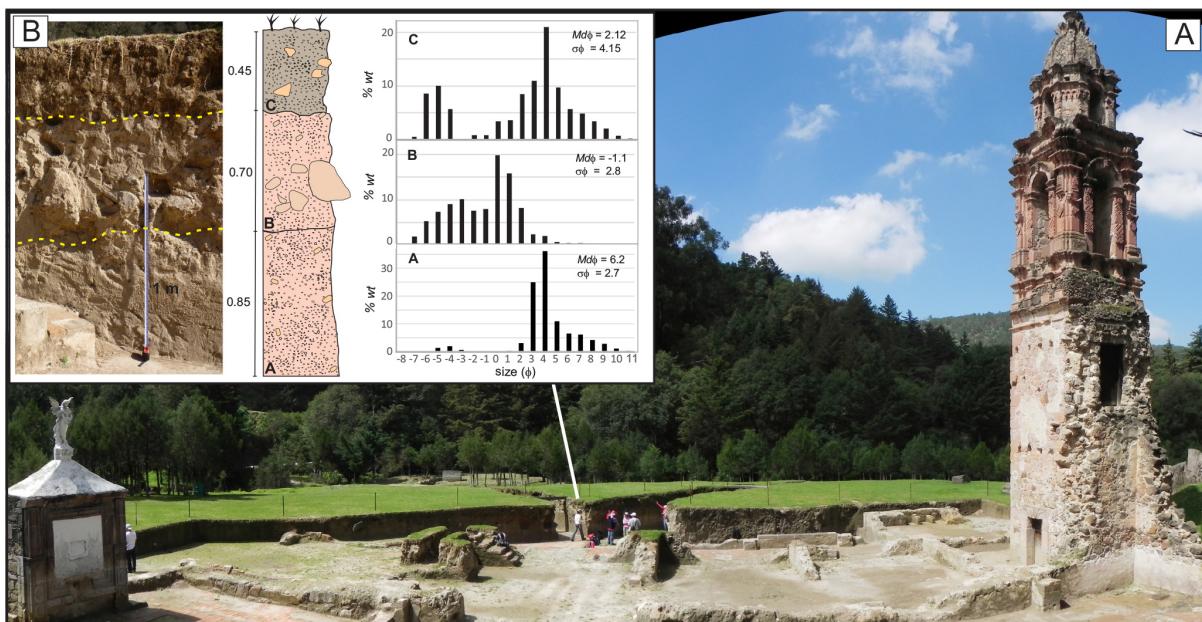
Site TL01 (remains of the El Carmen church) exhibits an extraordinary sequence of the TFD made of three different layers (A–C) separated by erosive contacts. The intermediate unit, which is rich in boulder-size fragments and church blocks, seems to correlate with the deposit at all other locations (Fig. 12a–b). These layers are light tan in color, massive, and partly indurated with voids. The lowermost layer

A rests on the 1937 El Carmen church floor (Fig. 12b). It is 40 cm thick and contains sporadic subangular clasts usually smaller than 3 cm set in a silty to clayey matrix (~ 95 %).

Layer B (≤ 0.85 cm thick) consists of angular to subangular clasts (30–84 cm in diameter) set in a clayey–silty matrix (80 %). This layer contains stone church blocks, glassware, pottery, bricks, wood chips, and charcoal. Layer C (≤ 60 cm thick) is heterolithologic with ignimbrite and metamorphic subangular fragments ranging in size from 1.5 to 6 cm in diameter. The clasts are dispersed in the middle part of the bed within a sandy to silty matrix (70–75 % wt.). The upper portion of layer C grades into the modern soil.

Figure 12. (a) Panoramic view from the east of the remains of El Carmen church buried by the tailings flood deposit (section TL-01). The excavation of the church remains exposed the ancient floor of the sanctuary. (b) Stratigraphic column showing three beds separated by dashed yellow lines and their granulometric bimodal distributions.

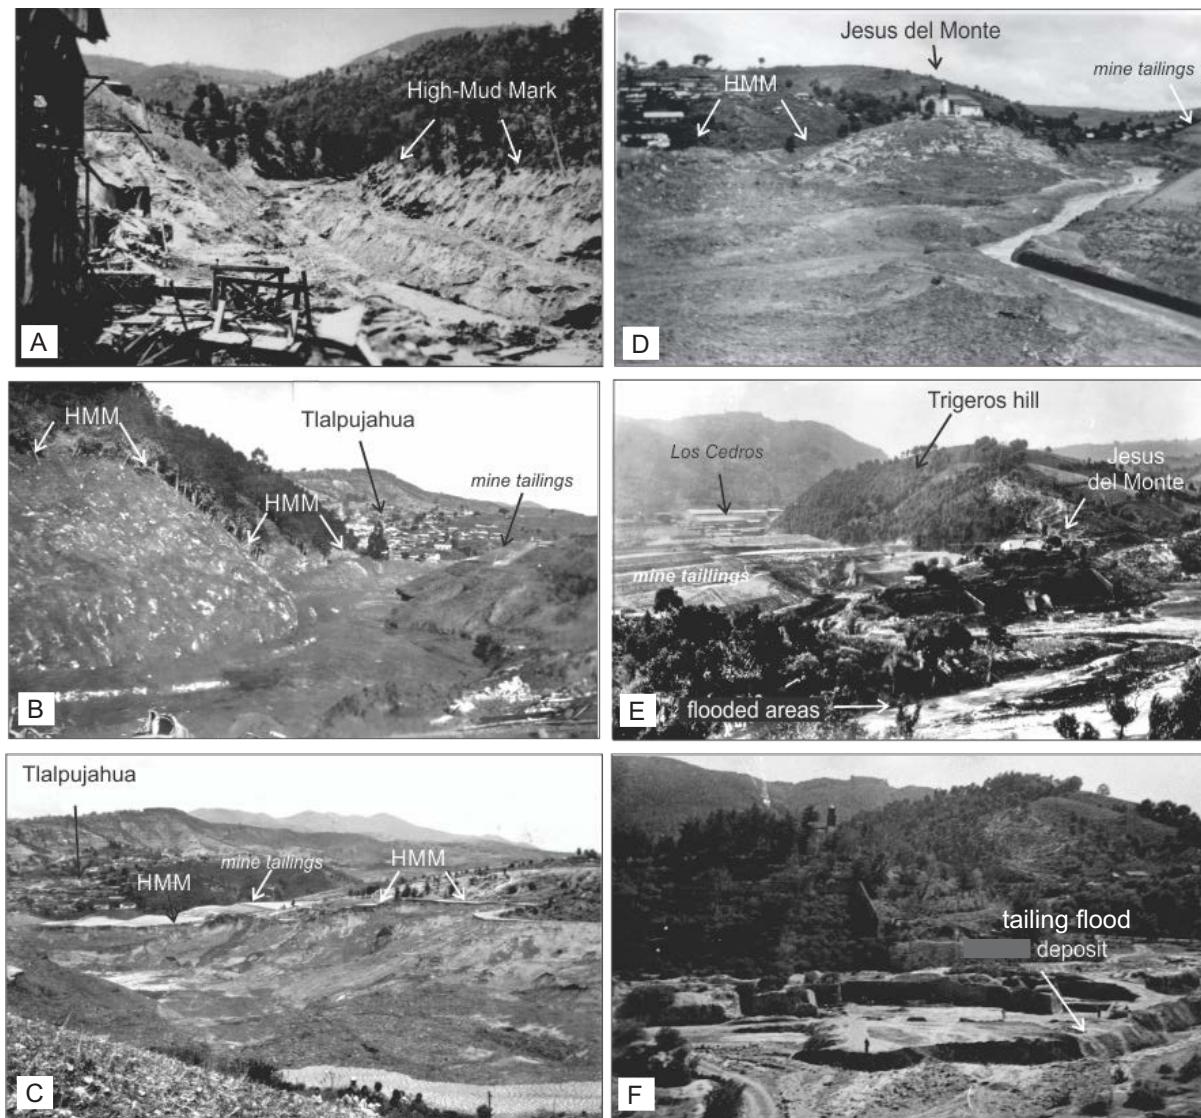
As previously discussed, there were at least three flow surges. The first and largest flow originated in the Sangria gully, and the later smaller flows involved sources at the Dos Estrellas stream. Eyewitness accounts, historical photographs, and recent fieldwork helped us to understand the dynamic behavior of the largest flow. The flow was sourced from somewhere along the Sangria gully, the initial mass fed by the fine-grained tailings (silt and sand material) and cyanide mixed with water that rapidly rushed down the gully. At ca. 0.7 km from the probable source, the flow initially struck the Los Cedros metallurgical plant and impacted against Trigueros' northern side hill, scraping ca. 30 m of forest (Fig. 14a).

Figure 14. Photographs of damage caused by the tailings flood in 1937 at different locations of this study: Los Cedros metallurgical plant (**a**), Trigueros hill (**b**), the Dos Estrellas stream between Trigueros and Jesus del Monte (**c**), and Jesus del Monte (**d**)–(**f**). HMM: high-mud marks.

sustained flow wave that rushed downstream towards the village of Tlalpujahua, scouring the old road, trees, and tailings from the retaining wall of the dam (Fig. 14b). Unfortunately, several neighborhoods stood downstream and were completely devastated by the flood (Fig. 14c). Pictures of the places and remains of these neighborhoods show the maximum thickness of deposits and the high-water marks suggesting that the wave was moving as an hyperconcentrated flow (ca. 50 % sediment concentration). Downstream, the Tlalpujahua River carved a gully between the outskirts of the Tlalpujahua village and the Jesus del Monte hill, which was surrounded by several neighborhoods, including La Cuadrilla, at its base.
