The behaviour of roof gable walls under the effect of earthquake load

M. Kamanli¹ and F. S. Balik²

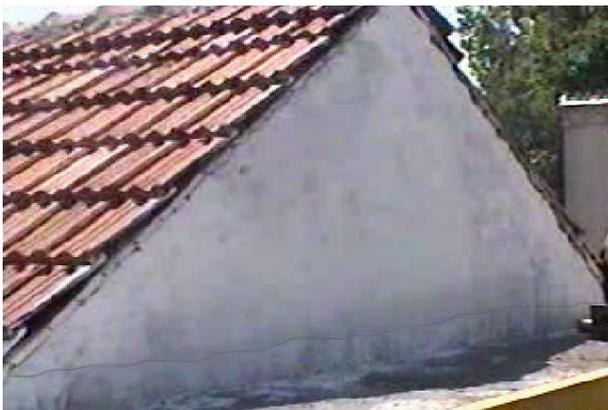
After 1st loading with 15 mm beginning translatory motion, microcracks were formed throughout the gable wall at the level of first line bricks on the bottom of plastered gable wall (Fig. 6).

Fig. 6. Microcracks occurred on plastered gable wall.

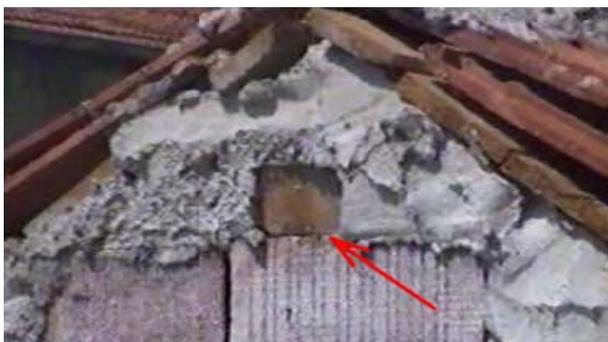
After 2nd loading with east-directioned and 20 mm beginning translatory motion, no damages were occurred in addition to the 1st loading. At the end of 3rd loading with west-directioned and 20 mm beginning translatory motion, the microcracks on the plastered gable wall increased, a displacement was occurred by ridge board of gable wall without plaster outwards the roof and slidings occurred in some tiles (Figs. 7 and 8).

Fig. 7. The view of gable wall without plaster.

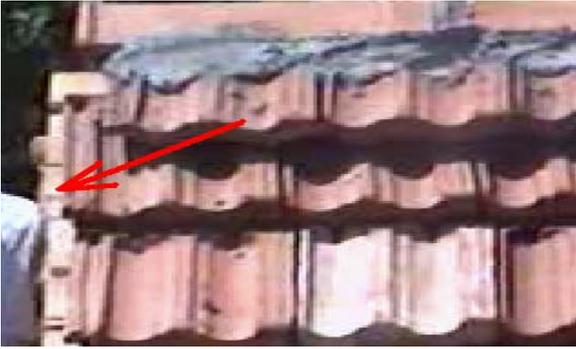
Fig. 8. Sliding occurred on tiles.

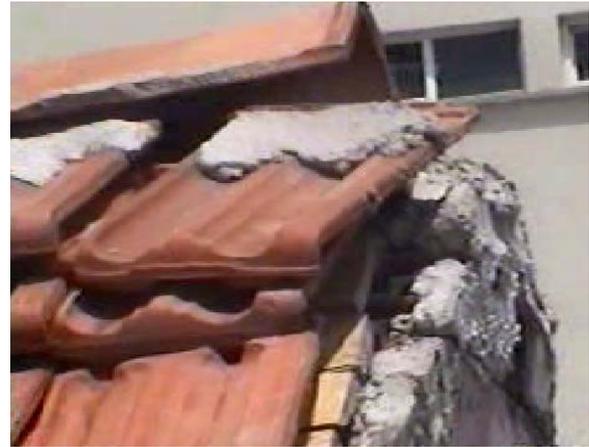
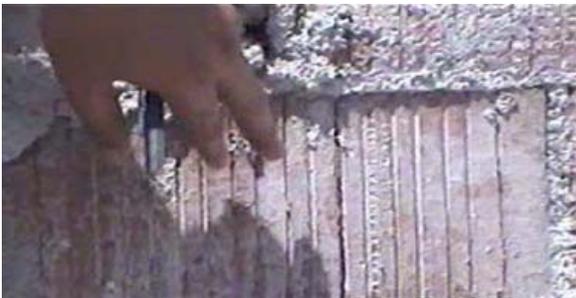
In the 4th loading with east-directioned and 30 mm beginning translatory motion, the displacement which occurred at the ridge board of gable wall without plaster outwards the roof increased a bit more and its length reached up to “cm”. The slidings occurred in tiles significantly increased. It was observed that vertical cracks occurred in the medium line bricks of gable wall without plaster (Fig. 9). In addition to this, micro plaster cracks occurred at the top of plastered gable wall (Fig. 10).

Fig. 9. Vertical cracks occurred on bricks.

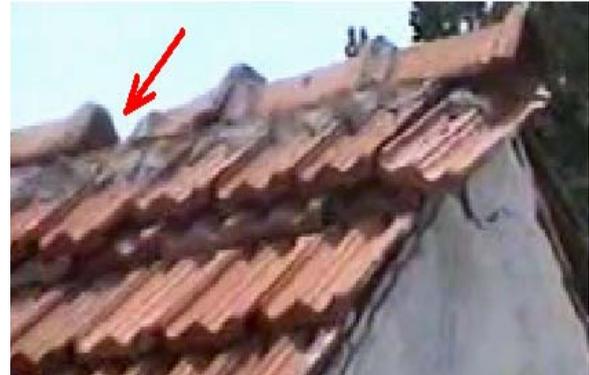
In the 7th loading with west-directioned and 30 mm beginning translatory motion, an expansion was observed in the cracks of the gable wall. The slidings in the tiles and ridge tiles also increased (Fig. 12).

Fig. 12. Damages occurred with 7th loading.

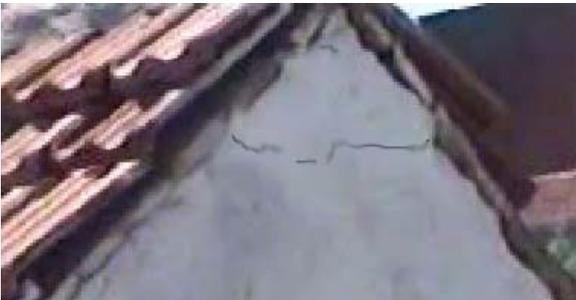
Fig. 10. The view of plastered gable wall.

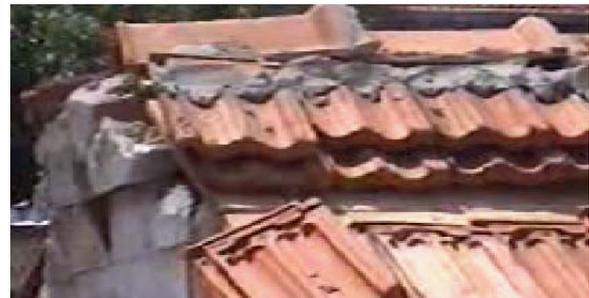
The 8th loading was applied with 30 mm beginning translatory motion in the west direction. After loading, the displacement occurred at the top of the gable wall without plaster increased and reached up to 8 cm (Fig. 13). The slidings observed in tiles and ridge tiles increased even more.

Fig. 13. The view of gable wall without plaster.

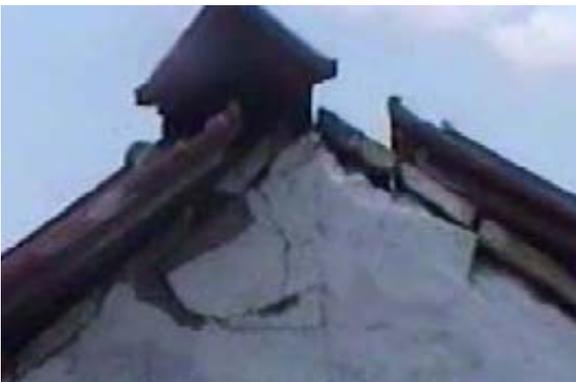
plastered gable wall (Fig. 11). The slidings observed in tiles and ridge tiles⁵ significantly increased.

Fig. 11. The view of plastered gable wall cracks.

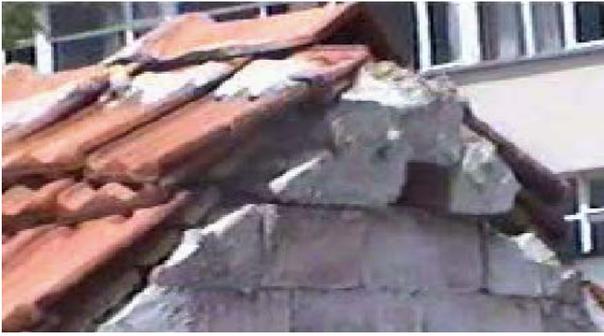
At the end of the 9th loading with 45 mm beginning translatory motion applied from the east, the length of the displacement observed at the top of the gable wall without plaster reached up to 13 cm (Fig. 14).

Fig. 14. The view of gable wall without plaster at the end of the 9th loading.

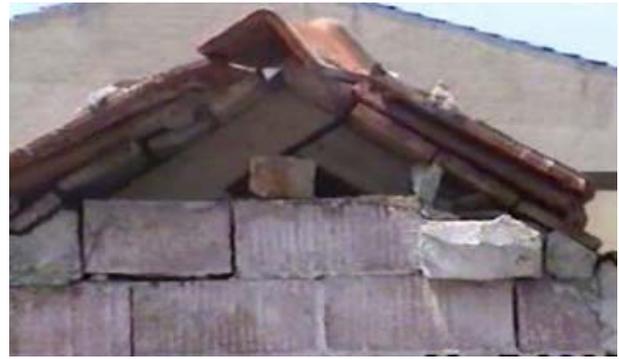
In the 7th loading with 45 mm beginning translatory motion applied from the east direction, the plaster cracks of plastered gable wall increased (Fig. 15). The slidings observed in tiles and ridge tiles significantly increased. The last line bricks of gable wall without plaster collapsed by sliding from the roof (Fig. 16).

Fig. 16. Damages occurred with 10th loading.

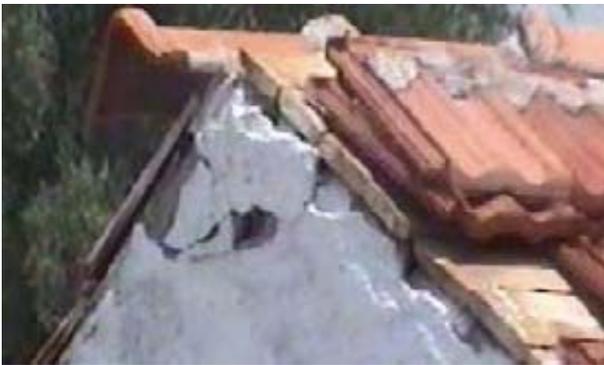
Fig. 15. The view of top of plastered gable wall at the end of the 10th loading.

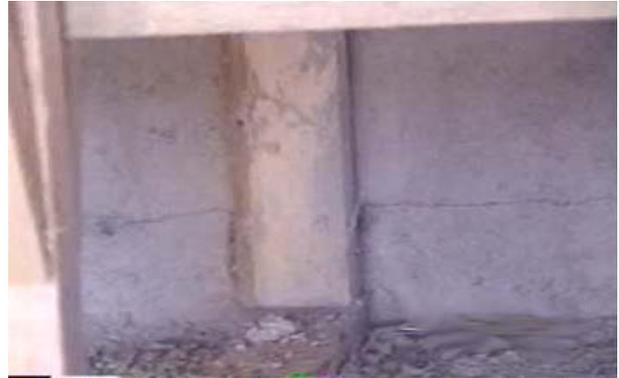
b) At the end of the investigation, the outside plaster cracks observed at the level of first line bricks of plastered gable wall were also observed in the inside plaster (Fig. 17).

Fig. 17. Cracks occurred in inside plaster.

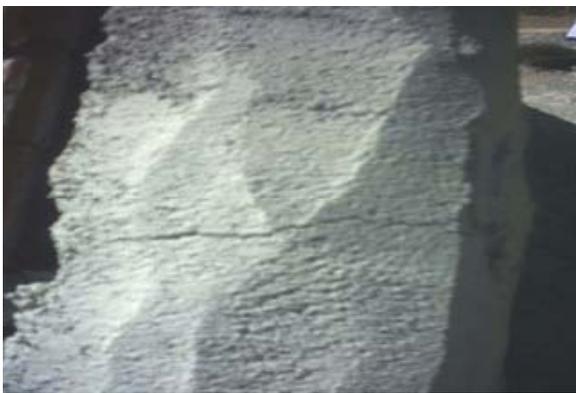
After 1st loading with 15 mm beginning translatory motion applied from the west, microcracks were formed on the coping of plastered gable wall (Fig. 19).

Fig. 19. Damages occurred with 1st loading.

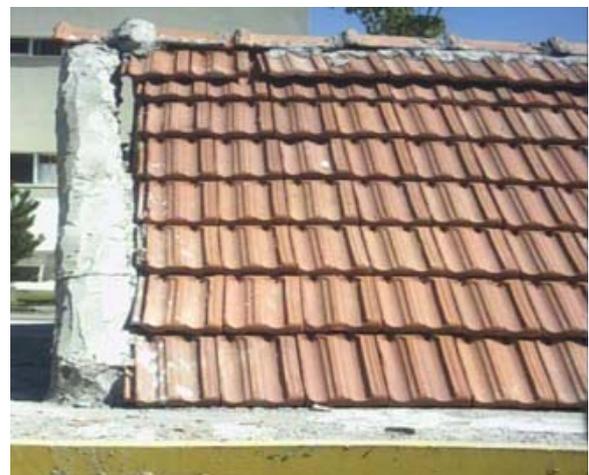
In the 2nd loading with west-directioned and 15 mm beginning translatory motion, microcracks formed on the coping after 1st loading increased a bit more. The plastered gable wall had a 2 cm outwards displacement at the top (Fig. 20). The plaster cracks that can be seen in Fig. 21 occurred at the level of lower bricks of plastered gable wall.

Fig. 20. The view of plastered gable wall.

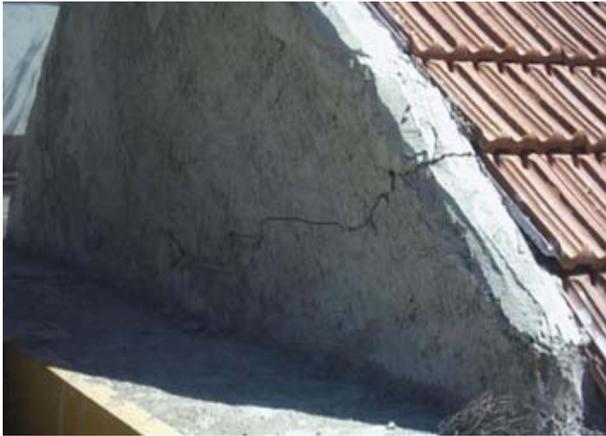
Fig. 21. Plaster cracks occurred with 2nd loading.

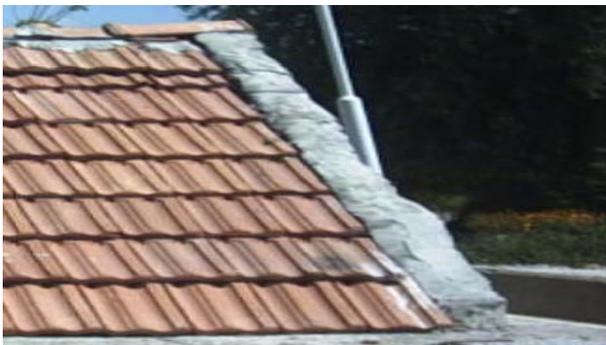
At the end of 3rd loading with east-directioned and 20 mm beginning translatory motion, the microcracks formed on the plastered gable wall at the end of 2nd loading increased, 2 cm outwards displacement at the top of gable wall without plaster (Fig. 22) and slidings in the tiles occurred.

Fig. 22. The view of gable wall without plaster at the end of 3rd loading.

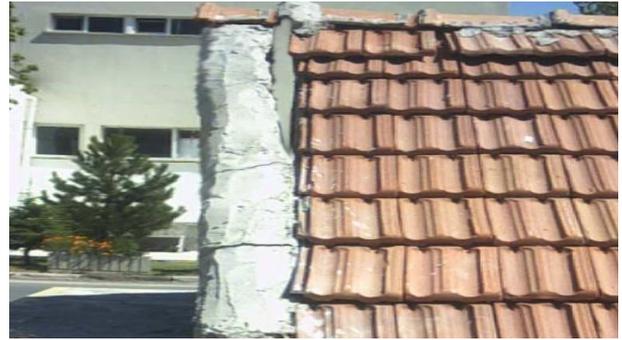
In the 4th loading with 20 mm beginning translatory motion in the west direction, the displacement occurred at the top of the plastered gable wall increased and reached up to 8 cm (Fig. 23). The slidings observed in the tiles significantly increased.

Fig. 23. The view of plastered gable wall at the end of 4th loading.

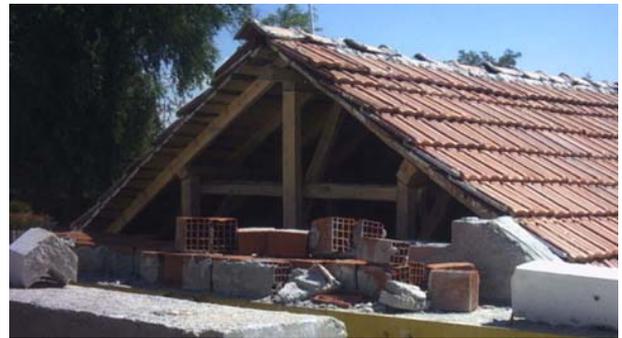
At the end of 6th loading with 30 mm beginning translatory motion in the west direction, the plastered gable wall collapsed outwards as a whole at the level of plaster cracks occurred previously (Fig. 24). The slidings observed in the tiles and ridge tiles significantly increased. The displacement occurred at the top of the gable wall without plaster increased and reached up to approximately 6 cm.

In this experiment, it was considered that the following cases were effective among the reasons for the collapse of plastered gable wall before the one without plaster;

1. the production of plaster mortar and pointing stuff used in bonding of gable wall with the cement stored in humid medium,
2. 2 cm gap left between plastered gable wall and the roof while bonding,
3. using imprecise labour while bonding the plastered gable wall.

Fig. 24. The view of collapsed plastered gable wall at the end of 6th loading.

1. As it's known, if the gable wall of a masonry construction in disaster area is set on a horizontal beam at the uppermost floor and its height exceeds 2 m, the vertical and skewed beam should be constructed. Application of this not only for roof gable walls but also for masonry constructions is accepted as the first precaution to increase the strength and construction security of the gable walls.
2. As a second precaution, the gable walls should be constructed from reinforced concrete materials which meet both their tensile strength and compressive force requirements.
