Human activity and damaging landslides and floods on Madeira Island

D. Baioni

Received: 3 August 2011 – Accepted: 26 September 2011 – Published: 15 November 2011

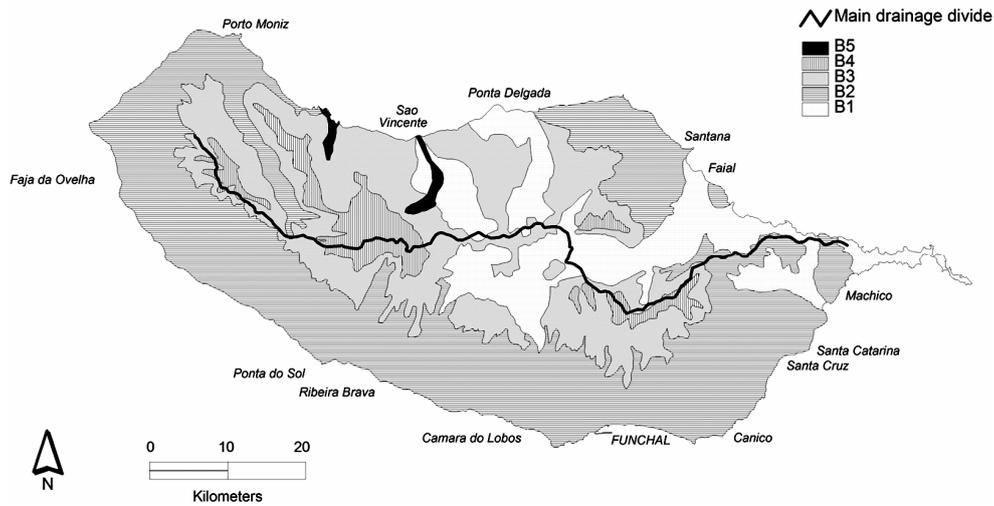
Fig. 2. Geology of Madeira Island (after Zbyszewski et al., 1975). (B1) basaltic pyroclasts; (B2) explosive and effusive material; (B3) pyroclastic materials; (B4) thick basaltic flow; (B5) last volcanic stage.

Madeira Island was formed by volcanic activity in the Miocene period; its geology is illustrated in Fig. 2 (after Zbyszewski et al., 1975). The formation of Madeira began in the Middle Miocene with explosive submarine eruptions consisting mainly of basaltic pyroclasts (B1 complex). After a very long pause, further volcanic activity formed an extensive complex made up of explosive and effusive material (B2 complex). After another interruption, renewed volcanic activity formed a basaltic complex where flows dominate over pyroclastic materials (B3 complex). The B3 complex was then successively overlaid by thick basaltic flows attributed to fissural volcanism (B4 complex); during the last volcanic stage, the eruptions filled existing valleys in the northwestern part of the island (B5 complex). The central region has the characteristic of a volcanic rift (Geldmacher and Hoernle, 2000) with swarms of vertical dikes, normal faults, graben structures, and cinder cones, all parallel to the E-W trending long axis of the island.

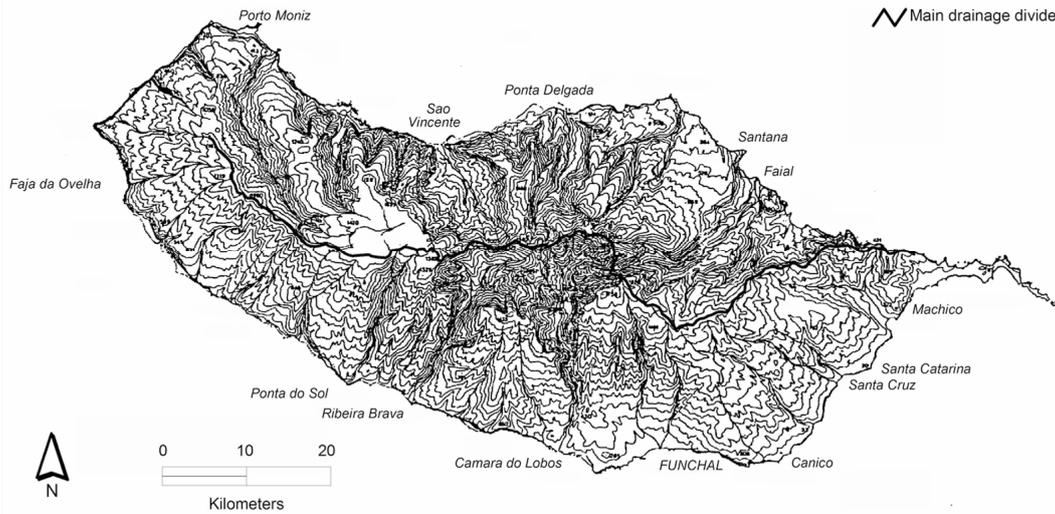
Fig. 3. Topography of Madeira Island (equidistance 100 m.) modified by Galopim de Carvalho and Brandao, 1991.

The island is mountainous, especially in the central part (Fig. 3), with altitudes that reach 1860 m a.s.l. The average altitude is 700 m and 90 % of the island is over 500 m

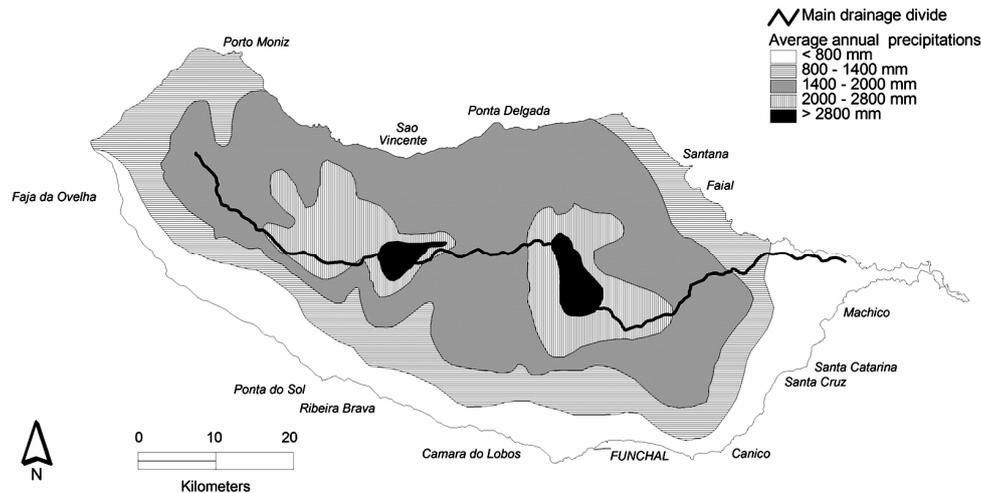
Fig. 4. Average annual precipitation in Madeira Island (historical records 1961–1990). Image (modified) from Ministerio do Ambiente e do ordenamento do Territorio of Portugal website.

The annual precipitation on Madeira (Fig. 4) varies from 600–800 mm on the south coast to 1500–2000 mm on the north coast, reaching 3000 mm in the higher areas. The rainfalls are often violent with an intensity that can reach 500 mm in a single day (the maximum recorded is 522.3 mm), especially in autumn and early spring when very high-intensity rainfalls occur within a very short time (sometimes no more than three hours) and are often associated with strong winds and stormy seas.

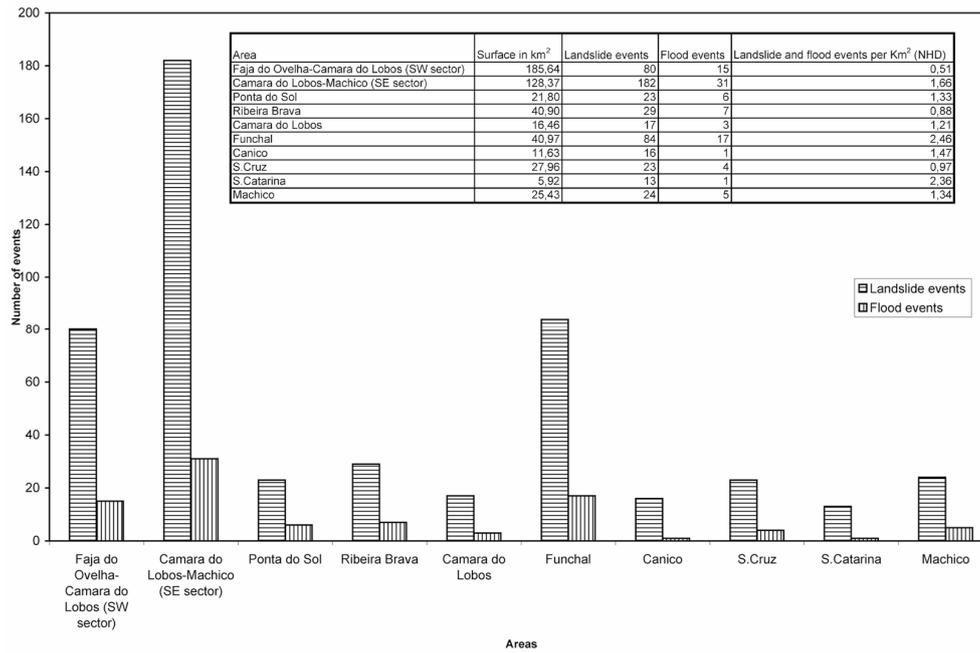
Fig. 5. Distribution of landslide and flood events that occurred in the period 1941–1991 in the sector of the island located to the south of the main drainage divide and in the main urban areas. The table also indicates the density of damaging events (NHD) expressed as number of events per km².

The data for landslide events that occurred between 1941 and 1991 (illustrated in Fig. 5) reveal that: (i) 182 landslides (69.5 %) occurred in the southeastern sector between Camara da Lobos and Machico and 80 in the remaining southwestern sector; (ii) the areas with the highest number of landslides correspond to the drainage basins where the main urban centers are located, that is, in the southeastern sector, the capital, Funchal (84 events), Santa Cruz (23 events), and Machico (24 events), and in the southwestern sector, Ponta do Sol (23 events) and Ribeira Brava (29 events). The remaining parts of the territory, which are not so intensely affected by human activity, have much fewer landslide occurrences.

The data for floods that occurred between 1941 and 1991 (Fig. 5) reveal that: (i) out of a total of 46 events recorded and located within 11 drainage basins, 31 (67.4 %) occurred in the southeastern area between Camara do Lobos and Machico, while 15 events occurred in the remainder of the southwestern sector; (ii) the areas with the most floods are those drainage basins where the main urban centers are located, that is, in the southeastern sector, the capital, Funchal (17 events), Santa Cruz (4 events), and Machico (5 events), and in the southwestern sector, Ponta do Sol (6 events) and Ribeira Brava (7 events).

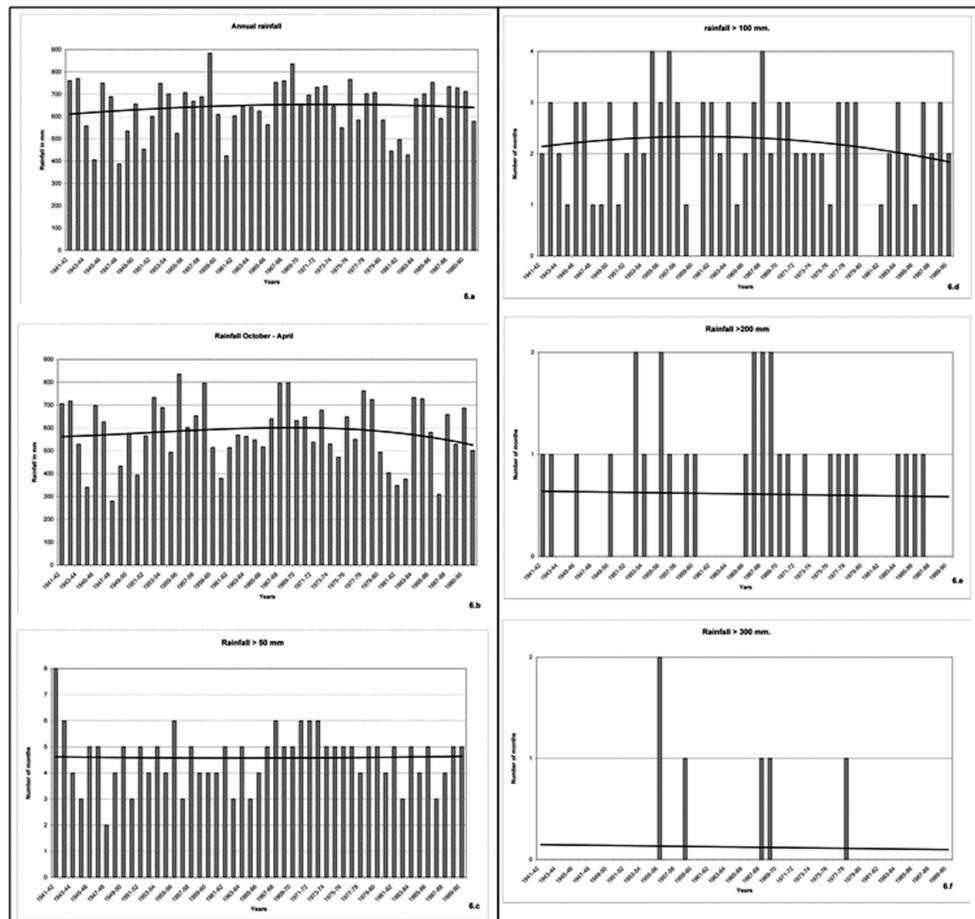
Fig. 6. Rainfall recorded in Santa Catarina for the period 1941–1991; annual values (a); total values for the period October–April for each year (b); number of months with rainfall over 50 mm. (c); number of months with rainfall over 100 mm. (d); number of months with rainfall over 200 mm. (e); number of months with rainfall over 300 mm. (f).

Rainfall data from 1941 to 1991 recorded at the Santa Catarina station near the airport (Fig. 6) reveal that: (i) the average annual rainfall value is 681.4 mm, and the maximum value is 1236.0 mm (recorded in 1968), and the minimum value is 387.4 mm (recorded in 1947); (ii) the annual rainfall (Fig. 6a) shows a modest increasing trend from 1941 to

1969 and then a decreasing trend from 1970 to 1991; (iii) the total rainfall for the period between October and April for each year (Fig. 6b) shows an increasing trend for the period from 1941/1942 to 1960/1961, followed by stable values during the period 1962/1963–1973/1974 and a decreasing trend for the period 1974/1975–1990/1991, which has become more evident since the 1978–1979 season; (iv) the number of months for each year with different classes of rainfall values (over 50 mm (Fig. 6c); 100 mm (Fig. 6d); 200 mm (Fig. 6e); and 300 mm (Fig. 6f)) shows no significant variation for the lowest class (number of months with rainfall higher than 50 mm) and decreasing trends over time for all the other classes. The data also show no significant variation in the number of high-intensity and high-magnitude rainfall events.

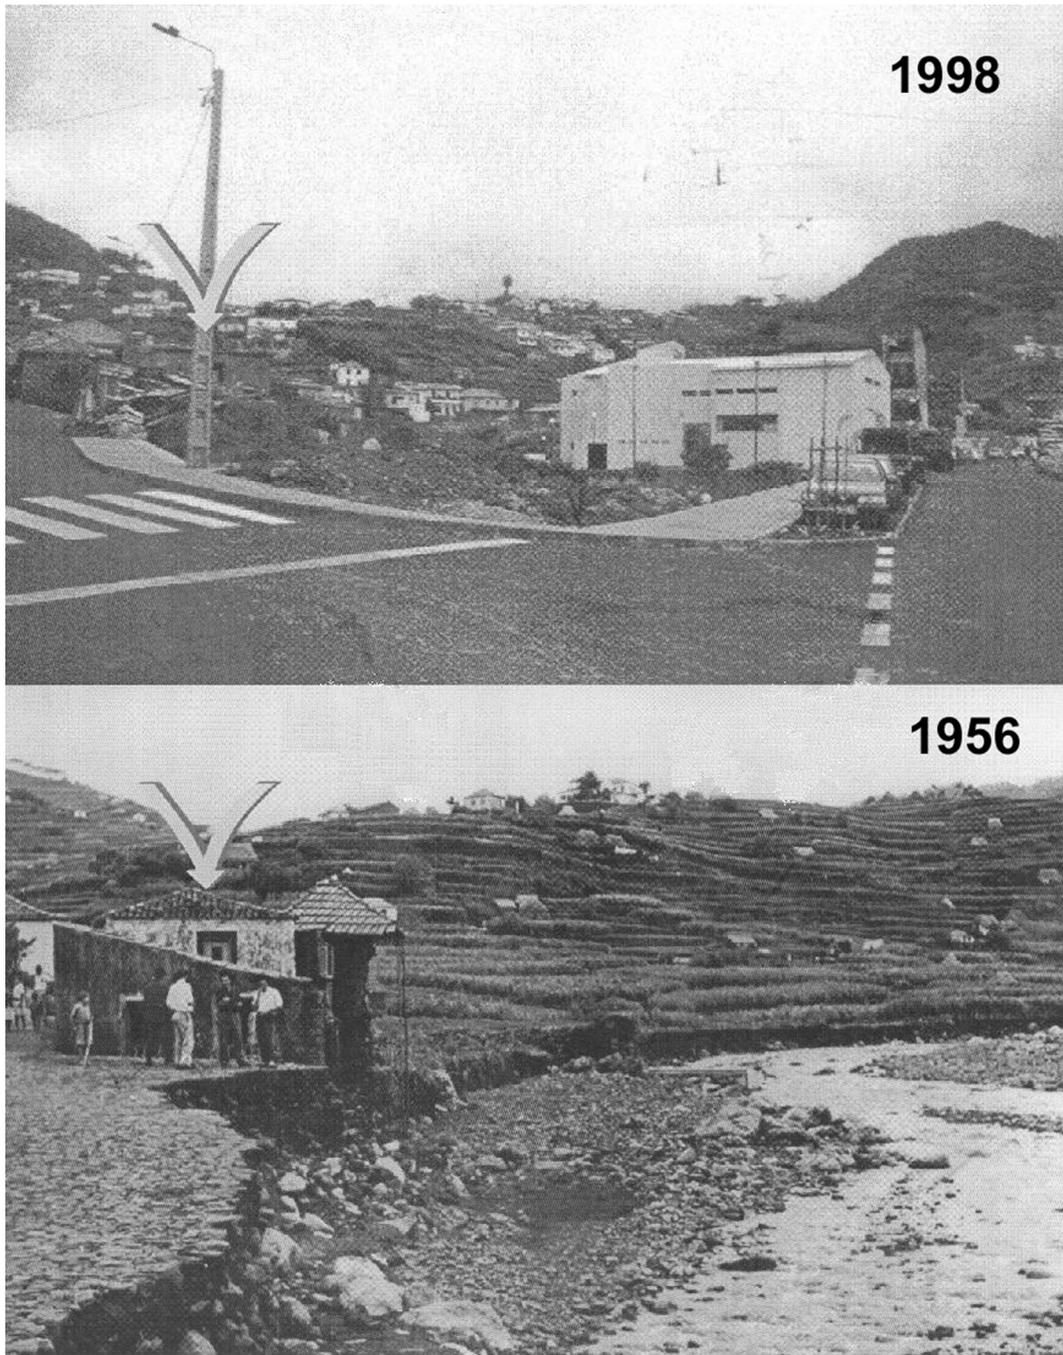
Fig. 7. City of Machico: the same area (white arrow indicate the same building) during the flood occurring in 1956 and after the construction of the local fireworks station building (white building) in 1998. Image courtesy of Domingos Rodrigues (Madeira University).

In particular, the urbanization of the flood plain areas of the main rivers without regard to past peak flow stages may cause property damage that could be avoided, an example of which can be found in the city of Machico (Fig. 7) which has experienced recent urbanization in an area earlier affected by a catastrophic flood.

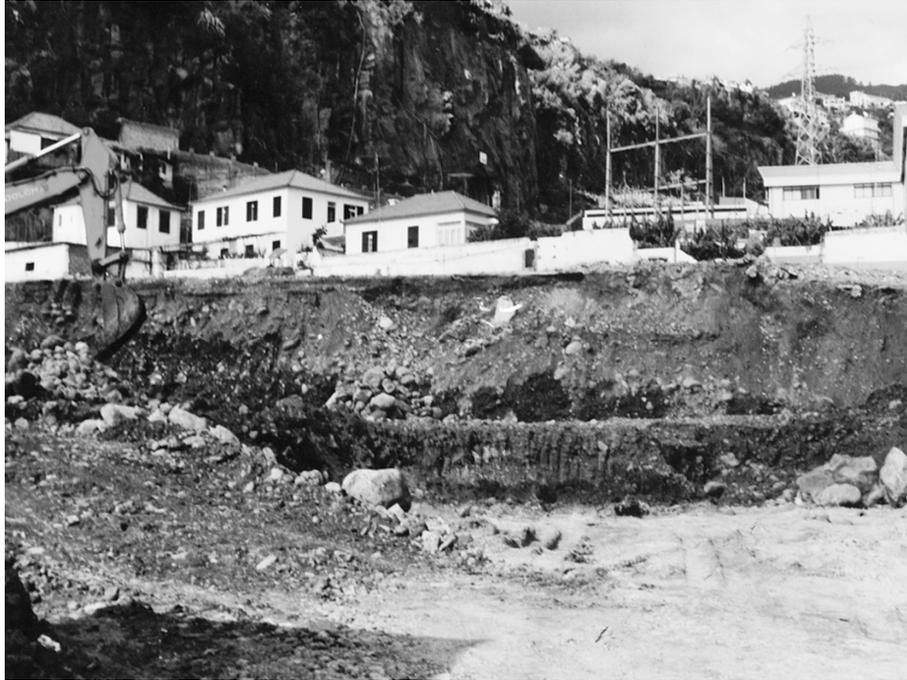
Fig. 8. City of Funchal: excavation works to make a new building area removing the support of the area already built (image taken by the author).

To create flat areas for home and footpath construction, slopes have been excavated and lateral support removed (Fig. 8) by digging away part of the steep slopes. The phenomenon of decreased hill slope stability due to excavation is well known in Machico, where excavation for house construction has been the main triggering cause for slope failure and creep movement.

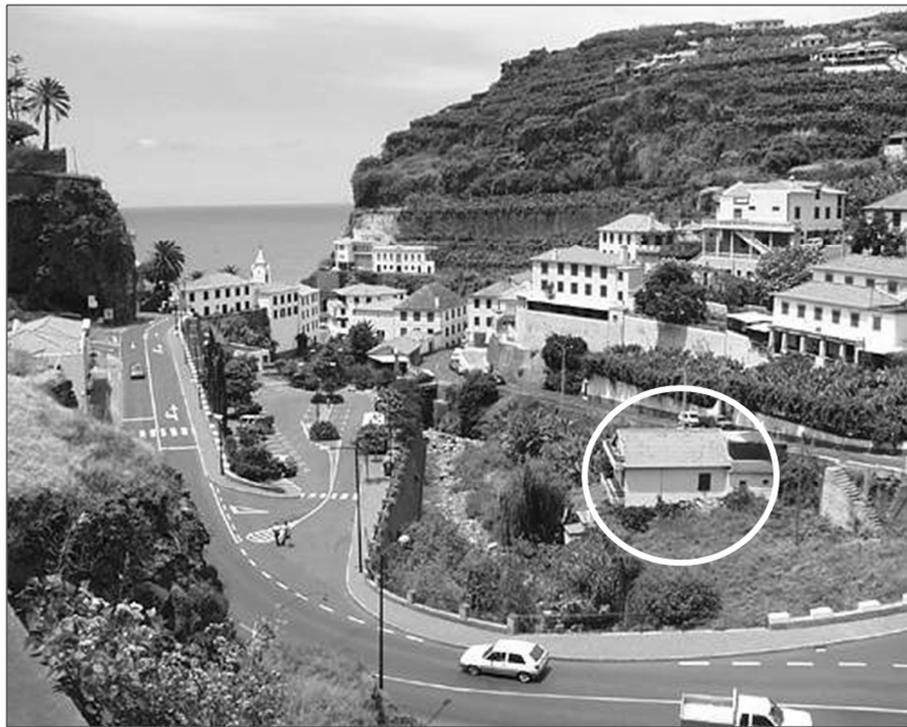
Fig. 9. City of Ponta do Sol: artificial elbow of the course of the “Ribeira do Ponta do Sol” built in the upper part of the city; inside the artificial riverbed a house is located (white circle). Image courtesy of Domingos Rodrigues (Madeira University).

An example of heavy modification of the drainage system can be found in the city of Ponta do Sol (Fig. 9) where along

the course of the main river (Ribeira do Ponta do Sol), human activity has brought about: (i) a change in the original route through the creation of an artificial elbow, (ii) a reduction of the original size of the riverbed and its replacement by artificial canals, and (iii) occupancy of the riverbed by houses.
