The 6 August 2010 Mount Meager rock slide-debris flow, Coast Mountains, British Columbia: characteristics, dynamics, and implications for hazard and risk assessment

Abstract. A large rock avalanche occurred at 03:27:30 PDT, 6 August 2010, in the Mount Meager Volcanic Complex southwest British Columbia. The landslide initiated as a rock slide in Pleistocene rhyodacitic volcanic rock with the collapse of the secondary peak of Mount Meager. The detached rock mass impacted the volcano's weathered and saturated flanks, creating a visible seismic signature on nearby seismographs. Undrained loading of the sloping flank caused the immediate and extremely rapid evacuation of the entire flank with a strong horizontal force, as the rock slide transformed into a debris flow. The disintegrating mass travelled down Capricorn Creek at an average velocity of 64 m s^{-1} , exhibiting dramatic super-elevation in bends to the intersection of Meager Creek, 7.8 km from the source. At Meager Creek the debris impacted the south side of Meager valley, causing a runup of 270 m above the valley floor and the deflection of the landslide debris both upstream (for 3.7 km) and downstream into the Lillooet Rive

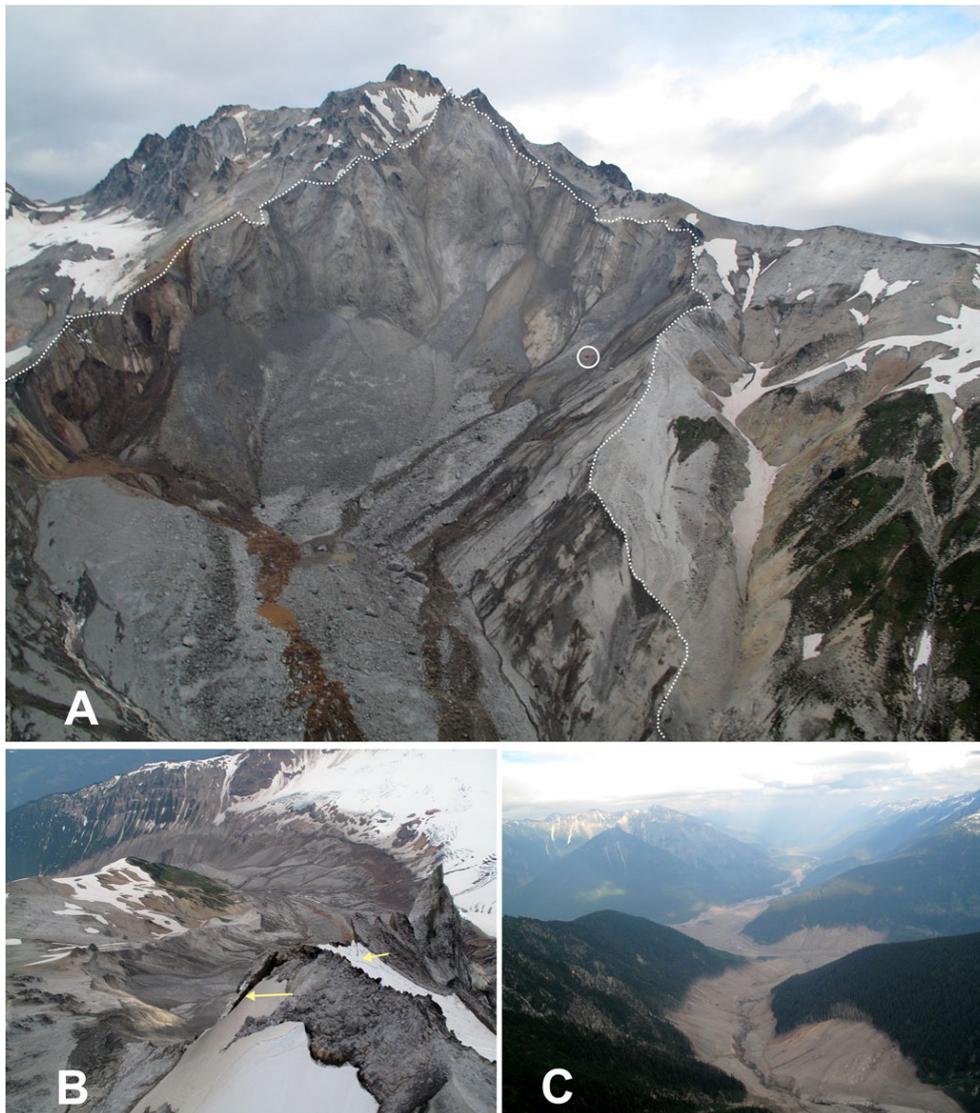
Fig. 2. The $48.5 \times 10^6 \text{ m}^3$ rock slide – debris flow from Mount Meager, August 06, 2010. The outline of the initial failure is shown in (A) as a white dashed line. The landslide is approximately south-facing. The lateral shear surfaces are approximately 70 vertical meters high; a helicopter provides scale (inside the white circle). Note the considerable groundwater emerging through weathered bedrock on the western margin and from several other places including the vertical bedrock backscarp. A remnant of the south peak of Mount Meager remains at the apex of the backscarp, where tension cracks persist (some visible in B). Ongoing rock fall from the remaining peak and the sidewalls continued for several months after the main event. The immediate run-out, viewed from the peak looking down, around the first bend of Capricorn Creek is shown in (B). The full extent of the landslide is very difficult to see in any single picture, but (C) gives a sense of the extent to which the run-out inundated several valleys.

onto the saturated flank of the mountain where it incorporated a significant volume of material, forming a highly mobile, very rapid debris flow (Fig. 2). The landslide travelled downslope at high velocity over Capricorn Glacier, and then down the entire 7 km length of Capricorn Creek. At the mouth of Capricorn Creek the landslide debris encountered the opposing wall of the Meager Creek – Capricorn Creek confluence; causing a dramatic split in the moving debris that travelled both upstream, filling and damming Meager Creek, and downstream into the wider Lillooet River valley, where it briefly dammed the Lillooet River.

surface seepage observed throughout the failure surface and along the lateral shears following the 2010 event (Fig. 2a). The largest visible bedrock spring occurred along the west lateral scarp and was the location of at least two previous landslides, occurring in 2009 and 1998 (Fig. 4). Water supply was exacerbated by summer melt of snow and ice, causing even greater saturation of slopes.

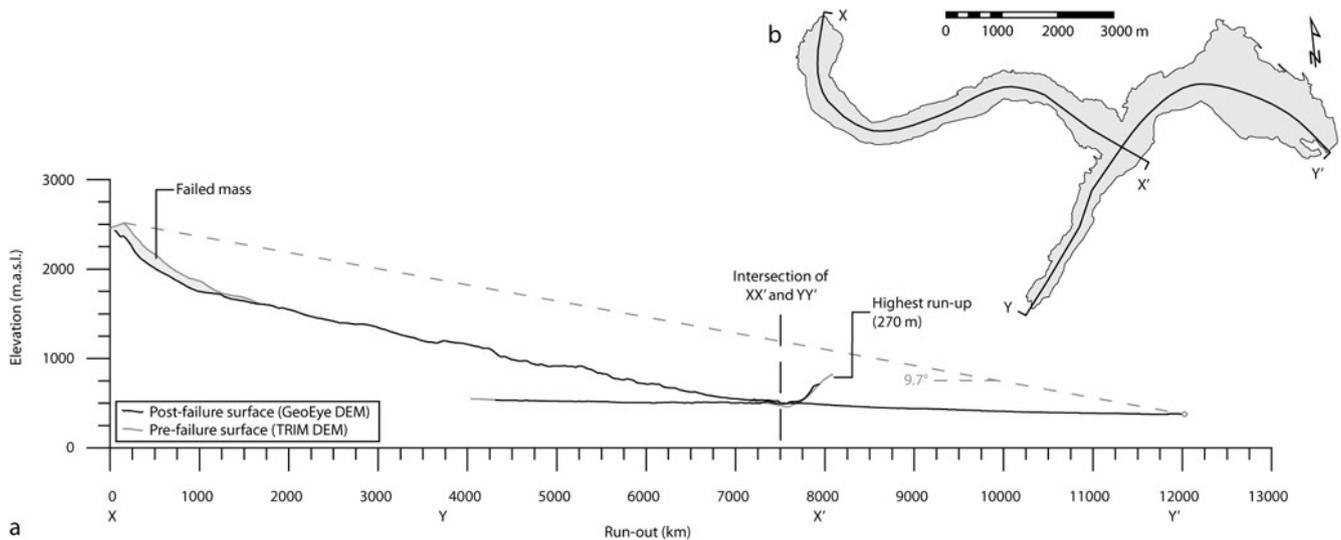
Fig. 3. Profile of the Mount Meager landslide.

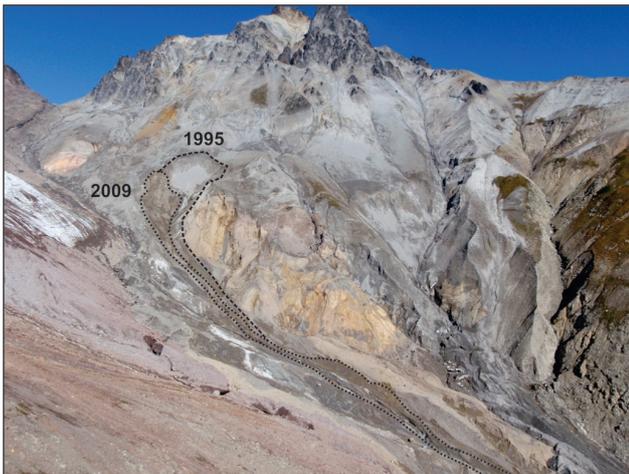
Fig. 4. Mount Meager before the 2010 landslide. The sources and upper paths of the 2009 and 1995 Mount Meager debris flows are outlined and coincide roughly with the present-day location of the lateral shear. The darker colour of the 2009 event is from groundwater saturation, and the orange staining of rock on the lower slopes indicates long-term exposure to high groundwater levels and hydrothermally altered volcanic rock (photograph by Dave Southam).

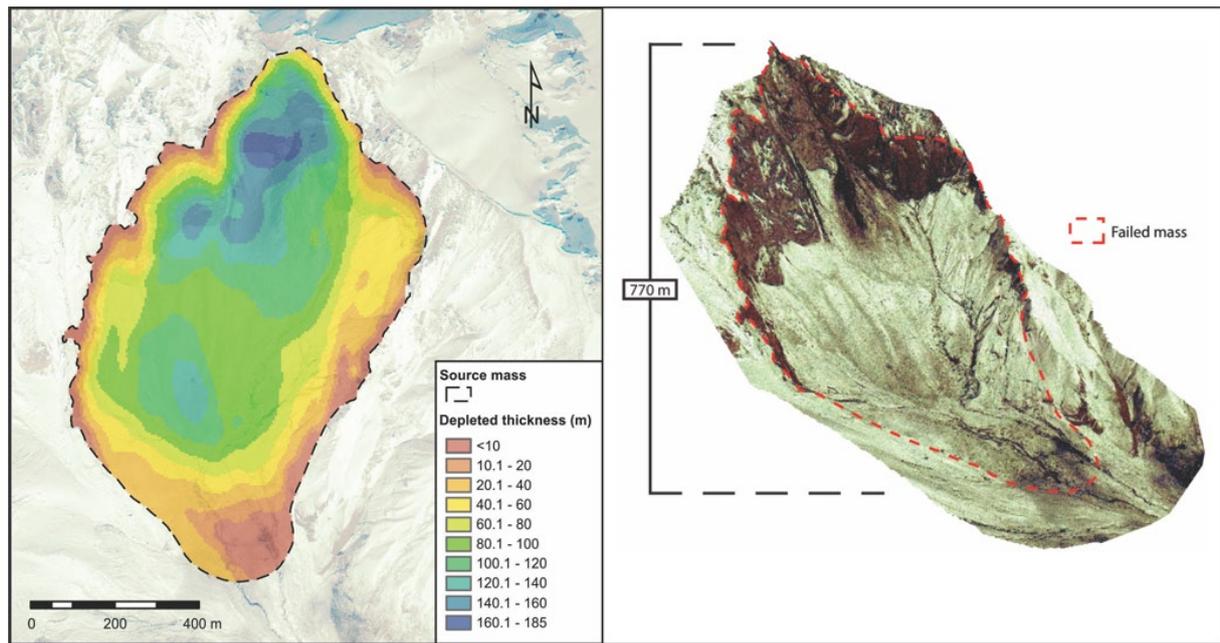
Fig. 5. The difference in depth between the TRIM (before) and GeoEye DEMs used to calculate volume. The strong lateral shears, high backscarp and bulge of the pre-failure flank are all readily interpreted from the differencing map. The landslide outline was accurately delineated based on new imagery (right side of figure). The total calculated volume is $48.5 \times 10^6 \text{ m}^3$.

A robust volume analysis of the initial failure mass was accomplished by comparing pre- and post-event digital elevation models (DEMs) of the landslide (Fig. 5). Topographic data representing the pre-event surface was obtained from a 25 m resolution Terrain Resource Inventory Mapping (TRIM) DEM, the British Columbia provincial standard base map. The post-event surface (DEM) was created using two sets of 5 m resolution GeoEye stereo images obtained 22 August and 21 September 2010.

A difference calculation was then performed on the two surfaces inside the landslide track, using raster math in a Geographic Information System (GIS), and summing the total difference for each pixel in the initiation zone. The resulting volume calculated for the initial failure is $48.5 \times 10^6 \text{ m}^3$.

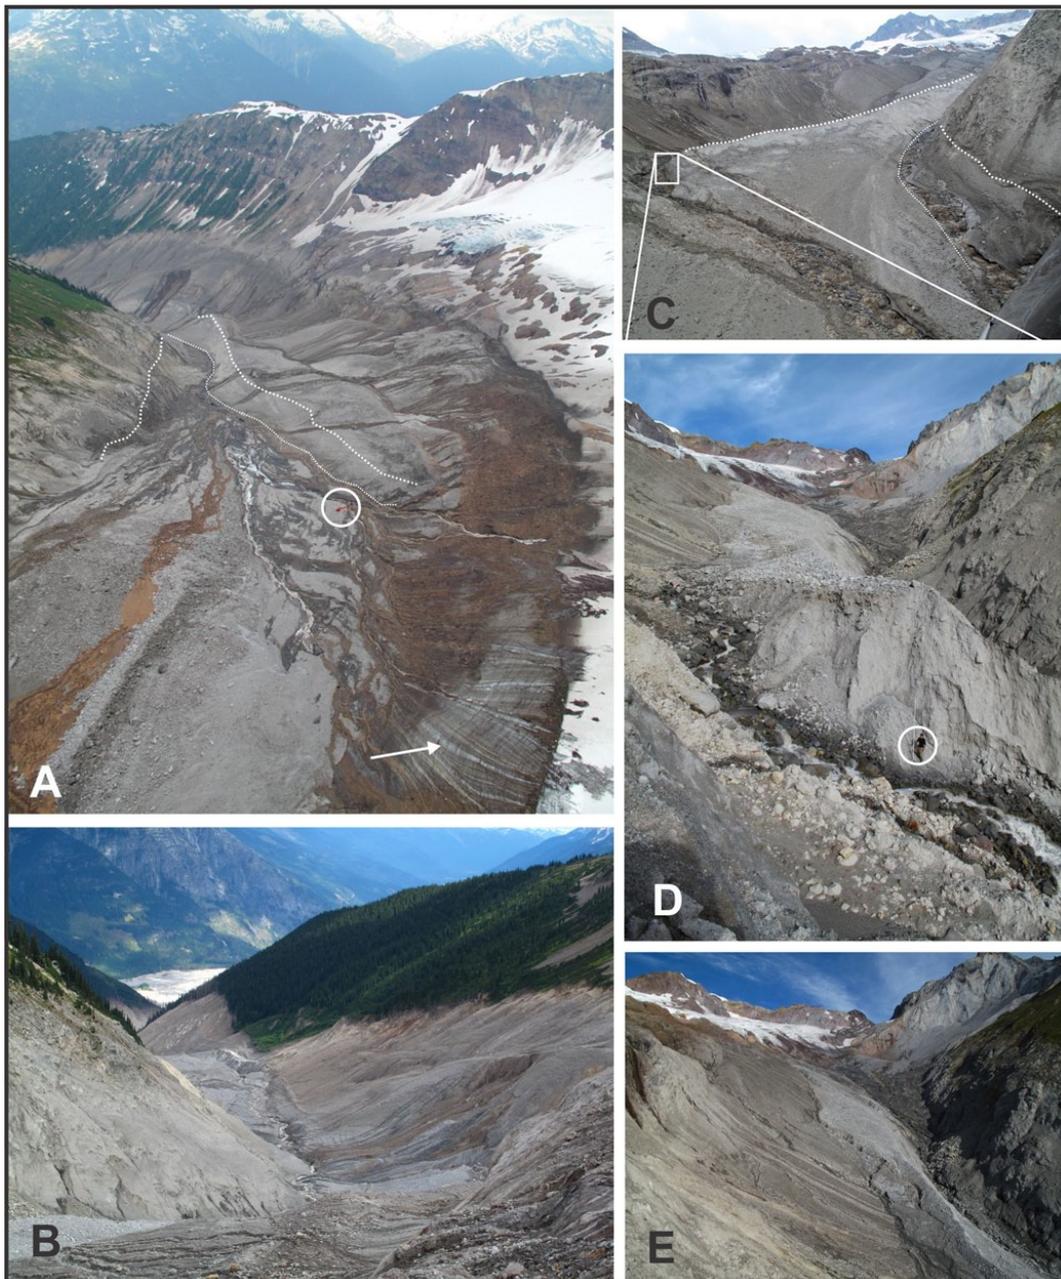
Fig. 6. Looking down the initial landslide path (helicopter in white circle for scale). Note the ice of Capricorn Glacier, intact with longitudinal melt lines perpendicular to the direction of flow (A). Overspray is evident beyond the path edge, particularly on the snow. The lower portion of the valley was in-filled by deposits from the avalanche, which was subsequently evacuated along the left side of the valley (shown by white dotted lines) in one or more liquid slurries. Looking further down the landslide run-out, through the first bend (B), deposition is evident even on the valley sidewalls. Images (C) and (D) show valley floor deposition as viewed from below and (E) looks back up at the initiation zone. White dotted lines in (C) correspond to those in A and the white circle in (D) shows a person for scale. Ice persists in the valley floor at the base of the deposit (A) and remains largely undamaged, though directly over-ridden (indicated by white arrow).

The disintegrated landslide mass left the initiation zone in a largely horizontal trajectory and traversed Capricorn Glacier, causing almost no damage to the glacier itself (note the drainage features of Capricorn Glacier, perpendicular to the landslide flow, in Fig. 6a), and flowed into the first bend of the Capricorn Creek valley (Fig. 6b). By this time the

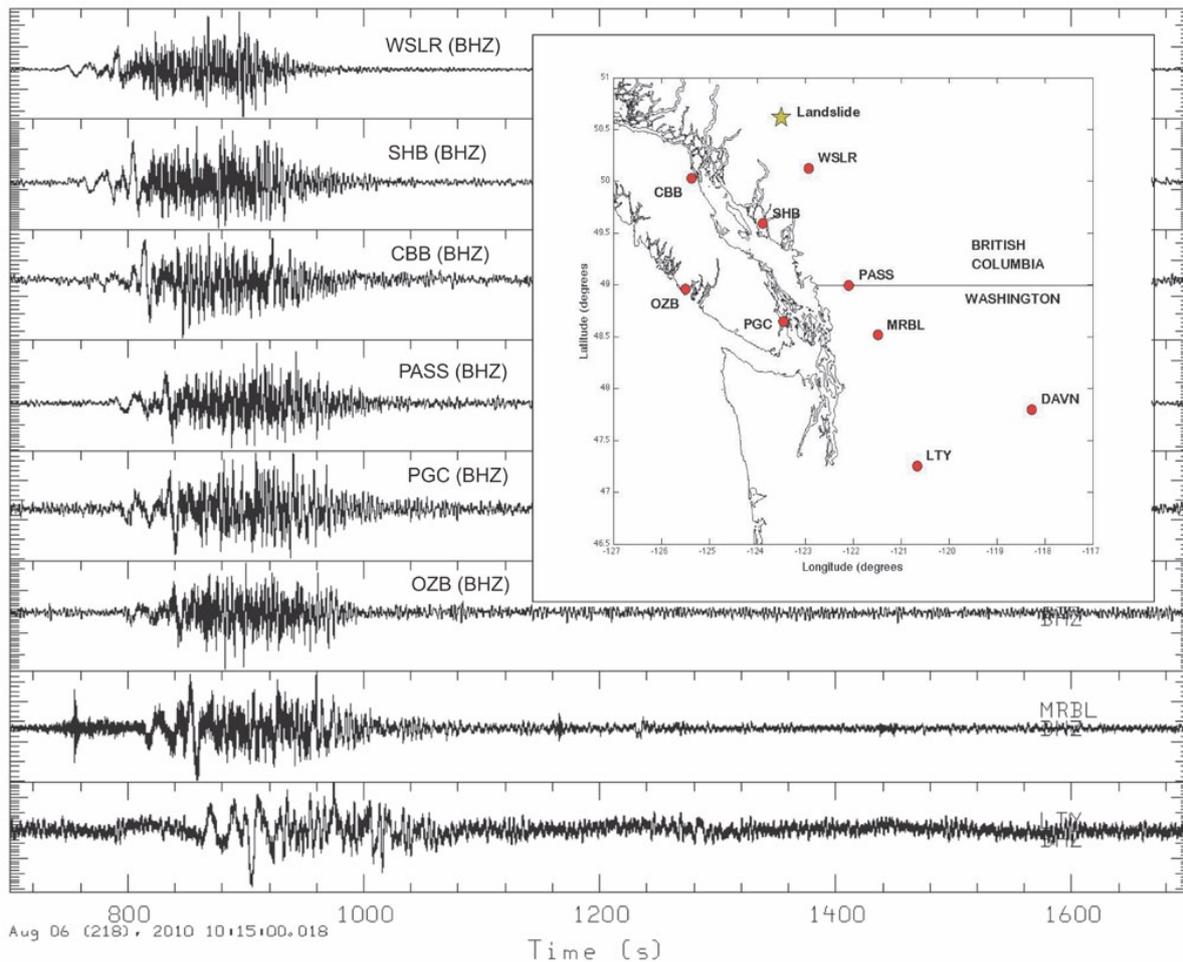
Fig. 7. Raw seismic signals from Mount Meager landslide recorded across southwestern Canada and northern Washington State (CNSN and PNSN data). Station and landslide location indicated on inset map.

The Meager Creek landslide generated long-period seismic waves that were visible at stations from southern California to northern Alaska, up to 2800 km away. A sample of vertical-component broadband seismograms of this event is displayed on Fig. 7. No known earthquake was associated with the failure, but the event itself was assigned an equivalent local magnitude of 2.6 by the Canadian Seismic Network. Landslides are distinguished from seismic signals by a characteristically high ratio of long period to short period energy waves (Weichert et al., 1994; McSaveney and Downes, 2002). The long-period surface waves generated by the Mount Meager event were much stronger than would be expected from an earthquake of the same magnitude.

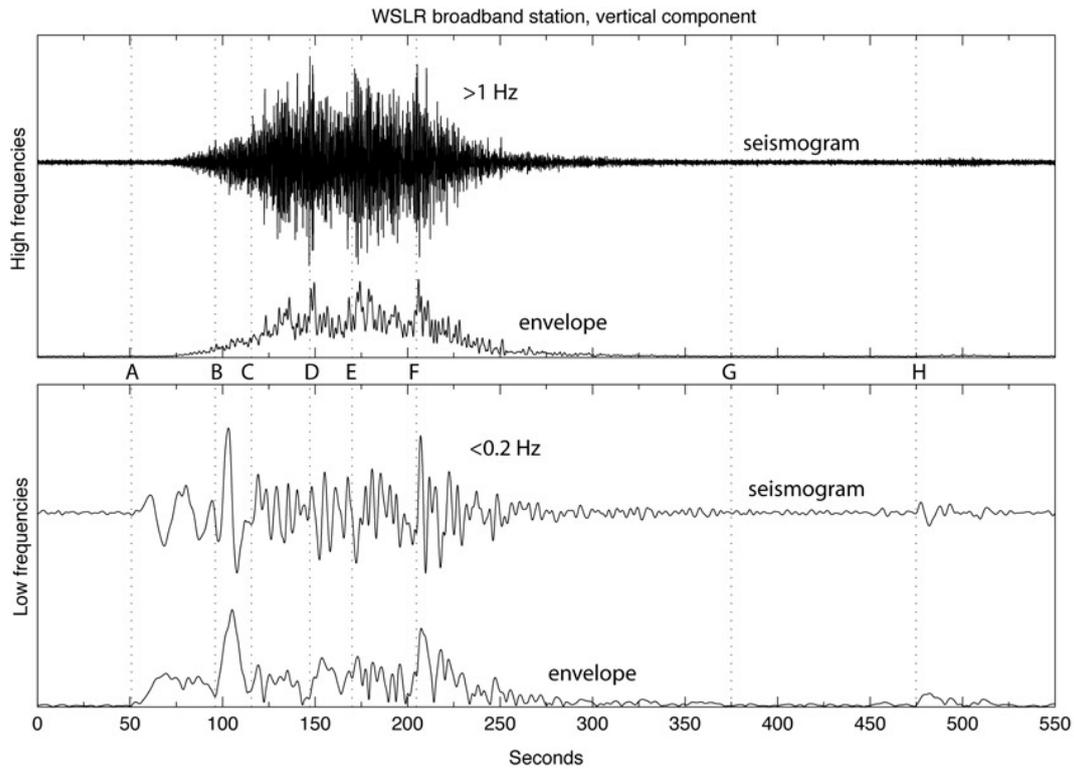
Fig. 8. WSLR broadband recording of the landslide single-pass highpass filtered (>1 Hz top) and lowpass filtered (<0.2 Hz, bottom) and plotted with envelopes. Dashed vertical lines are labeled with letters that correspond to Fig. 9 and discussion in text.

Phases of landslide activity were inferred over the next 200 s based on analysis of seismic wave type, amplitude, and relative timing and corroborated by field observations. The pulses, their source description, and time from the signal onset are described in Table 2, with locations shown on Fig. 9. Identified pulses are nearly identical at other broadband stations, with some variation due to the radiation pattern, showing that these are source effects, not site effects or path effects.

The most well-defined of the long-period source events are A, B, and F. Event A is interpreted to be initial failures from the upper slopes onto the flanks below. The dominant period of these waves is about 17 to 20 s, indicating a source process of about an equivalent length (Kanamori and Given 1982). This was confirmed by preliminary waveform modeling. Event B is higher in amplitude than Event A and is composed primarily of Rayleigh waves, suggesting a dominantly vertical force. This is interpreted as the collapse of the secondary peak onto the flanks below, mobilizing and disaggregating the material below into a high-velocity debris flow. The period of these Rayleigh waves was 10 s, indicating a shorter source process than the initial failures (A), consistent with the expected signature of a collapse of the secondary peak of Mount Meager. These initial massive failures (A and B) are roughly equivalent to a single force source mechanism in the opposite direction of slide movement as a block accelerates, and in the same direction as slope movement as a block decelerates (Kanamori and Given, 1982; Dahlen, 1993; Julian et al., 1998). The polarization of the first arrivals of the Rayleigh waves and the variability in the amplitudes of both types of surface waves with azimuth indicate the correct radiation pattern for a single force. Preliminary waveform modeling supports the single force mechanism and suggests forces on the order of 10^9 N for event A and 10^9 – 10^{10} N for event B.

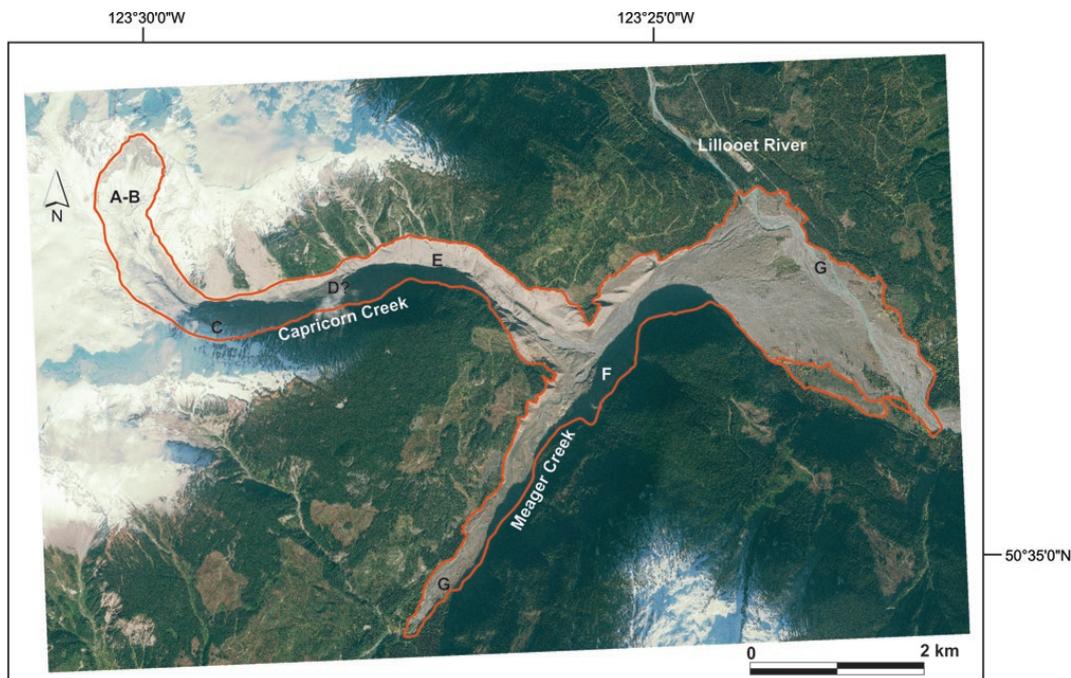
Fig. 9. The complete outline of the Mount Meager landslide showing the initiation zone (A–B), the two major bends (C and E), the facing wall of Meager Creek (F), and the bifurcated flow that travelled up Meager Creek, and across the Lillooet River (G). The image was taken following the breach of the Meager Creek dam, and fluvial reworking and considerable incision of the dam itself are evident.

Path width from the GeoEye image (Fig. 9) was entered directly into DAN-W along with topography and model parameters. Field evidence of post-failure behaviour indicated limited path-erosion and therefore entrainment was not considered in this simulation.

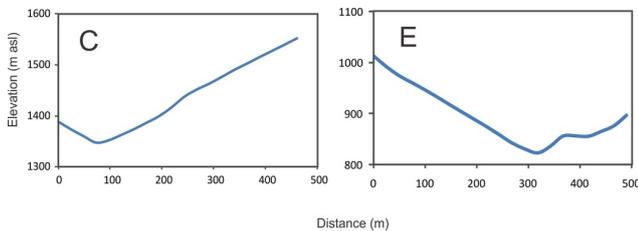
Fig. 10. Cross-sectional profiles from the upper bend (C) and the lower bend (E) used for velocity calculations in Fig. 9.

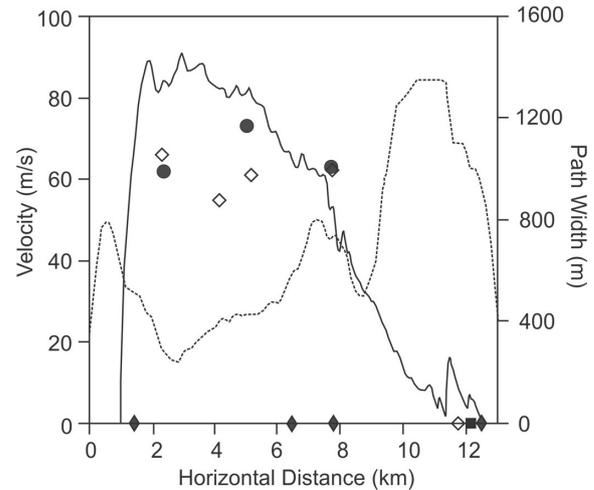
Fig. 11. The plot of frontal velocity versus path distance (solid line) and path width versus path distance (dashed line) for the 2010 Mount Meager landslide. Velocities are compared to estimates from superelevation and run-up data (black dots) and seismic analysis (open diamonds). The black square is actual field run-out and filled black diamonds denote the segments corresponding to the four materials in Table 3.

Overall, the simulation gave a mean velocity to the confluence of Capricorn and Meager creeks of 68.4 m s^{-1} and a peak velocity of 91.2 m s^{-1} . This compares favorably to the mean velocity of 67 m s^{-1} derived from the seismic traces.

fan into the Lillooet River valley. The sudden deceleration is evident in Figs. 11 and 12.

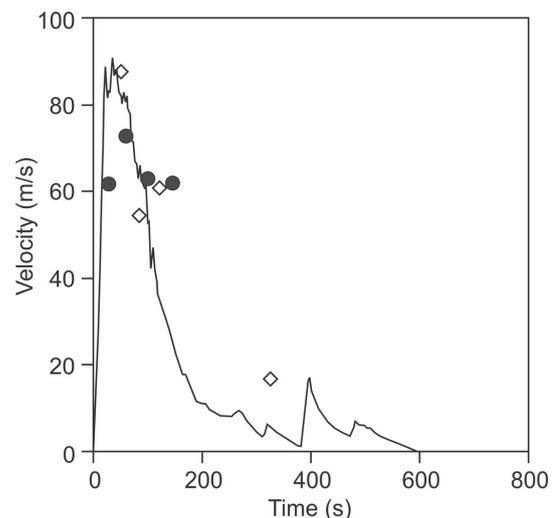
Fig. 12. DAN-W simulation plot of velocity versus time. Velocities are compared to estimates from superelevation in bends and run-up geometry (black dots) and seismic analysis (diamonds).

With reference to velocity versus time relationships, there is broad correspondence between the results of DAN-W and the seismic trace for the initial part of the path up to the run-up at the confluence of Capricorn and Meager creeks. We note, however, that in Fig. 12, a large discrepancy is evident in run-out times between the seismic (324 s) and DAN-W analyses (621 s). This may be explained by the low

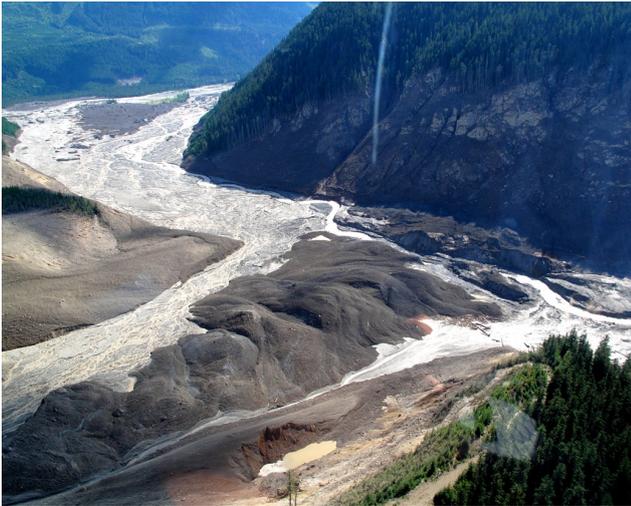
Fig. 13. The Meager Creek barrier after the dam outburst flood at the confluence of Capricorn and Meager creeks.

At the confluence of Capricorn and Meager creeks, the landslide encountered the opposing rock wall of the Meager Creek valley causing a vertical run up of 270 m and leaving a roughly triangular landslide dam (the Meager Creek barrier) approximately $700 \text{ m} \times 500 \text{ m}$ at the base, with a thickness of 30–50 m (Figs. 13 and 14). The landslide dam completely blocked Meager Creek for 19 hours, causing the formation of a landslide dam lake, and ultimately failing into the Lillooet River valley.

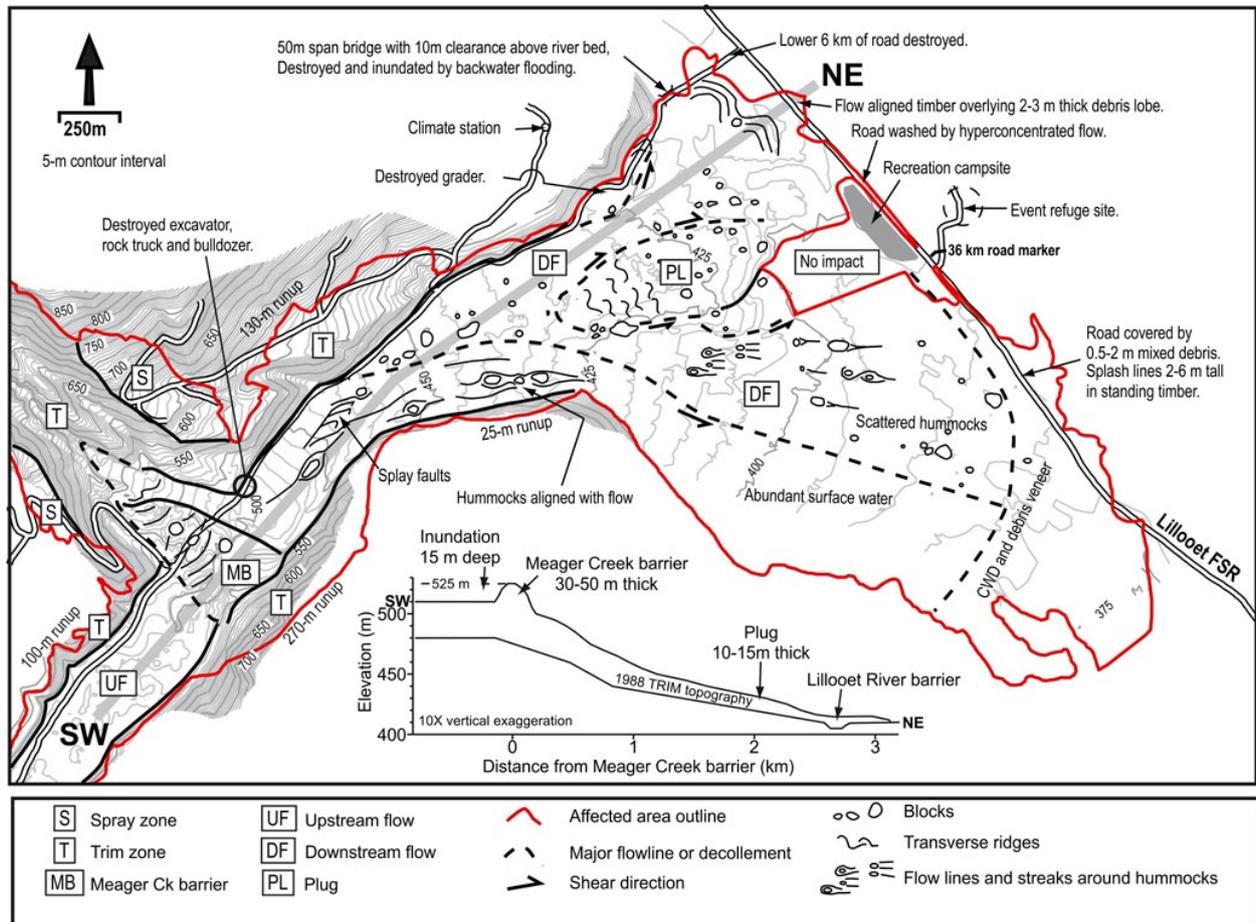
Fig. 14. Map of the landslide deposit in the valleys of lowermost Meager Creek and Lillooet River (see text for description).

The debris flow spread across the Lillooet River valley, leaving behind abundant ponded surface water, hummocks, blocks, and compression ridges. Ongoing debris flows subsequent to the main event in-filled the south side of the valley, and reworking of the deposit began almost immediately following the landslide dam failure.

The morphology and architecture of the deposit is typical of large volcanic landslides, with hummocky topography, longitudinal flow banding and areas of transverse compression ridges (Siebert, 1984; Glicken, 1991; Dufresne and Davies, 2009). The low relief areas are underlain by matrix-supported, poorly-sorted debris with grain sizes ranging from

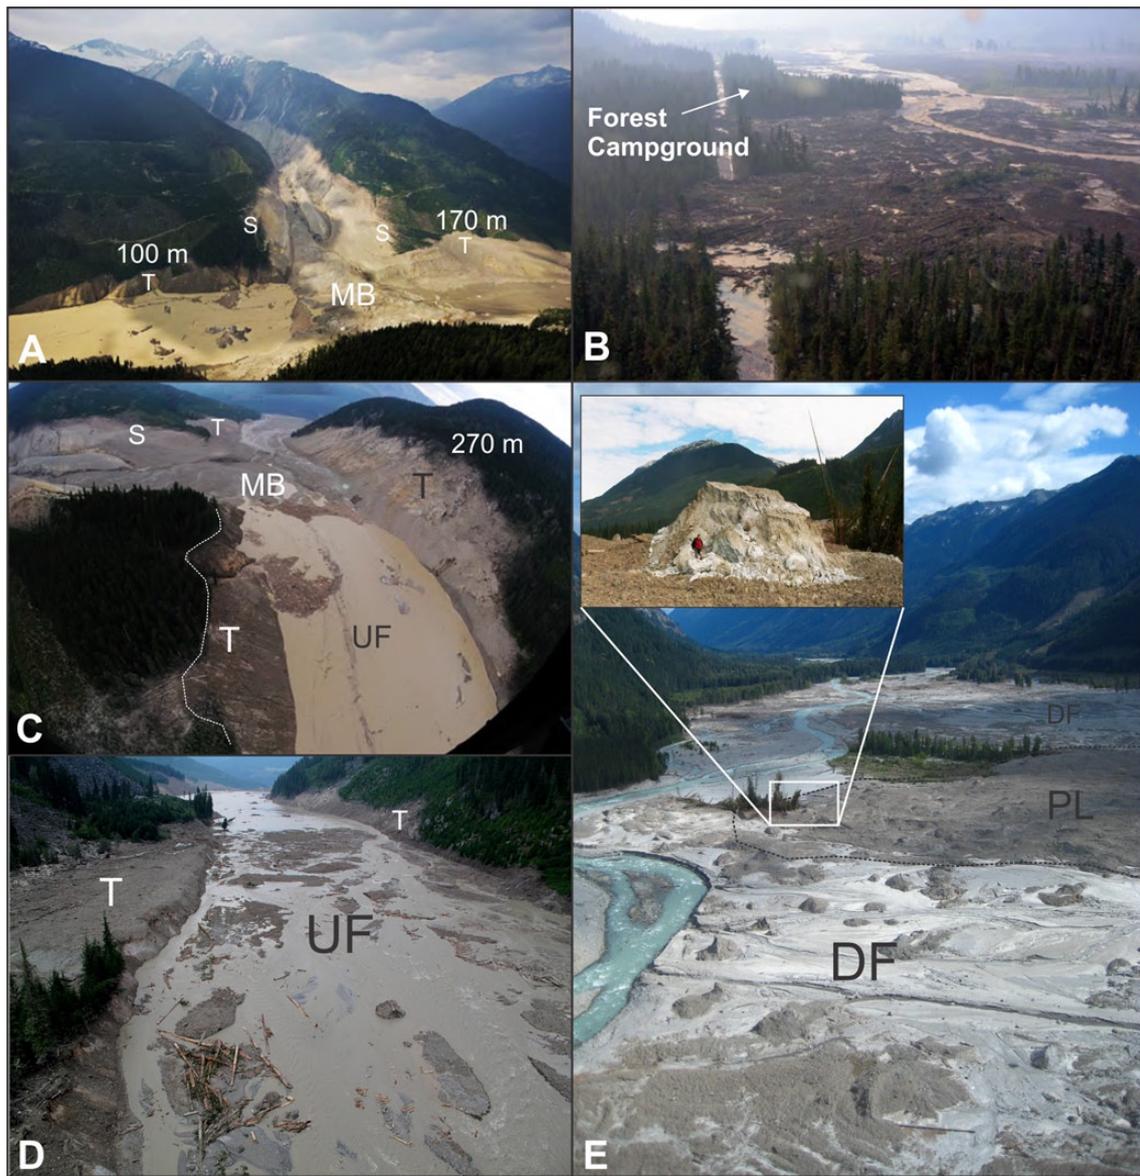
Fig. 15. Deposition features in lower Meager Creek. PL = plug; DF = downstream flow; UF = upstream flow; T = trim zone; S = spray zone. Image (A) is at the Capricorn–Meager confluence (photo by B. Makarewicz); (B) shows the downstream flow against the east wall of the Lillooet River valley; (C) and (D) are upstream of the Meager Barrier (photo C by D. B. Steers); and (E) is the downstream flow and plug.

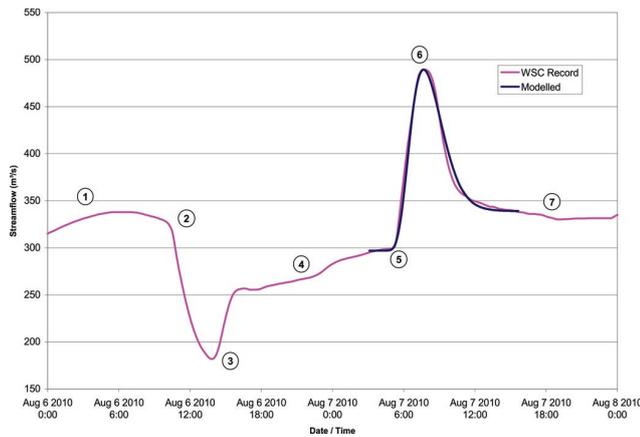
Fig. 16. WSC gauge 08MG005, Lillooet River near Pemberton. The gauge records the response of the Lillooet River at Pemberton to the Mount Meager landslide and subsequent damming events. Delay time to the station is approximately 6 h and 45 min. 1, stable base flow (curve is diurnal fluctuation in stream flow); 2, initial drop in flow due to the complete blockage of Meager Creek, and partial blockage of Lillooet at 10:15; flow dropped to $182 \text{ m}^3 \text{ s}^{-1}$; 3, rapid recovery of flow beginning at 13:15 associated with the incision of Lillooet River through the landslide deposit; 4, continued gradual recovery of Lillooet River flow, minus the Meager Creek portion; 5, arrival of the Meager dam breach floodwave at 05:15; 6, arrival of the flood peak at 07:45; 7, re-establishment of stream flow conditions. The blue line represents the modelled dam breach and corroborates the observed stage discharge at Pemberton.

The lake overtopped the landslide dam at around 23:30 h on 6 August and reached a peak discharge of several hundred m³ s⁻¹ at about 01:00 h on 7 August. The floodwave travelled downstream toward Pemberton with an average velocity of approximately 2.5 m s⁻¹. The peak passed the Hurley River Forest Service Road bridge (38 km downstream) at about 04:30 h and the Water Survey of Canada gauge (61 km downstream) at 07:45 h. Flows attenuated in velocity and volume with distance; however, high flows persisted and discharge at Pemberton, almost 7 h after the peak remained about 200 m³ s⁻¹ above the pre-wave condition.
