Characteristics of damage to buildings by debris flows on 7 August 2010 in Zhouqu, Western China

K. H. Hu^{1,2}, P. Cui^{1,2}, and J. Q. Zhang^{1,2}

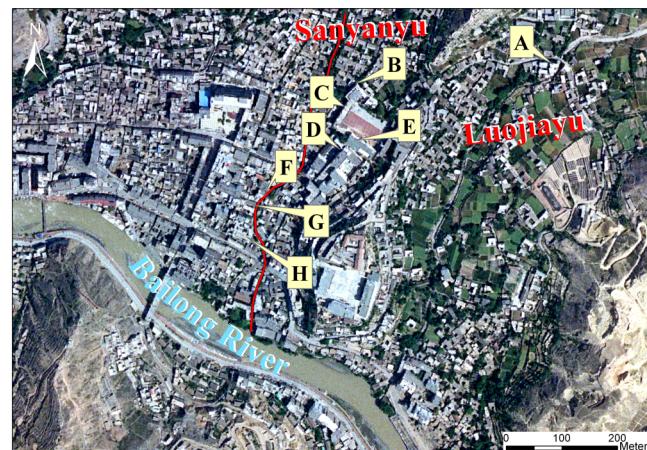
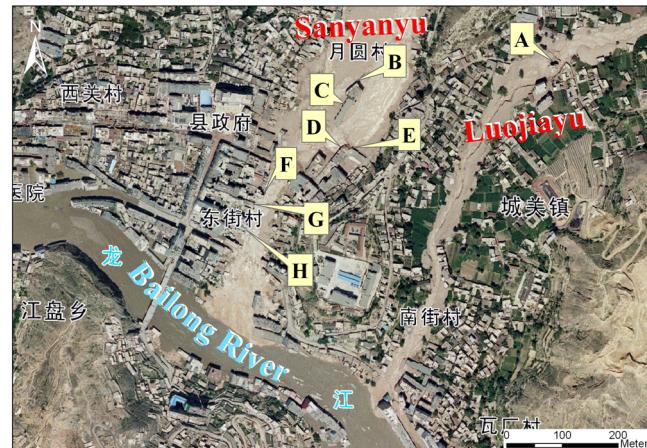
Fig. 2. Damage to buildings in Zhouqu city by the debris flows on 7 August 2010. (a) ALOS satellite image on 10 March 2010. (b) Aerial photo on 10 August 2010 published by the National Administration of Surveying, Mapping and Geoinformation. The red solid line in (a) indicates the drainage channel before the event. The labels A–H indicate the locations of the eight buildings presented in this case study. Note that a large deviation is seen between the location of Building E in (a) and (b) because the building was moved downstream by debris flows.

The debris flows hit three suburban villages and the densely populated zone of the city. Subsequently, the debris flowed into Bailong River and formed a 1.2-km-long dam completely blocking the river (Fig. 2), inundating nearly one-third of the urban area. As of 1 September 2010, the disaster has affected 4496 families and resulted in 1471 dead and 294 missing persons. The event also destroyed 233.4 acres of farmland and damaged 53 buildings, making it the severest debris-flow disaster since 1949.

Most of the buildings on both sides of the channel were buried or completely destroyed (Fig. 2). Eight surviving buildings were chosen as study cases. Although severely damaged, part of information on the damage can be recovered from the photos. The buildings represented three kinds of structure (brick-concrete, reinforced-concrete frame, and brick masonry), two of which are common in the mountain areas of China (Table 2).

Damage to the eight buildings was characterized by four features: frontal impact, dominant in the proximal portion of debris flows; accumulation and abrasion, dominant in the distal portion of debris flows; the boundary decreasing effect; and the back shielding effect. The most severe damage occurred to buildings that were located around the main streamline and impacted by proximal debris flows in which most of the mass and energy was concentrated (Fig. 3). For example, buildings A, B, and E were located in the centre of the flooded areas. The bottom two and half storeys of building A at Luojiayu were partially destroyed by the impacting forces, and then the remaining upper floors collapsed (Fig. 3a). Building B was located 60 m north of building E. Both were heavily damaged by the direct impact of the main flows at an angle of approximately 90°. In these cases, the damage due to frontal or orthogonal impact is far greater than that due to accumulation and abrasion. Moreover, the scale of damage the two buildings experienced is different and is related to their configuration. Building E was toppled and pushed 18 m downstream (Fig. 3c), whereas only the upstream wall and corridor of building B were destroyed.

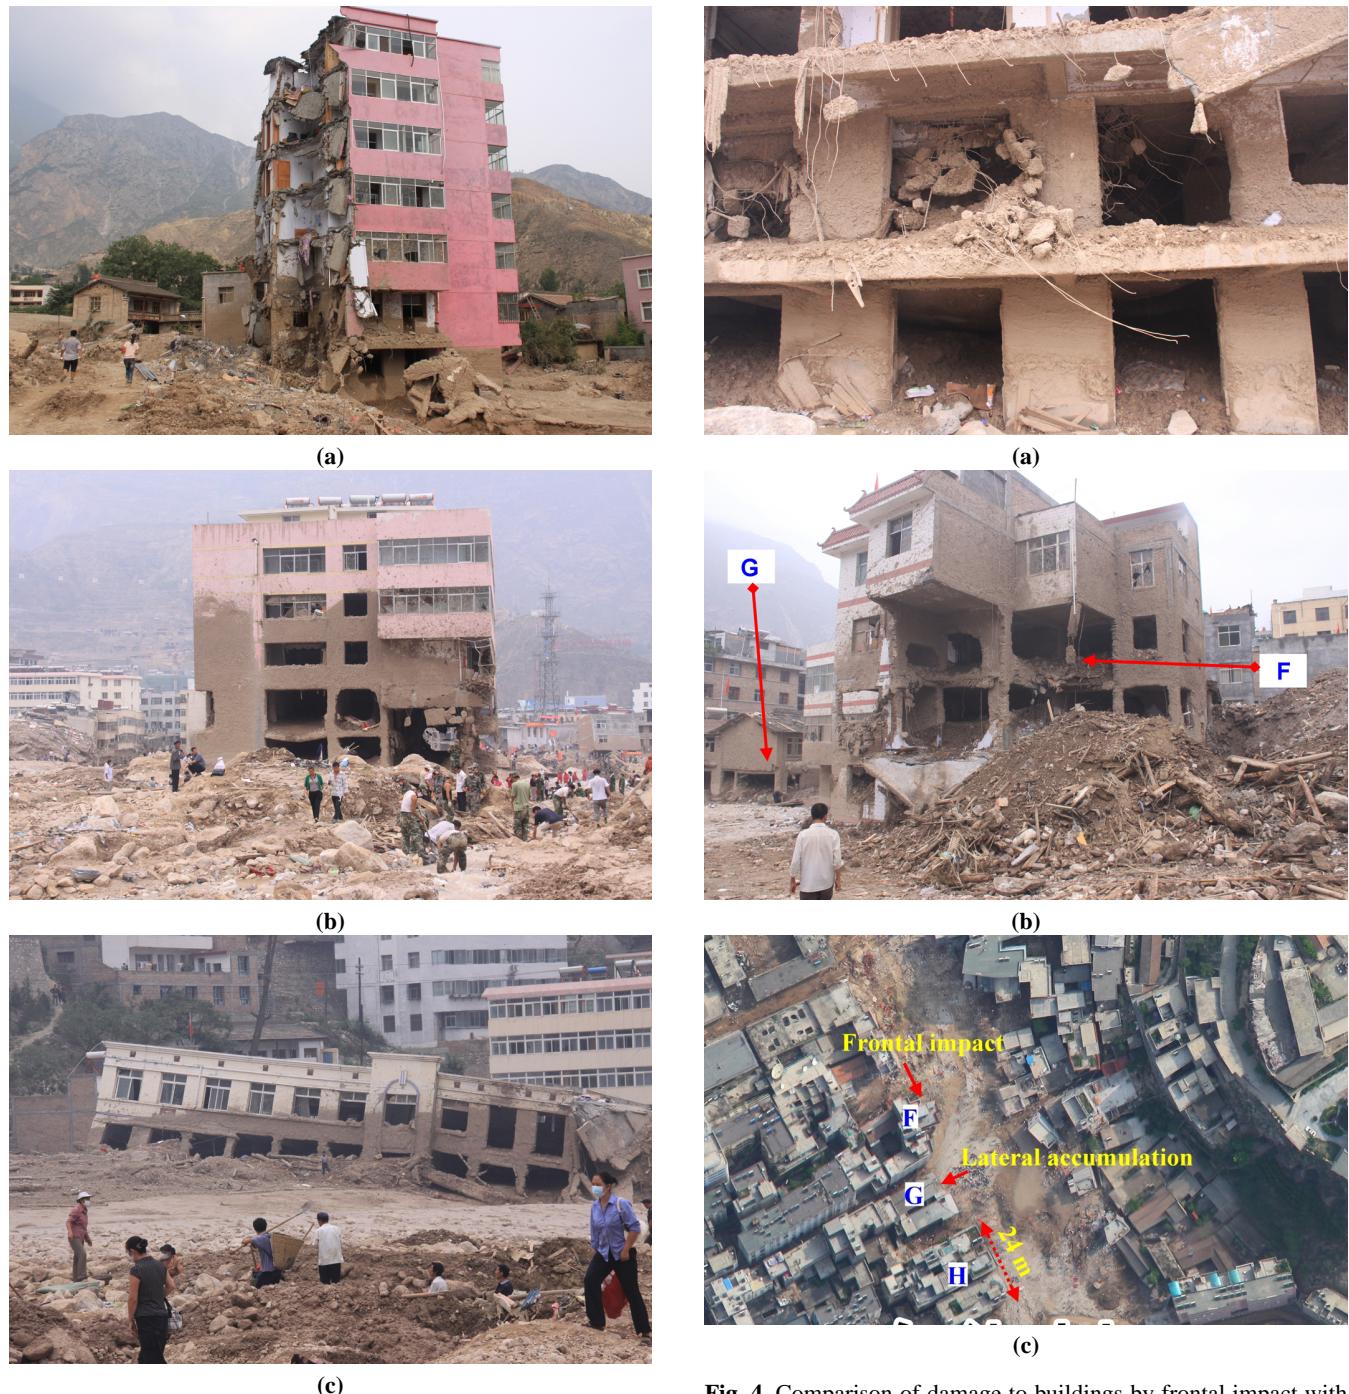
When the main flow direction is parallel to the contact face or the building is impacted by distal debris flows, the damage is dominated by lateral abrasion or accumulation. As such, the sidewall of building B was abraded, but only the windows and doors were destroyed (Fig. 4a). Damage caused by lateral accumulation and abrasion is far smaller than that caused by frontal impact, because the velocity component along the main stream is higher than the lateral or transverse component. Building F, a four-storey residential

building with a reinforced-concrete frame, was obviously stronger than building G, an old two-storey brick masonry building. However, the protruding portion of building F was destroyed under the frontal impact of proximal debris flows, while the structure of building G had no damage, only being buried half a storey deep by distal debris flows (Fig. 4b–c). The first two features suggest that the vulnerability has a clear dependence on the debris-flow portions. For example, Michael-Leiba et al. (2003) distinguished the damage by proximal debris flows from that by distal debris flows and defined the vulnerabilities for elements at risk susceptible to proximal and distal debris flows by values of 1 and 0.1, respectively.

The third noticeable feature was the longitudinal boundary decreasing effect. It is evident in the damage to building H, three rows of five-storey terraced buildings with reinforced-concrete frames (Fig. 5). The total length of building H was 24 m (Fig. 4c). Debris flows destroyed three storeys of the first row and two storeys of the second row. However, for the third row, no pillars were destroyed and only the first storey was buried. The losses decreased by one-third progressively per 8 m along the boundary of building H. That means the energy consumed by destroying the pillars of the first two storeys reduced the impact force of the flow. After impacting

Thus, buildings in the buffer zone suffer less damage than those in the undisturbed zone. This feature, called the back shielding effect, is illustrated in Fig. 6a, which shows that building C, next to the heavily damaged building B, suffered no damage apart from its first storey being buried. However, the outcome of the back shielding effect depends on the quality of the upstream building. If the upstream building is not strong enough, secondary damage may occur. The collapsed building E is a failed case of the shielding effect. Building E was initially knocked down by debris flows because its foundation was not good, and then it struck one side of building D, a six-storey residential building behind E, toppling D instead of protecting it. The bottom four floors of D were pushed down like stacked dominoes because the building did not have a reinforced concrete frame structure and was unable to withstand horizontal thrust. The walls between any neighbouring two of the bottom four floors collapsed, and the floors were displaced downward by approximately two metres. Only the top two floors were relatively unaffected (Fig. 6b). In contrast to the shielding effect, the protruding part of a building is more easily damaged, as shown by building F (Fig. 4b).

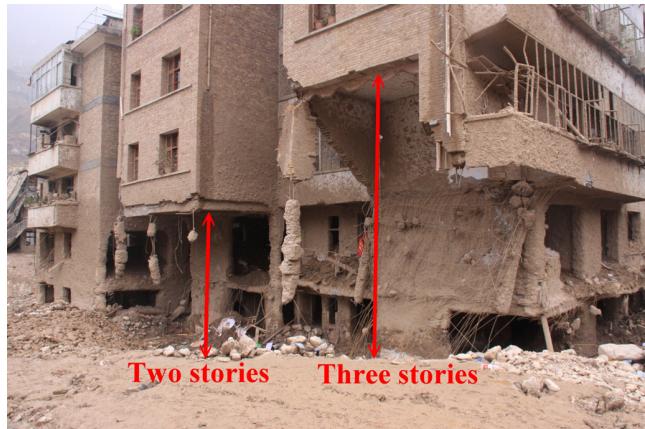
Fig. 5. Differing extent of damage to building H by longitudinally decreasing impact force.

the front two rows, the flow bodies on the boundary decelerated and did little harm to the last row. However, the flows destroyed a building 20 m downstream of building H. This shows that the boundary part of the flows can gain kinetic energy from gravitational energy and the central part when

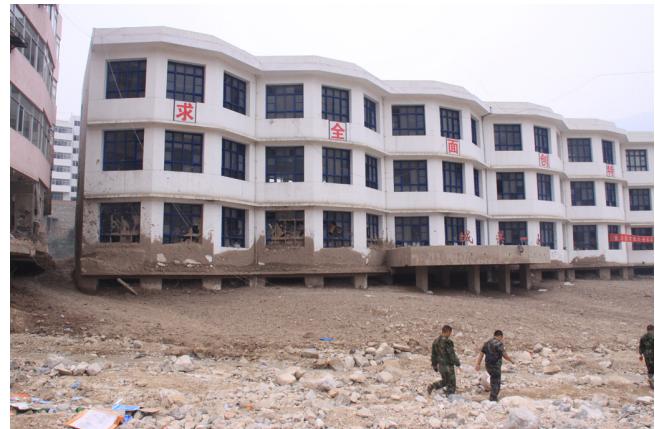
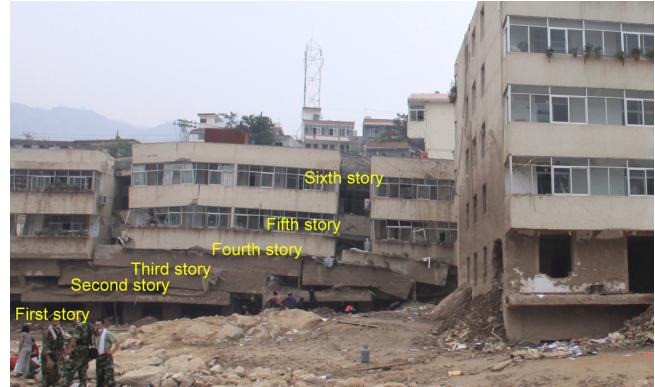
Fig. 6. Back shielding effects. (a) Building C. (b) Building D. Building D was knocked down by the collapse of building E, a case of a failed shielding effect.
