Triggering conditions and depositional characteristics of a disastrous debris flow event in Zhouqu city, Gansu Province, northwestern China

Abstract. On 7 August 2010, catastrophic debris flows were triggered by a rainstorm in the catchments of the Sanyanyu and Luojiayu torrents, Zhouqu County, Gansu Province northwestern China. These two debris flows originated shortly after a rainstorm with an intensity of 77.3 mm h^{-1} and transported a total volume of about 2.2 million m^3 , which was deposited on an existing debris fan and into a river. This catastrophic event killed 1765 people living on this densely urbanised fan. The poorly sorted sediment contains boulders up to 3–4 m in diameter. In this study, the geomorphological features of both debris flow catchment areas are analyzed based on the interpretation of high-resolution remote sensing imagery combined with field investigation. The characteristics of the triggering rainfall and the initiation of the debris flow occurrence are discussed. Using empirical equations, the peak velocities and discharges of the debris flows were estimated to be around 9.7 m s^{-1} and $1358 \text{ m}^3 \text{ s}^{-1}$ for the Sanyanyu torrent and

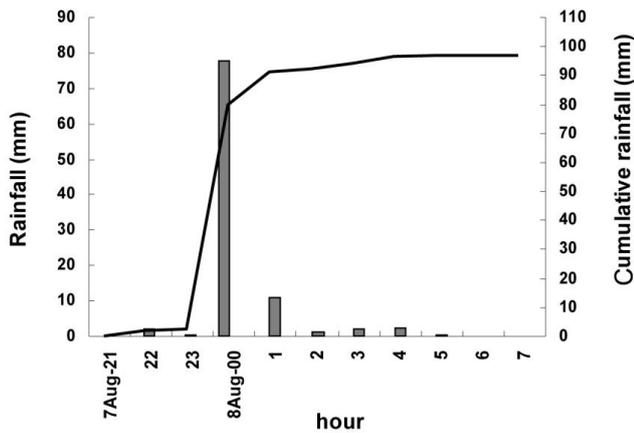
Fig. 2. Hourly and cumulative rainfall on 7 and 8 August 2010 at Dongshan rain-gage station.

A rain-gage was located in the Dongshan area at about 10 km northeast of Zhouqu city. Yu et al. (2010) and Zhao et al. (2010) assumed that this rain-gage most likely has recorded the amount of rain which triggered the debris-flows because of its location at a high elevation (2150 m a.s.l.). The recorded data show that precipitation in the Zhouqu area started at 8:00 p.m. on 7 August. The accumulated rainfall of 96.7 mm was recorded from 8:00 p.m. on 7 August to 04:00 a.m. on 8 August (Fig. 2). This is an amount with a return period of more than 100 yr (Zhao et al., 2010). The rainfall intensity that triggered the debris flows occurred between 11:00 and 12:00 p.m.: 77.3 mm h⁻¹ was recorded during that hour. Many eyewitnesses in Zhouqu city stated that the debris flows started around 11:40 p.m. and ended at 00:30 a.m. next day. After the end of the debris flows, high water discharges were reported in the stream channels until 10:00 a.m. on 8 August.

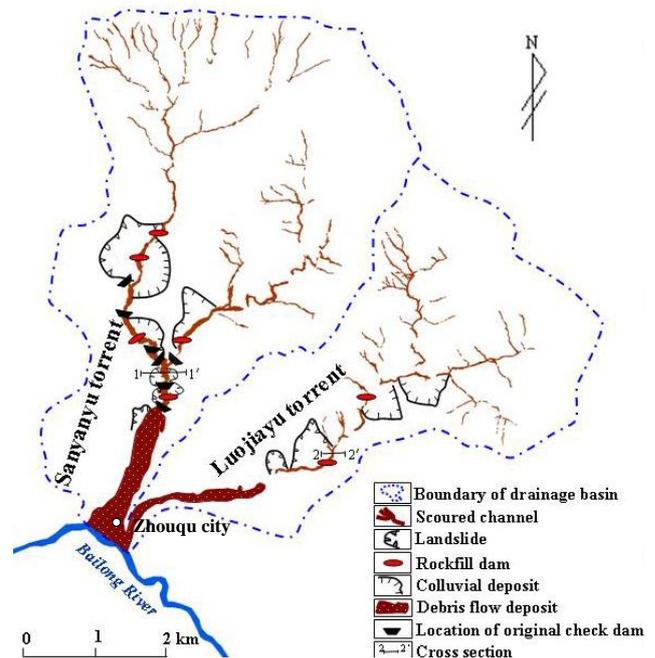
Fig. 3. Geomorphological sketch map of the Sanyanyu and Luojiaju catchments based on field investigations combined with the interpretation of a Quickbird image taken on 15 August 2010 (immediately after the Zhouqu debris flows occurrence).

Many colluvial deposits derived from rockfall and other mass-wasting processes were observed in the transport zone of the Sanyangyu torrent, which may have contributed to debris flow occurrence (Figs. 6 and 7). Geomorphological mapping (Fig. 3) indicates that colluvial deposits were mainly

Seven check dams had been constructed as stone masonry structures since 1997. In Fig. 3, the locations of these original check dams are shown. These check dams have average dimensions of 20–40 m long and 4–8 m high and the basin behind them had been filled half or totally before the event.

Using field measurement, we determined that the depositional fan of the Sanyanyu debris flow has a length of more than 2.1 km and an average width of 190 m (Figs. 3 and 11), while the Luojiayu debris flow fan is more than 2.2 km long

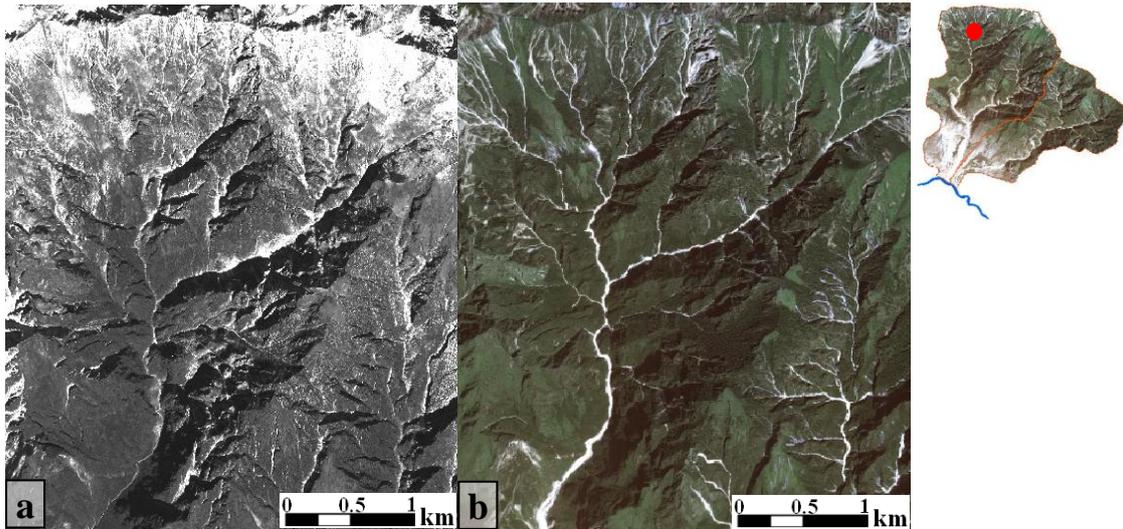
Fig. 4. Imagery showing the debris flow development in the initiation area of the Sanyangyu basin by comparison of imagery prior to and after the rainstorm event (**a**: Worldview image taken on 16 May 2010 prior to the event; **b**: Quickbird image taken on 15 August 2010 after the event).

showed significant changes in the channels in the debris flow initiation area at an elevation over 2400 m a.s.l. Initiation sites were marked by fresh scouring within or near an ephemeral channel. Figures 4 and 5 show evidence of scouring of the original channels in the initiation area of the Sanyangyu and Luojiayu torrents: the torrent banks were greatly widened after the rainstorm event. According to the “Report of the Survey of the Sanyangyu debris flow hazards

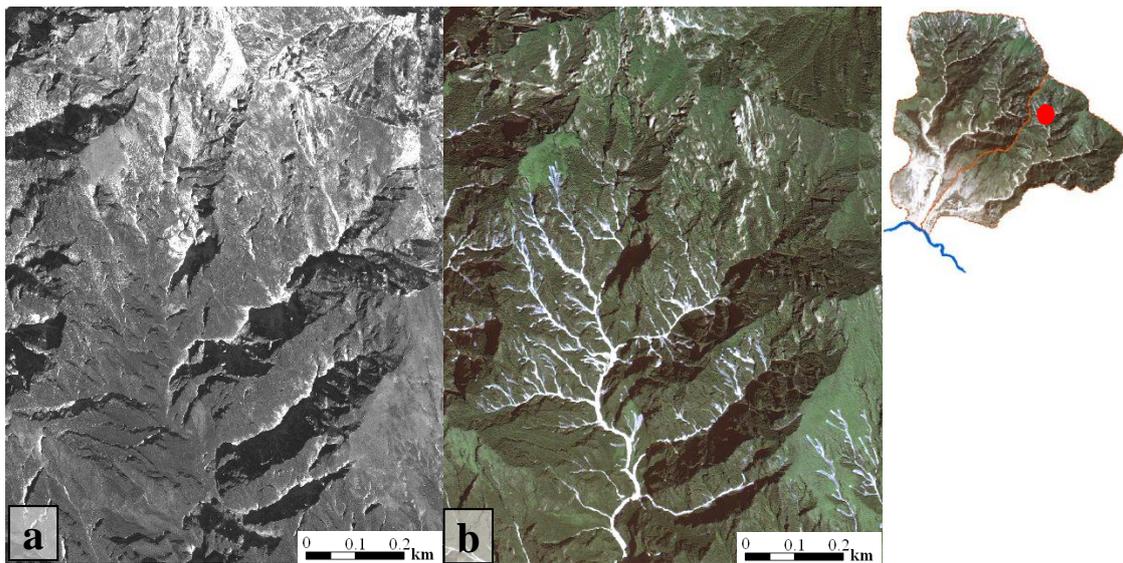
Fig. 5. Imagery showing the debris flow initiation sites of the Luojiayu basin by comparison of imagery prior to and after the rainstorm event (**a**: Worldview image taken on 16 May 2010 prior to the event; **b**: Quickbird image taken on 15 August 2010 after the event). The scoured gullies were considerably widened due to upstream overland flow after the event.

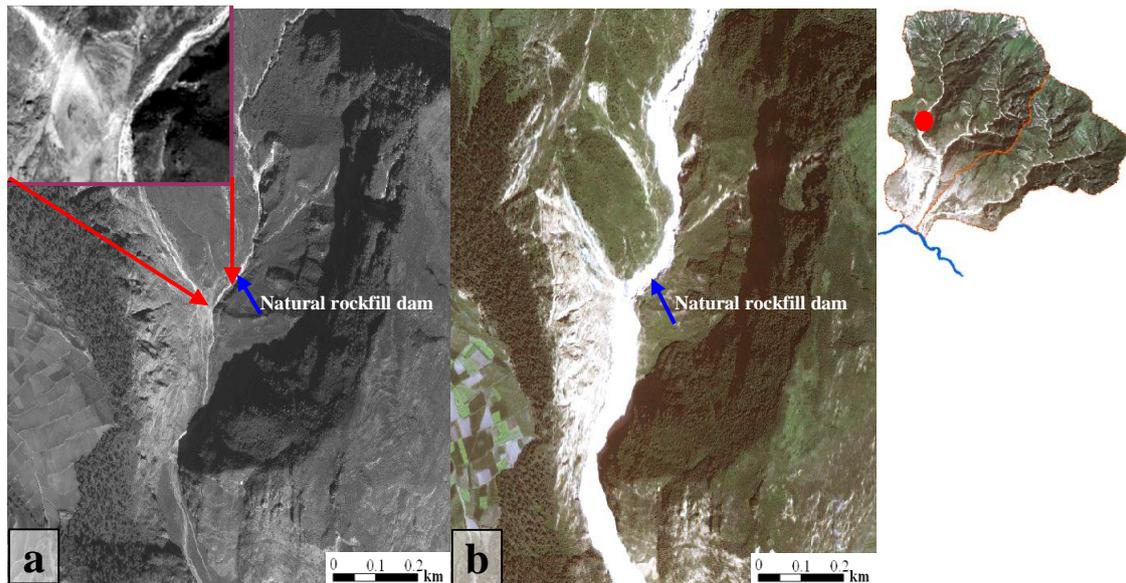
Fig. 6. Imagery showing erosive features of the debris flow channel and hillslope failures in colluvial deposits in the transport zone of the Sanyangyu catchment after the rainstorm event. The breaching of a significant natural rockfill dam resulted in intensive channel erosion and an instant increase in the flow discharge.

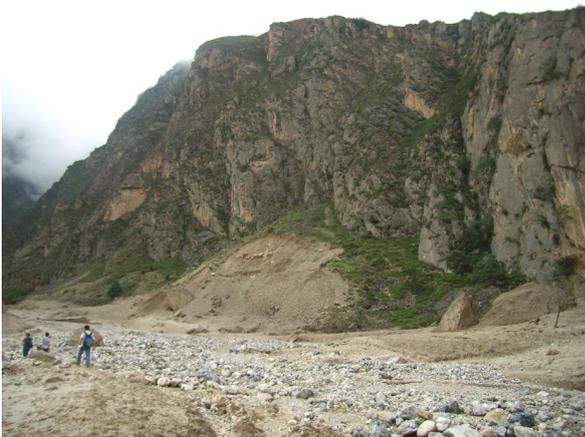
Fig. 7. Colluvial deposit derived from rockfall. The erosion by the massive and rapid debris flow resulted in colluvium failure producing more sediment volume for the debris flow.

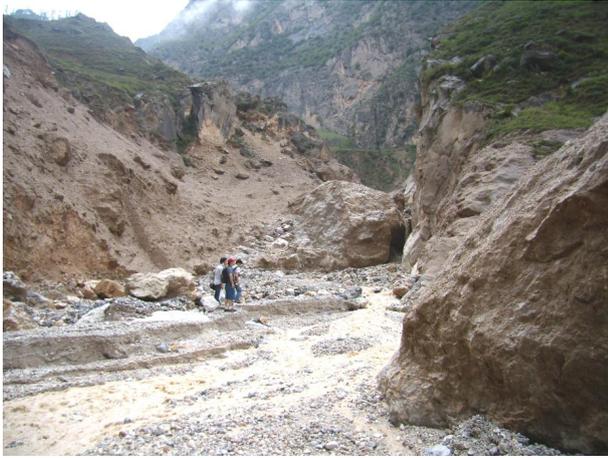
Fig. 8. Natural rockfill dam in the Sanyangyu torrent, which was scoured by the 7 August 2010 debris flow event. Only a large boulder was left in the channel after breaching of the dam.

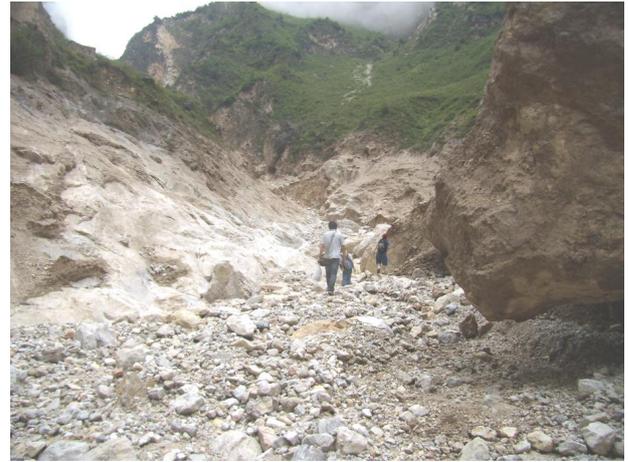
Fig. 9. Main flow track of the Sanyangyu torrent. The channel banks were scoured and widened after debris flow moved down-slope.

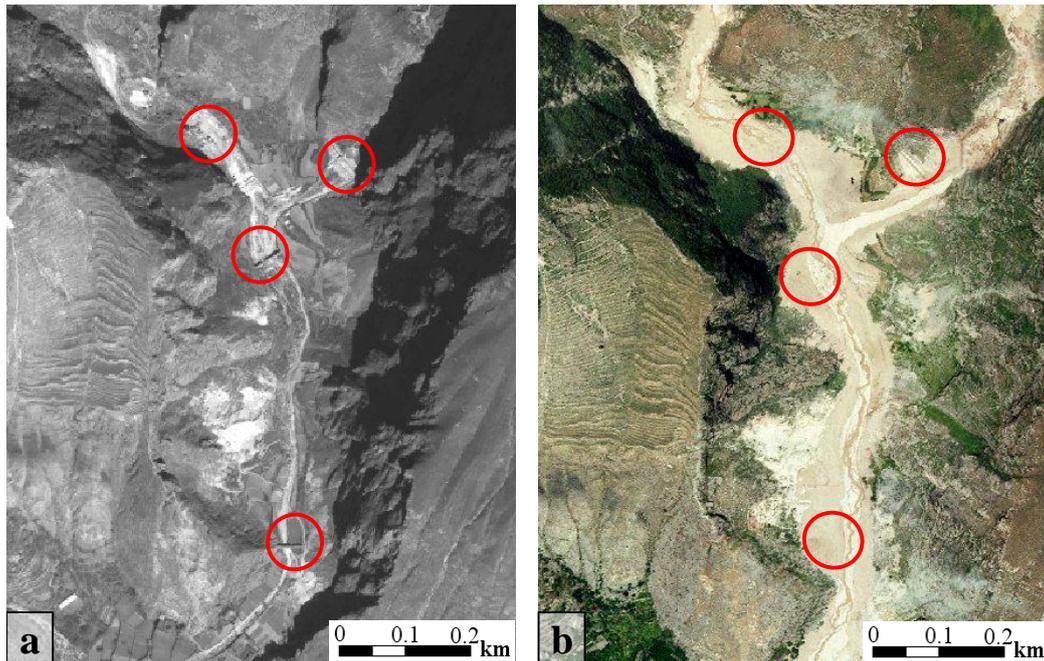
Fig. 10. Comparison of the imageries prior to and after the event showing that four previous debris flow control structures were destroyed in the Sanyangyu torrent. (a: Worldview image taken on 16 May 2010 prior to the event; b: Quickbird image taken on 15 August 2010 after the Zhouqu debris flow event.)

However, all of them were destroyed during this catastrophic event (Figs. 10 and 11). Field reconnaissance indicated that the debris flow also incorporated 10–15 % of all materials stored behind the check dams into the flow due to the dam failure. However, the failure of the check dams did not result in a significant increase of flow volume and erosive potential as compared with the natural rockfill dam breach.

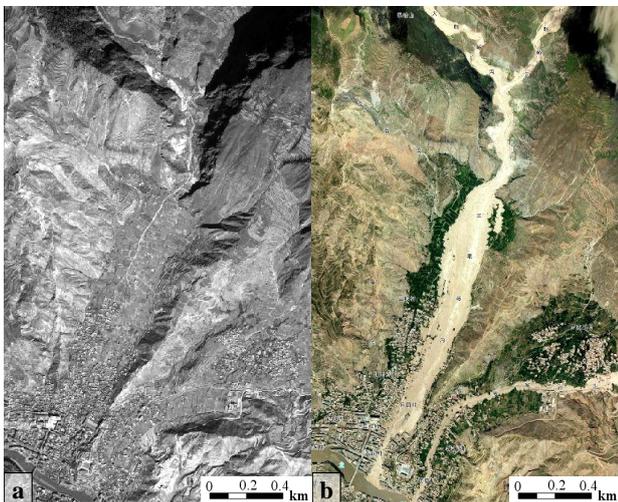
Fig. 11. Alluvial fan prior to and after the debris flow event. (a: Worldview image taken on 16 May 2010 prior to the event, showing the densely urbanized area in Zhouqu city; b: Quickbird image taken on 15 August 2010 after the Zhouqu debris flow event, showing the depositional zone of the debris flows. New debris flow deposits can be easily distinguished by their lighter tone.)

Zhouqu city was located on a severely damaged alluvial fan during the August 2010 event. Figures 11 and 12 show that the main damage due to the debris flows occurred in the central part of their depositional fan. At the fan apex, the peak volume of flow, probably during a debris-flow surge, exceeded the channel capacity resulting in the debris flows spreading boulders over the whole fan. The flows inundated the second storey of many apartment buildings, causing their partial collapse (Fig. 13), and also buried or completely destroyed many one and two-storey residential structures (Fig. 14).

The 7 August event clearly shows the effect of a built up area on the distribution of debris deposits on the fan (Figs. 11 and 12). The propagation and deposition of the debris flow material is not only determined by the topography of the fan but also by the location and characteristics of the buildings and the resistance against destruction of these buildings. Most hazard maps based on run-out modeling on alluvial fans take topography as the only controlling factor for the distribution of deposited material. However, more reliable results are obtained when the built up area is taken into consideration to assess the spatial distribution of the debris. The prediction of the degree of destruction of buildings during the run out and the subsequent changes in the flow pattern will, however, remain a very difficult task. Monitoring and early warning systems should be installed in the catchments above the potentially high risk areas. Construction of protective structures is still necessary to prevent repetition of the disasters because avoidance of debris flow hazard is not possible in Zhouqu city. These mitigation works are a significant effort to reduce the risk in areas recently affected by the catastrophic debris flow events.

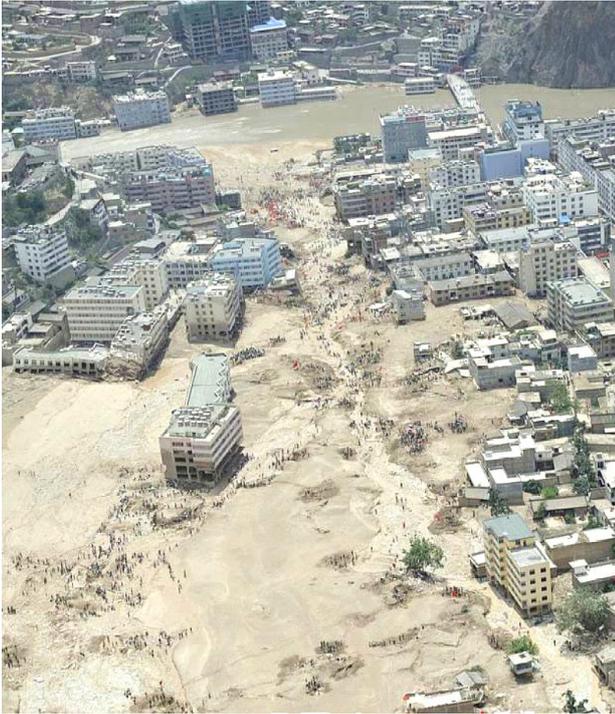
Fig. 12. The devastating amount of sediment and debris transported onto the existing alluvial fan as a result of the major debris flow of Zhouqu, China, 2010.

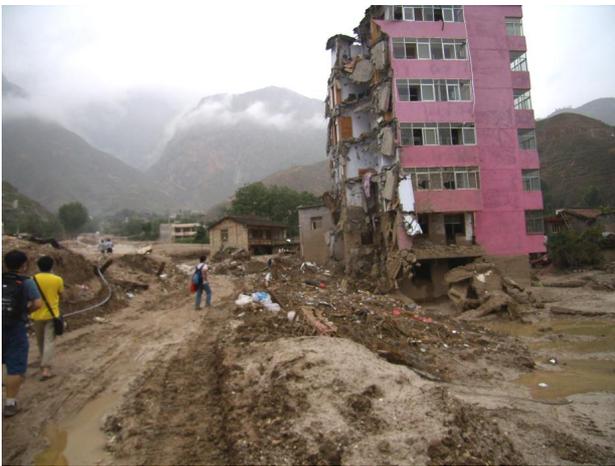
Fig. 13. Apartment buildings in Zhouqu city extensively damaged by the passage of the debris flow front of at least 4 m in height.

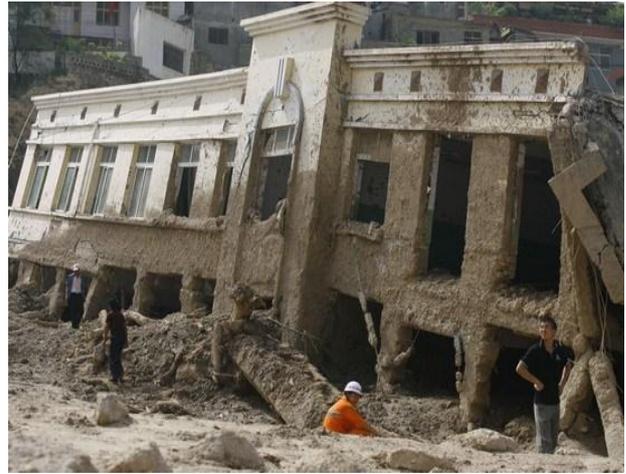
Fig. 14. A two-storey building was totally destroyed due to the direct impact of debris flow. Mud trace still remained on the wall of the building.

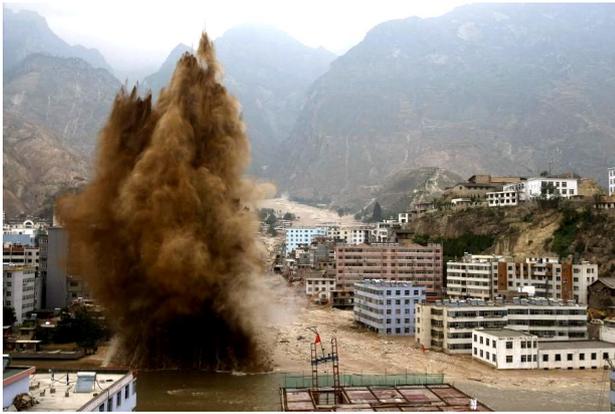
Fig. 15. Breaching of the debris-dams that partially blocked the river, raising the riverbed. After five days, an artificial spillway was completed to successfully release the impounded water.

The depositional fans extended into the Bailong River and produced a temporary debris-dam. It is difficult to determine the thickness of subaqueous deposits, but they were probably more than 9 m thick. This debris-dam raised the water level more than 8 m causing severe flooding in the Zhouqu city (Fig. 15). This debris dam was estimated to be 10 m in height, 70 m in length across the river, and 450 m in length along the river, resulting at the upstream side in a dammed lake with a length of 3 km. One third of Zhouqu city was inundated for 5 days. In order to reduce the urban flooding risk, emergency response was undertaken to remove the boulders and the finer-grained particles in a channel through the crest of the debris dam (Fig. 16). After five days, an artificial spillway was completed to successfully release the impounded water.

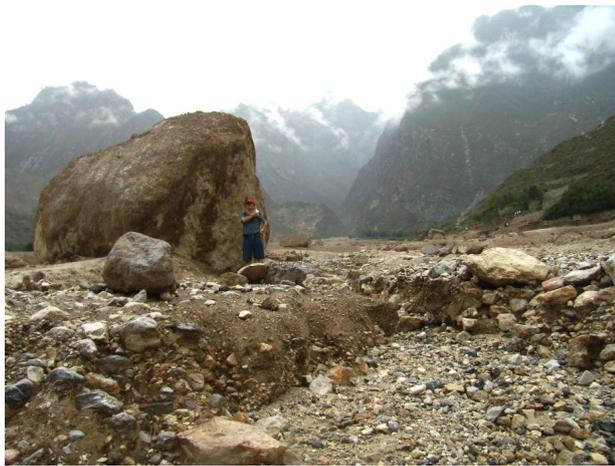
Fig. 16. Photography showing the largest boulder (which exceeded a diameter of 6 m) deposited in the depositional zone when the flow spread out over agricultural terraces.

abundant than coarse-grained materials in the matrix of the depositional fans of the debris flows in the study area (Yu et al., 2010). Field observation showed that most of the coarse-grained particles were accumulated in the highest part of the fan. The largest boulders deposited on the fan exceed a diameter of 6 m (Fig. 16).
