Developing fragility functions for aquaculture rafts and eelgrass in the case of the 2011 Great East Japan tsunami

Abstract. Since the two devastating tsunamis in 2004 (Indian Ocean) and 2011 (Great East Japan), new findings have emerged on the relationship between tsunami characteristics and damage in terms of fragility functions. Human loss and damage to buildings and infrastructures are the primary target of recovery and reconstruction; thus, such relationships for offshore properties and marine ecosystems remain unclear. To overcome this lack of knowledge, this study used the available data from two possible target areas (Mangokuura Lake and Matsushima Bay) from the 2011 Japan tsunami. This study has three main components: (1) reproduction of the 2011 tsunami, (2) damage investigation, and (3) fragility function development. First, the source models of the 2011 tsunami were verified and adjusted to reproduce the tsunami characteristics in the target areas. Second, the damage ratio (complete damage) of the aquaculture raft and eelgrass was investigated using satellite images taken before and after the 2011 tsunami through visual inspection and binarization. Third, the tsunami f

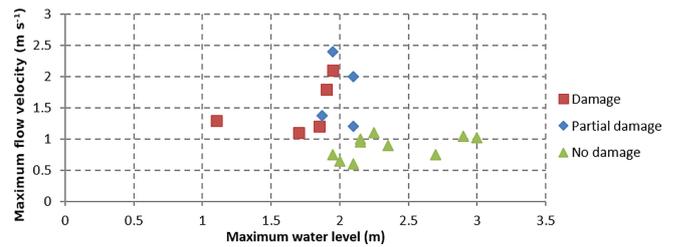
Figure 1. Damage criteria of the aquaculture raft based on the damage data from Kii Peninsula, western Japan, from the 1960 Chilean tsunami (Adapted from Nagano et al., 1991)

This section reviews selected previous studies related to the damage characteristics of offshore facilities and marine plants against tsunamis. The first attempt was based on the 1960 Chilean tsunami, which struck the west of Japan. The damaged aquaculture rafts were plotted against the simulated maximum water level and flow velocity (Nagano et al., 1991). As shown in Fig. 1, the damage to the aquaculture raft (pearl) begins to occur when the tsunami flow velocity is higher than 1 m s^{-1} regardless of the water level. Similarly, Kato et al. (2010) applied identical criteria to quantify the damage to aquaculture rafts in areas along the east coast of Japan, which were struck by the 2010 Chilean tsunami. They found that the damage on the east coast of Japan caused by the 2010 Chilean tsunami was accurately modeled by the proposed damage criteria developed from the data of the 1960 Chilean tsunami in the west of Japan.

A comparison of the aquaculture raft data in the cases of the 1960 Chilean tsunami (Fig. 1) and the 2011 Japan tsunami is shown in Fig. 11. Most of the aquaculture rafts that were not completely damaged in the 2011 tsunami were limited to a maximum flow velocity of less than 1.5 m s^{-1} . For both target areas, the damage probabilities for each range of the simulated water level and maximum flow velocity of both aquaculture rafts and eelgrass were calculated and are shown against a median value in a specific range of the grids. In Fig. 12, the preliminary scatterplot does not show any significant trend between the simulated maximum water level and the damage to the aquaculture rafts (Fig. 12a) and eelgrass (Fig. 12b) in Mangokuura Lake or between the simulated maximum flow velocity and the damage to eelgrass in Matsushima Bay (Fig. 12c). Thus, another expected parameter was used to develop the fragility functions: the simulated maximum flow velocity in Mangokuura Lake. To verify that our regression model is better than the predicted aver-

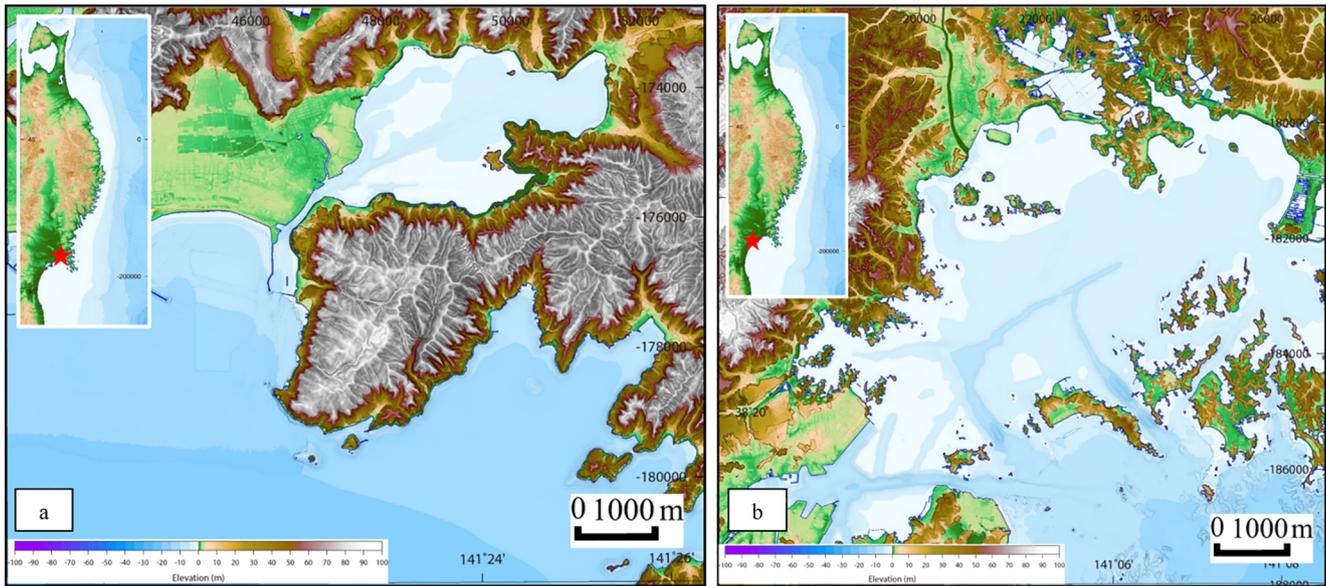
Figure 2. Study areas: (a) Mangokuura Lake and (b) Matsushima Bay.

Because the size of the 2011 tsunami was extremely large, most aquaculture rafts and other marine plants were completely destroyed. There are only two well-suited locations with specific coastal geography, namely, Mangokuura Lake and Matsushima Bay in Miyagi Prefecture (Fig. 2), where the effects of the tsunami were comparatively small (Suppasri et al., 2012) and the aquaculture rafts were undamaged and the eelgrass survived (Northwest Pacific Region Environmental Cooperation Center, 2016). Mangokuura Lake has a notably narrow entrance from the Pacific Ocean through Ishinomaki Bay, and the average sea depth is as shallow as 5 m or less. Matsushima Bay is protected by almost 300 small islands around the bay front. Thus, the 2011 tsunami inundation and run-up heights in both areas were less than 1–2 m, whereas they were as high as 10 m in other nearby areas (Suppasri et al., 2012). As a result, some aquaculture rafts and other marine plants survived in these two locations, which enabled the development of fragility functions.

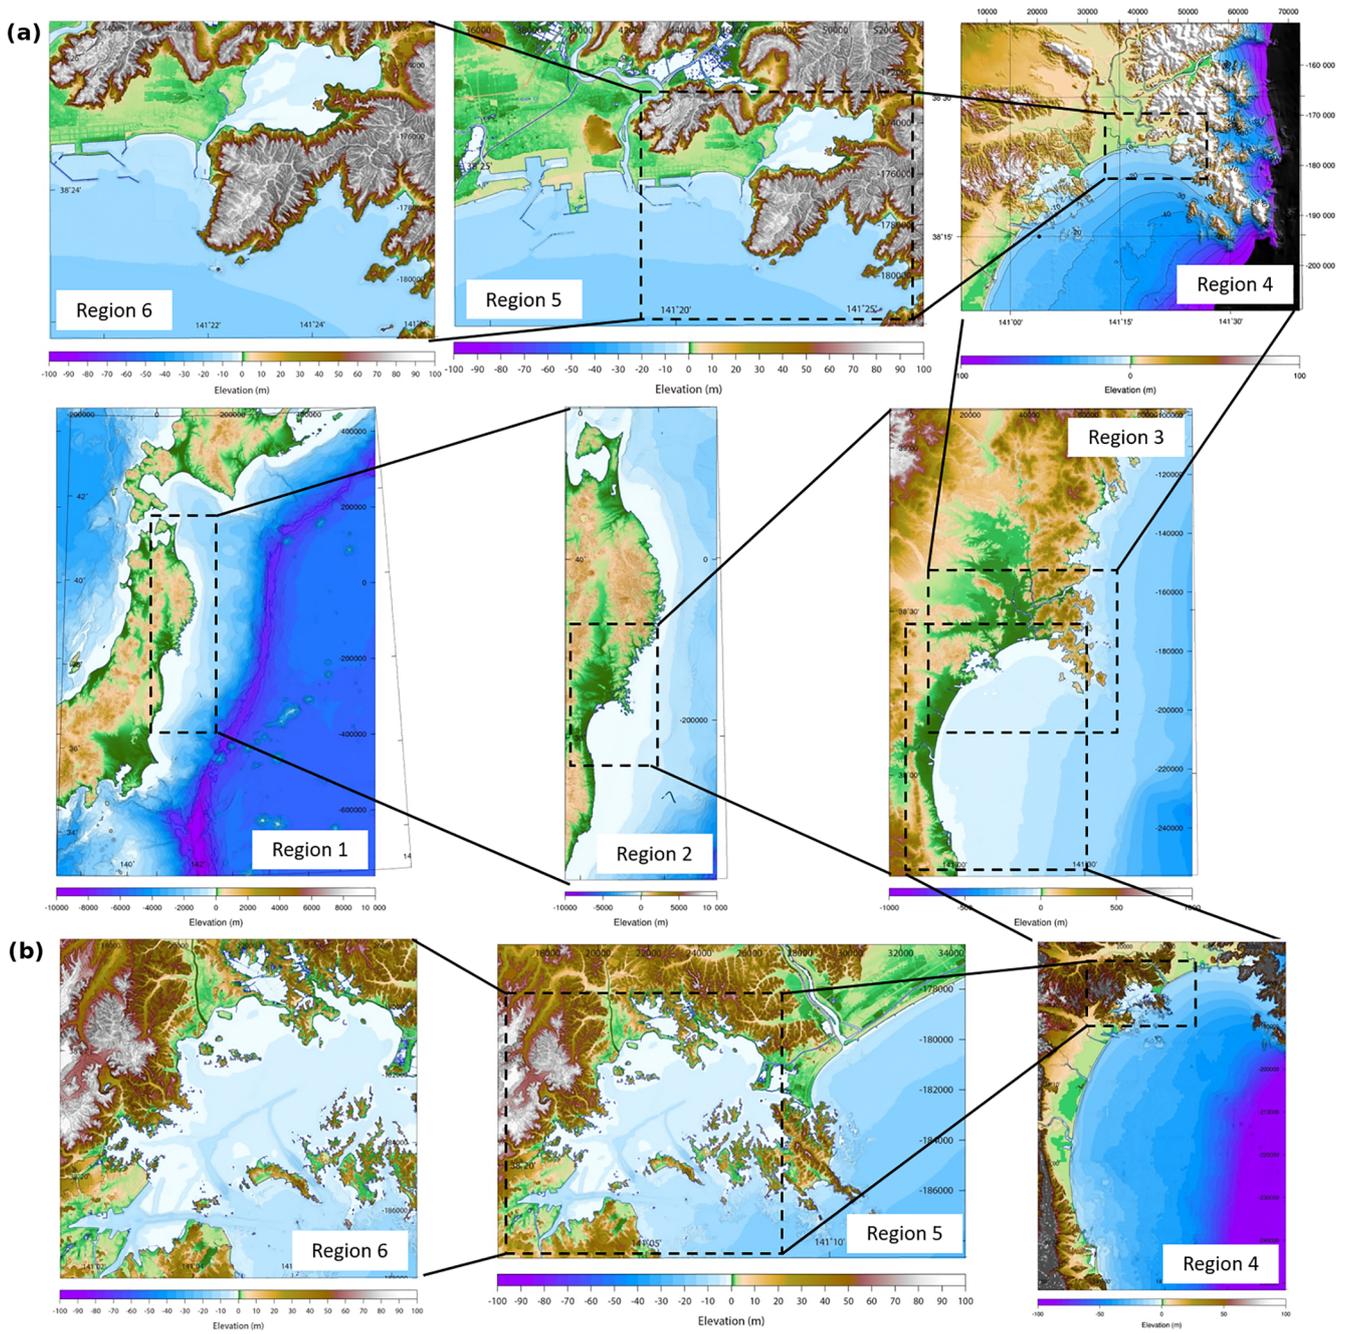
Figure 3. Six computational areas for (a) Mangokuura Lake and (b) Matsushima Bay.

2.1 Simulation conditions

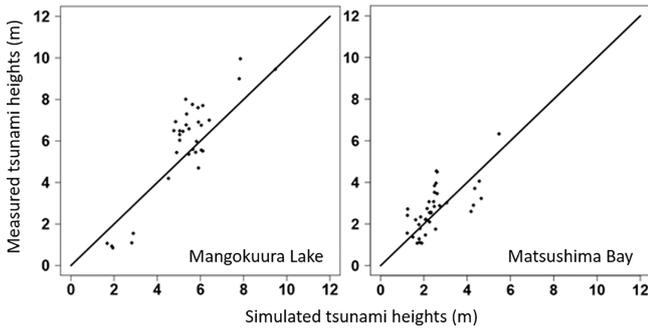
Figure 4. Comparison of the simulated and measured tsunami heights in Mangokuura Lake and Matsushima Bay.

For Mangokuura Lake, model 3 produced the optimal values of Aida's K and κ . Because K is slightly less than 1.0, the simulated tsunami heights are slightly larger than the measurement. Similarly, for Matsushima Bay, model 2 produced the best Aida's K and κ . Because K is larger than 1.0, the simulated tsunami heights are smaller than the measurement. To better obtain the tsunami parameters, the fault slip was scaled by the K values of 0.96 and 1.29 for Mangokuura Lake and Matsushima Bay, respectively, so that the reproduced tsunami closely matched the measured tsunami trace heights and satisfied the guideline of the Japan Society of Civil Engineers: $0.95 < K < 1.05$ and $\kappa < 1.45$ (Suppasri et al., 2011). As a result, the accuracy of the simulated tsunami parameters in both study areas was improved, as shown in Fig. 4.

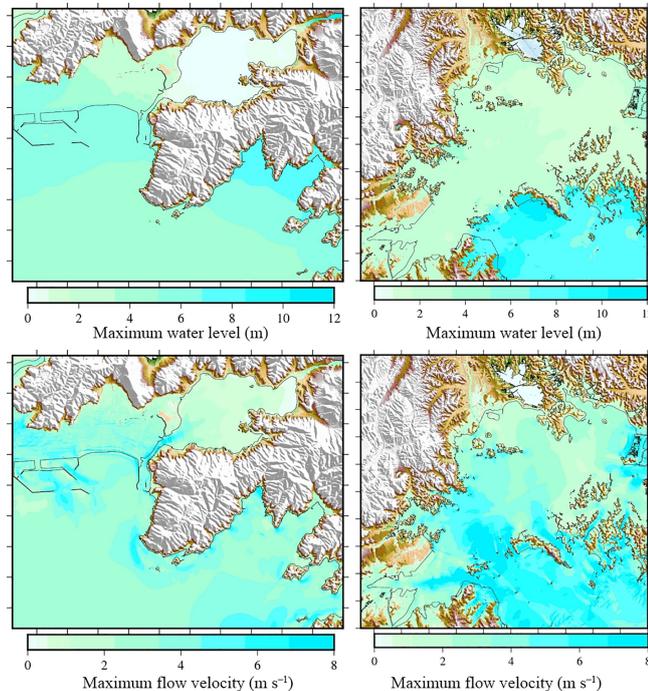
Figure 5. Simulated maximum water level and flow velocity in Mangokuura Lake and Matsushima Bay.

The hydrodynamic properties of the 2011 tsunami were reproduced based on the model calibration and verification as mentioned above. Figure 5 shows that the average maximum water level and flow velocity in the bay of Mangokuura Lake are approximately 0.5 m and $1\text{--}2$ m s $^{-1}$, respectively; those of Matsushima Bay are approximately 2 m and $3\text{--}5$ m s $^{-1}$, respectively; and the average offshore maximum water level and flow velocity in the other 2011 tsunami affected areas were much higher than these values (Suppasri et al., 2014).

- Based on the reproduced hydrodynamic characteristics of the 2011 tsunami, Matsushima Bay was hit by a stronger tsunami than Mangokuura Bay (Fig. 5).
- The maximum water level is not related to the damage to aquaculture rafts and eelgrass (Fig. 12).
- The threshold value (at 90 % damage probability) of the maximum flow velocity for completely damaged aqua-

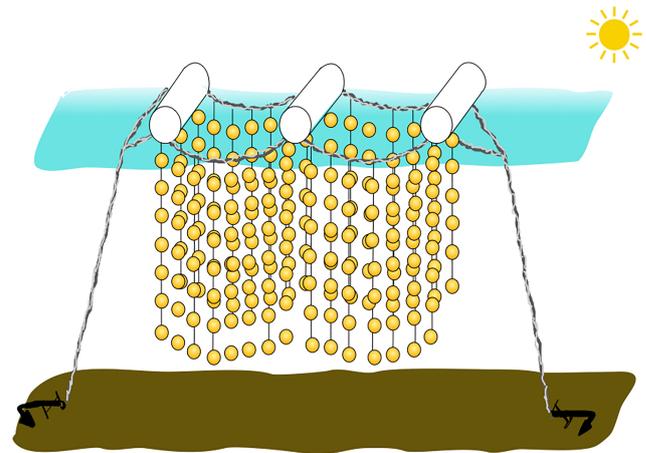
Figure 6. Aquaculture raft (long-line type).

Based on criteria for the recovery process developed by the Japan Fisheries Agency (2010), aquaculture raft damage can be classified into four types: (1) complete damage (washed away), (2) major damage (70–100 % physical damage), (3) moderate damage (30–70 % physical damage), and

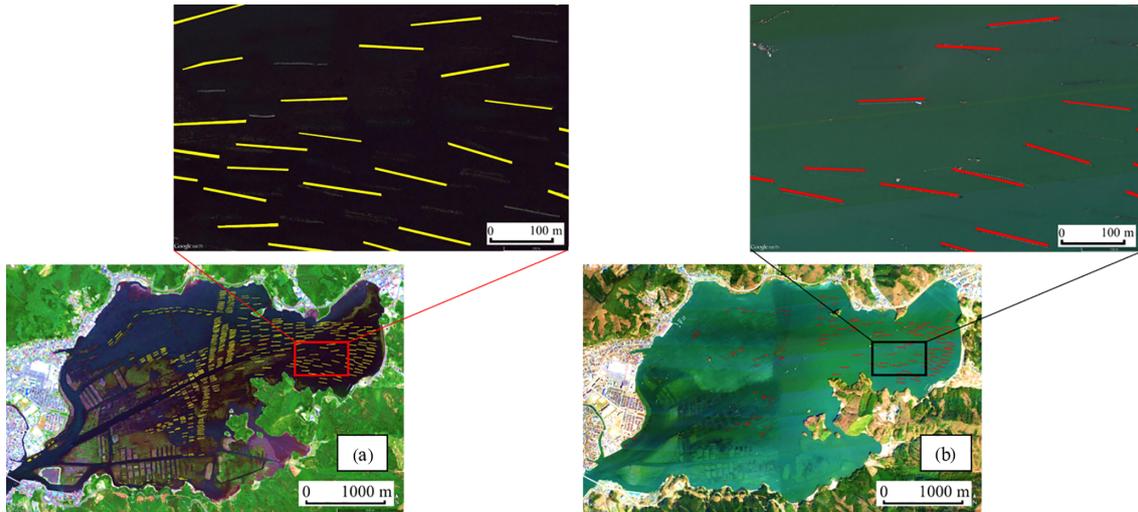
Figure 7. Visual damage interpretation of aquaculture rafts (long-line type) (a) before and (b) after the 2011 tsunami.

(4) minor damage (less than 30 % physical damage). Because of the limitations encountered when using satellite images, only the complete-damage (washed away) level could be investigated using the satellite images taken before and after the tsunami, similar to other previous studies related to buildings (Koshimura et al., 2009; Suppasri et al., 2011). In this study, only the long-line type of aquaculture raft (Fig. 6) had sufficient quantities to develop the fragility function. This type of aquaculture raft is common in the study area and is used for oyster and seaweed farming. Examples of the visual inspection of the aquaculture rafts in the lake before (Fig. 7a) and after the tsunami (Fig. 7b) are shown. Approximately half of the rafts remained after the tsunami; the others were completely washed away. The aquaculture rafts that completely disappeared were classified as complete damage (washed away), whereas the damage levels of the remaining aquaculture rafts ranged from no damage to major damage. This classification is used to calculate the damage probability of complete damage in Sect. 4. Figure 7 also shows the visual-inspection results (presented as polygons) of complete damage versus no damage and other damage levels for the aquaculture rafts (long-line type) in Mangokuura Lake. Many completely damaged aquaculture rafts were found near the entrance to and in the middle of the lake. Then, the created polygons were gridded into $5 \times 5 \text{ m}^2$ regions corresponding to the finest tsunami simulation grid (region 6). The simulated maximum water level and flow velocity were assigned to each grid. For Matsushima Bay, there was an insufficient number of long-line-type aquaculture rafts, and many rafts could not be classified into types. Therefore, only those aquaculture rafts in Mangokuura Lake that were completely damaged were used to develop the fragility functions.

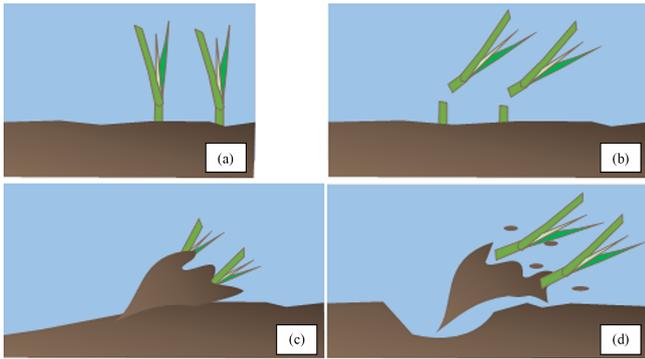
Figure 8. (a) Eelgrass and its damage pattern: (b) cut-off, (c) sand deposition and (d) erosion.

Damage to eelgrass occurs in one of three modes: cut-off, deposition, or erosion, as shown in Fig. 8. Although the deposi-

tion and erosion can be estimated using a sediment transport model, more detailed data and surveys are required to obtain the necessary data for the model input. This pilot study considered only the tsunami itself. In addition, the erosion was controlled primarily by the flow velocity. Therefore, the cut-off and erosion were considered damage from the horizontal force of the tsunami.

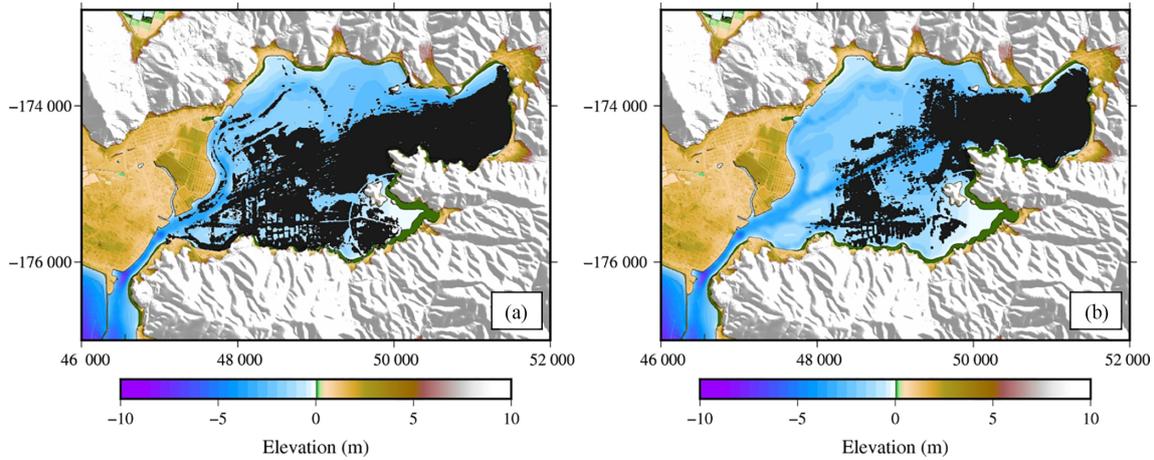
Figure 9. Areas of the eelgrass (a) before and (b) after the 2011 tsunami in Mangokuura Lake.

Color images from an actual satellite image taken before the 2011 tsunami and after the 2011 tsunami were analyzed (Northwest Pacific Region Environmental Cooperation Center, 2016; Tsujimoto et al., 2016). At this stage, the areas for land, sea, aquaculture raft, eelgrass, and mudflat were first identified. To identify only the eelgrass area, the colored images were binarized to binary (black and white) images using the ImageJ image analysis software, which is being developed at the National Institutes of Health, the United States (ImageJ, 2016). This binarization helps distinguish eelgrass and non-eelgrass areas. Figures 9 and 10 show the eelgrass areas before and after the 2011 tsunami in Mangokuura Lake

and Matsushima Bay, respectively. Similar to the aquaculture rafts, the eelgrass that was completely damaged could be investigated by comparing the images taken before and after the tsunami. The identified damaged and undamaged areas for both aquaculture rafts and eelgrass were gridded into $5 \times 5 \text{ m}^2$ regions. Then, the damage ratio of each grid was calculated, and the maximum simulated water level and flow velocity were assigned to each grid. Finally, another process was performed to create a list of the simulated tsunami characteristics (water level and velocity) and the damage ratio to develop the fragility function, as explained in the next section.

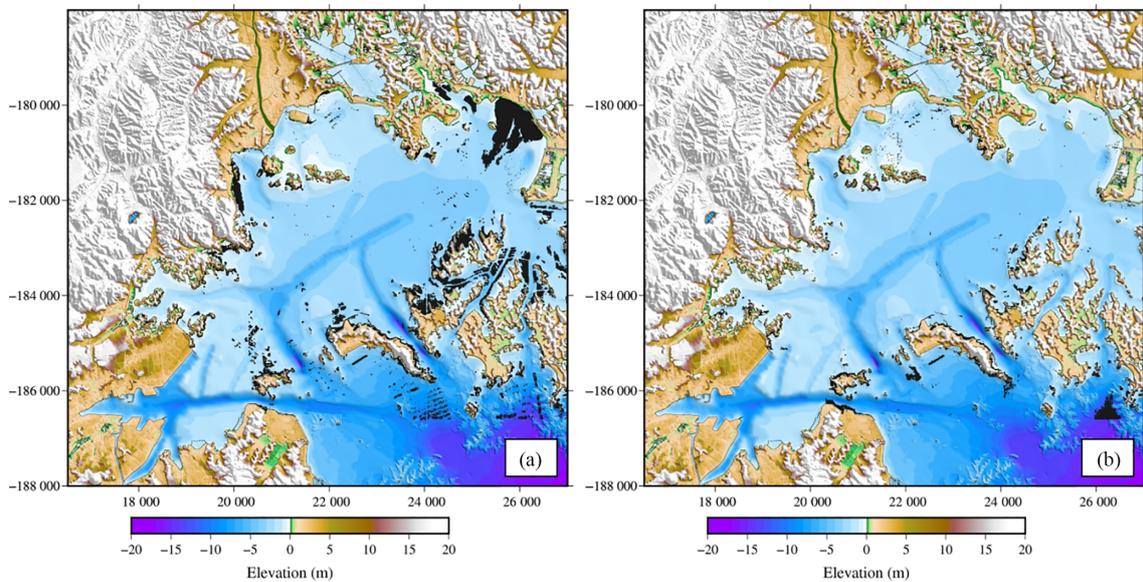
Figure 10. Areas of the eelgrass (a) before and (b) after the 2011 tsunami in Matsushima Bay.

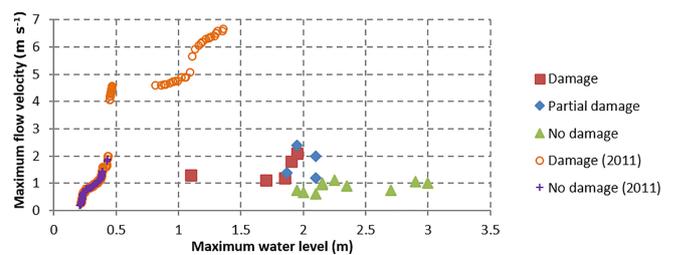
Figure 11. Comparison of the aquaculture raft data from the 1960 Chilean tsunami (Fig. 1) and the present study on the 2011 Japan tsunami.

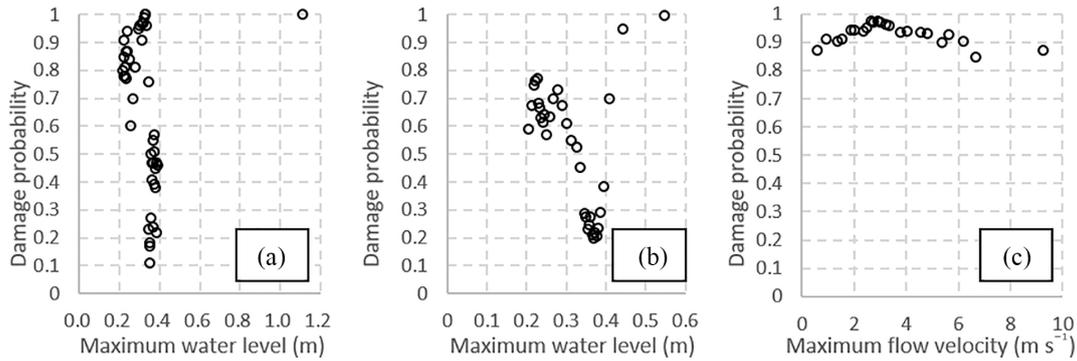
Figure 12. Maximum water level and complete-damage probability for the (a) aquaculture rafts and (b) eelgrass in Mangokuura Lake and for (c) eelgrass in Matsushima Bay.

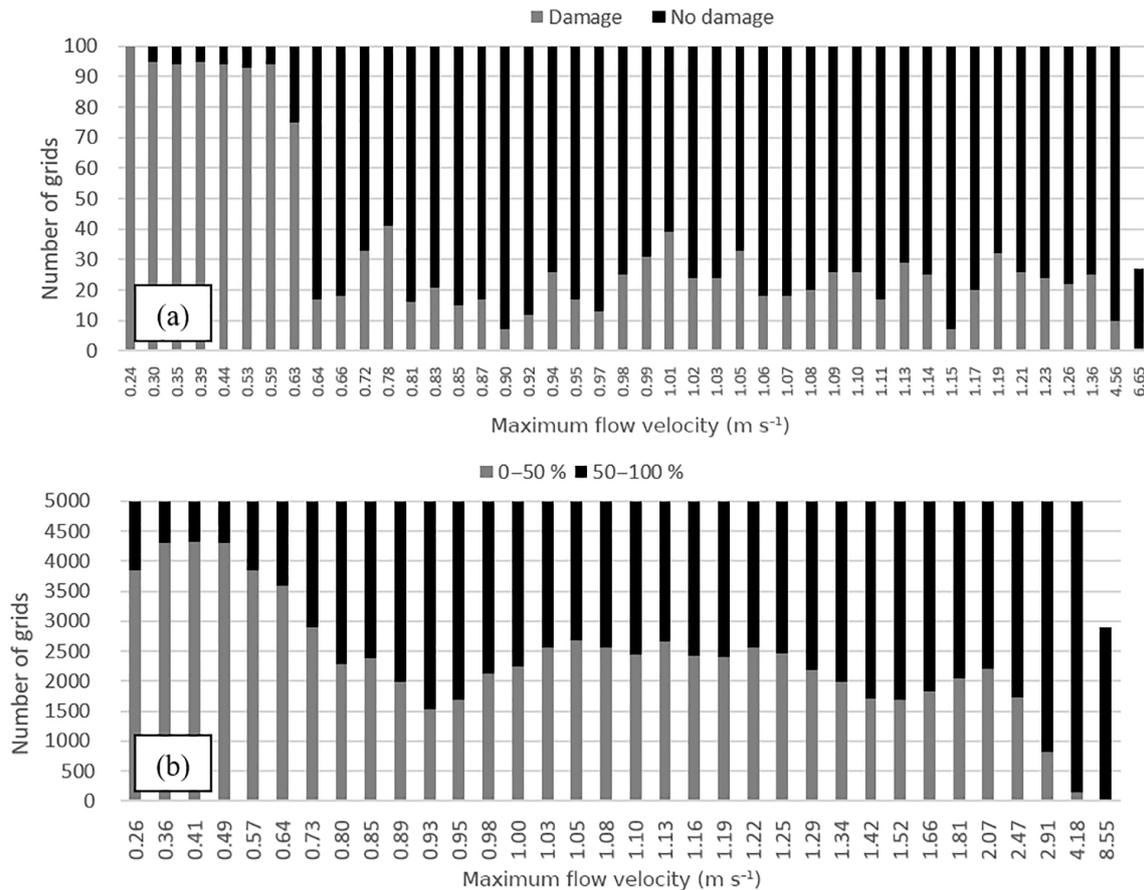
Figure 13. Histogram of the numbers of (a) damaged and undamaged aquaculture rafts and (b) 0–50 % damaged and 50–100 % damaged eelgrass in terms of the simulated flow velocity range in Mangokuura Lake.

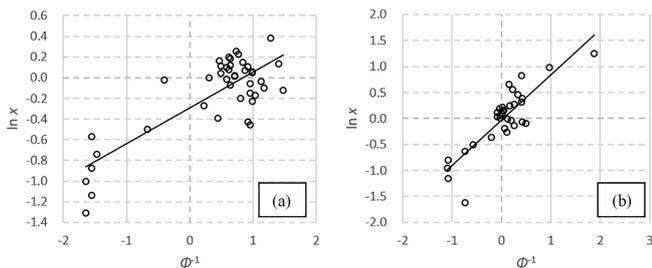
Figure 14. Least-squares fit on lognormal probability paper for the (a) aquaculture rafts and (b) eelgrass in Mangokuura Lake.

developed by applying the classical standardized lognormal distribution function throughout the linear regression analysis for both aquaculture rafts and eelgrass. For Mangokuura Lake, Fig. 12 shows the histograms of the numbers of damaged and undamaged aquaculture rafts in every 100 grids (Fig. 13a) and 0–50 % damaged and 50–100 % damaged eelgrass in every 5000 grids (Fig. 13b) in terms of the simulated maximum flow velocity range. Both histograms show that the damage data increase when the flow velocity increases. A linear regression analysis was performed to develop the fragility function. The cumulative probability P of occurrence of the damage is given in Eq. (4):

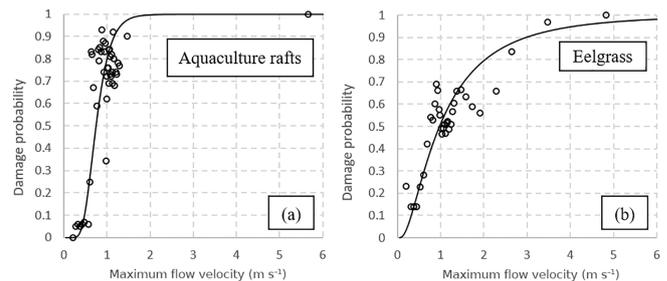
Figure 15. Tsunami fragility functions for completely damaged (a) aquaculture rafts and (b) eelgrass based on data from Mangokuura Lake.

With the regression analysis, the parameters that best fit the fragility functions with respect to the maximum flow velocity are shown in Table 2. The tsunami fragility curves for the aquaculture rafts and eelgrass were developed as shown in Fig. 15a and b, respectively. The proposed fragility functions show that a complete-damage ratio above 0.5 corresponds to maximum flow velocities of 0.8 m s^{-1} (aquaculture raft) and

1.0 m s^{-1} (eelgrass). A complete-damage ratio above 0.9 corresponds to maximum flow velocities of 1.3 m s^{-1} (aquaculture raft) and 3.0 m s^{-1} (eelgrass). The results for the aquaculture rafts are consistent with the previously proposed criteria (Nagano et al., 1991): at 1 m s^{-1} flow velocity, the damage ratio is almost 0.8.

culture rafts and eelgrass is 1.3 and 3.0 m s⁻¹, respectively (Fig. 15).
