Structural damages of L'Aquila (Italy) earthquake

H. Kaplan¹, H. Bilgin¹, S. Yilmaz², H. Binici¹, and A. Öztas¹

Abstract. On 6 April 2009 an earthquake of magnitude 6.3 occurred in L'Aquila city, Italy. In the city center and surrounding villages many masonry and reinforced concrete (RC) buildings were heavily damaged or collapsed. After the earthquake, the inspection carried out in the region provided relevant results concerning the quality of the materials, method of construction and the performance of the structures. The region was initially inhabited in the 13th century and has many historic structures. The main structural materials are unreinforced masonry (URM) composed of rubble stone, brick, and hollow clay tile. Masonry units suffered the worst damage. Wood flooring systems and corrugated steel roofs are common in URM buildings. Moreover, unconfined gable walls, excessive wall thicknesses without connection with each other are among the most common deficiencies of poorly constructed masonry structures. These walls caused an increase in earthquake loads. The quality of the materials and the construction were not in accordance with the standards. On the other hand, several

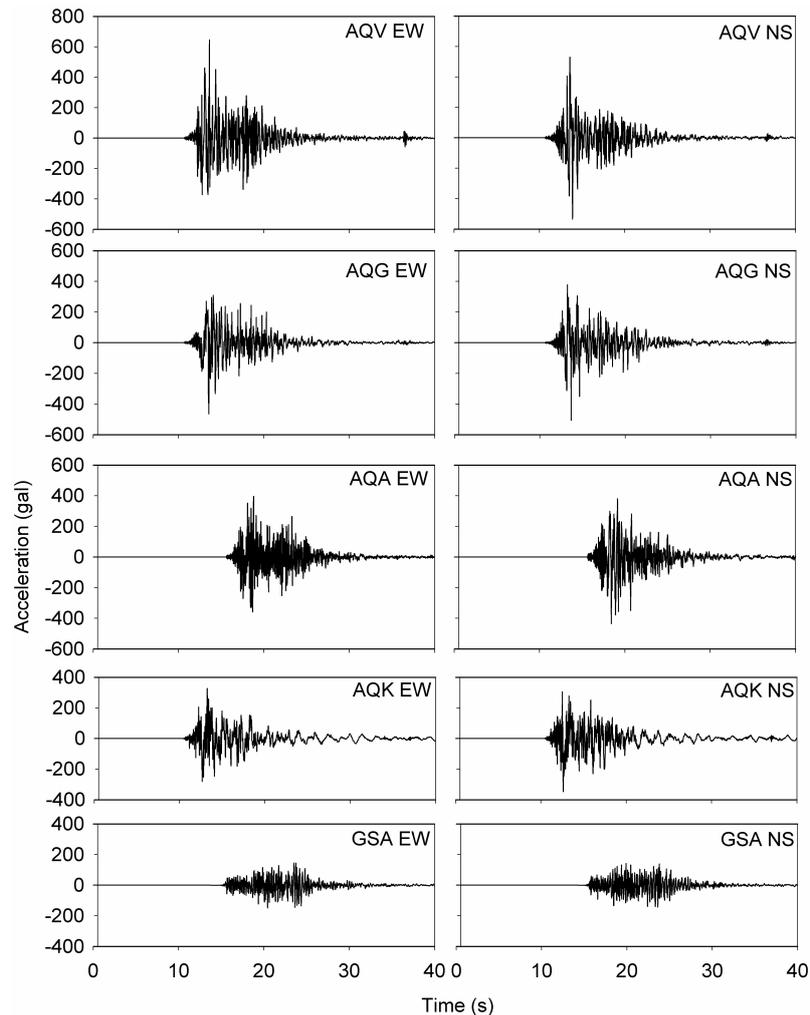
The table depicts quite high PGA values with respect to the magnitude of the event. For AQM station, PGA has also saturated, which makes it impossible to use the record. Horizontal components of the motion are given in Fig. 3 for five stations. Strong shaking duration of the earthquake (90% of the energy) was less than 10 s. Besides, 60% of the energy was exerted on the buildings within 3–5 s (Çelebi et al., 2010). Therefore, it can be categorized as a short event with high PGA values that are capable of producing high spectral accelerations. It is certain that a prolonged period of shaking with high accelerations would cause a heavier damage profile for buildings.

Fig. 3. Corrected acceleration records for five stations with $PGA > 0.1$ g (time not synchronized).

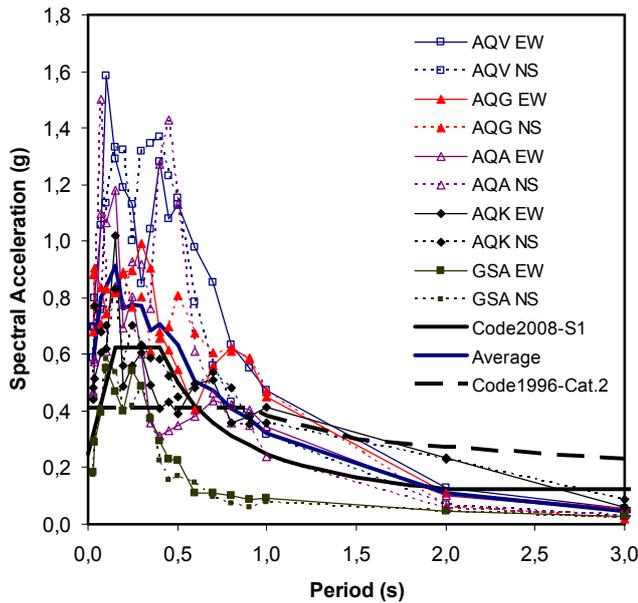
Figure 4 compares spectral acceleration values of each record and the average of them with the current design spectrum of the Italian Code (NTC2008) for rock type soils and that of 1996 Code for Category 2. The current code has greater spectral accelerations with respect to the older code. However, most of the buildings were not designed accord-

ing to 2008 code. Moreover, many of the buildings were non-engineered. Nevertheless, response spectra have much higher acceleration values than both codes especially for periods less than 1.0 s. This figure clearly shows that buildings were exposed to seismic forces higher than the expected design forces. The average spectrum of 10 strong motion components almost doubles the spectrum of 1996 code for $T < 0.5$ s. According to these records, the earthquake can be classified as a strong one.

Fig. 4. Response spectra of the records from 5 stations for 5% damping and comparison with NTS design spectrum.

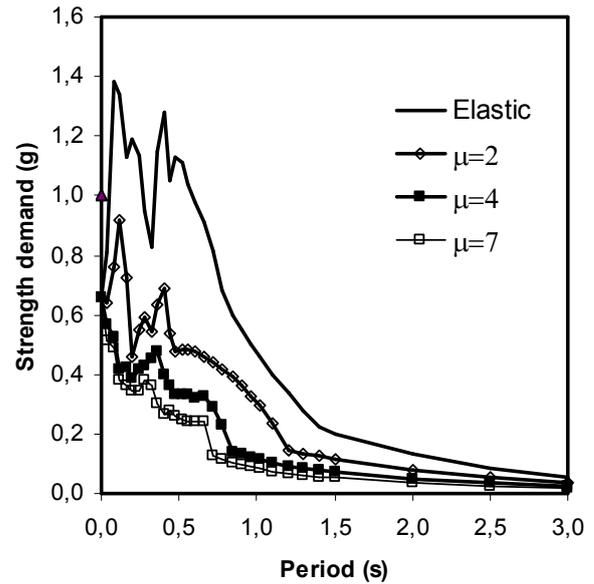
Elastic and inelastic demand spectra are plotted in Fig. 5. The inelastic demand level is also a good indicator of destructive potential of the earthquake. Even for a ductility level of 7, inelastic strength demand reaches to 40% of the total building weight, which includes dead loads and a fraction of live loads especially for small periods. On the other hand, many of the non-engineered buildings have low ductility; therefore many buildings are excited by inelastic seismic demands reaches up to 50% of their weight or more.

Fig. 5. Inelastic demand spectrum for AQV-EW record for different ductility levels.
