The Stava mudflow of 19 July 1985 (Northern Italy): a disaster that effective regulation might have prevented

F. Luino¹ and J. V. De Graff²

Abstract. The disaster occurring in the Eastern Italian Alps in the summer of 1985 was caused by the failure of two tailings dams located just upstream from the village of Stava in the municipality of Tesero (Trento province, Italy). The structure comprised two small storage basins for the deposition of tailings from the separation process of the Prestavel fluorite mine. On their downstream sides, the basins were contained by steep earth embankments, whereas upstream they rested directly on the natural slope. The total height from the base of the lower dam to the crest of the upper dam was over 50 m.

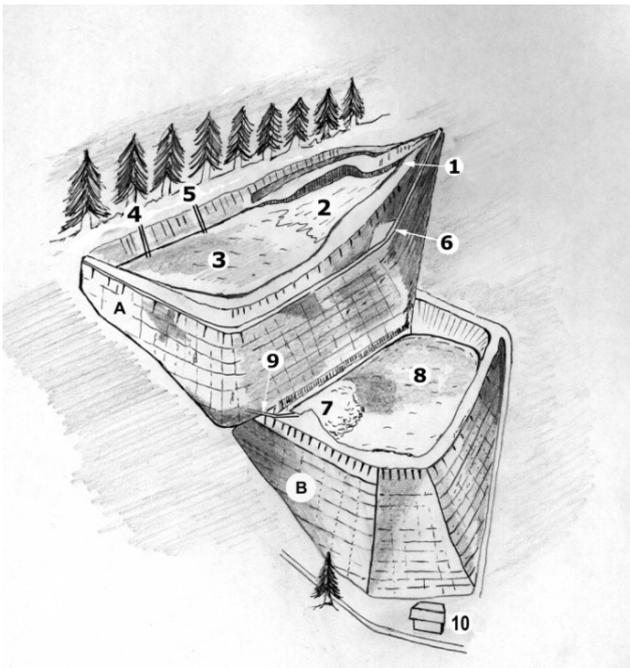
Fig. 2. Graphical representation of the Prestavel basins: (A) upper basin; (B) lower basin; (1) cyclone, (2) sandy deposit, (3) silty deposit, (4) drainage service, (5) emergency drainage, (6) service road, (7) sand cone, (8) silty deposit, (9) drainage from the upper basin, (10) caretaker's house.

Both basins had earth dams facing the valley and the mountain slopes. Laterally, the upper basin dam abutted against a densely forested slope. Its front embankment rested partly on the silt of the lower basin; this configuration reduced the surface area of the dam face (Fig. 2). Structurally, the dams were composed principally of medium-fine sand and thin or fairly uniform layers of saturated clayey silt.

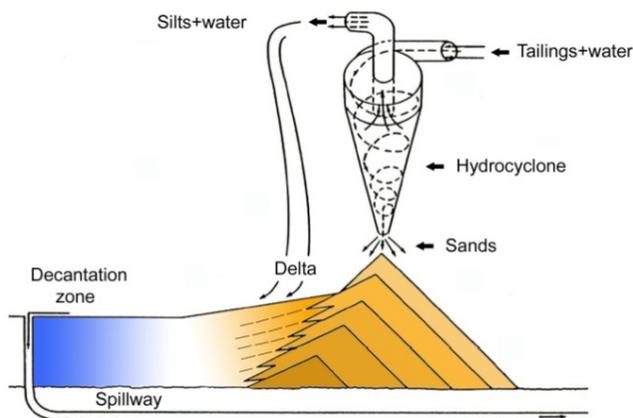
Two systems of tailings slurry disposal were employed: on-dam cycloning and central cycloning (USEPA, 1994). In on-dam cycloning, as shown in Fig. 4, the slurry is cycloned from the tailings materials using hydrocyclones moving on rails, which separate the larger tailings sand sized particles from the finer silt. The coarse materials deposit to form the dam crest, while the finer tailings are routed to the interior of the impoundment, where they deposit according to particle size, and form a sloping tailings beach surface along the interior perimeter of the dam. Central, or stationary, cycloning usually places a single cyclone over an abutment of the dam. A pool of clarified water accumulates upstream from the tailings sand beach. The dam crest is formed by cyclone sands mechanically moved from the cyclone location to the dam crest using a dragline or bulldozer.

Fig. 4. The embankments of the landfill minings are made through a process of centrifugation in a hydrocyclone in which are channeled the mud; sand is separated and used to realize the embankment, while the finer fraction, constituted by silty mud to settle, is discharged into the reservoir through a pipe (from Watermeyer and Williamson, 1979, modified).

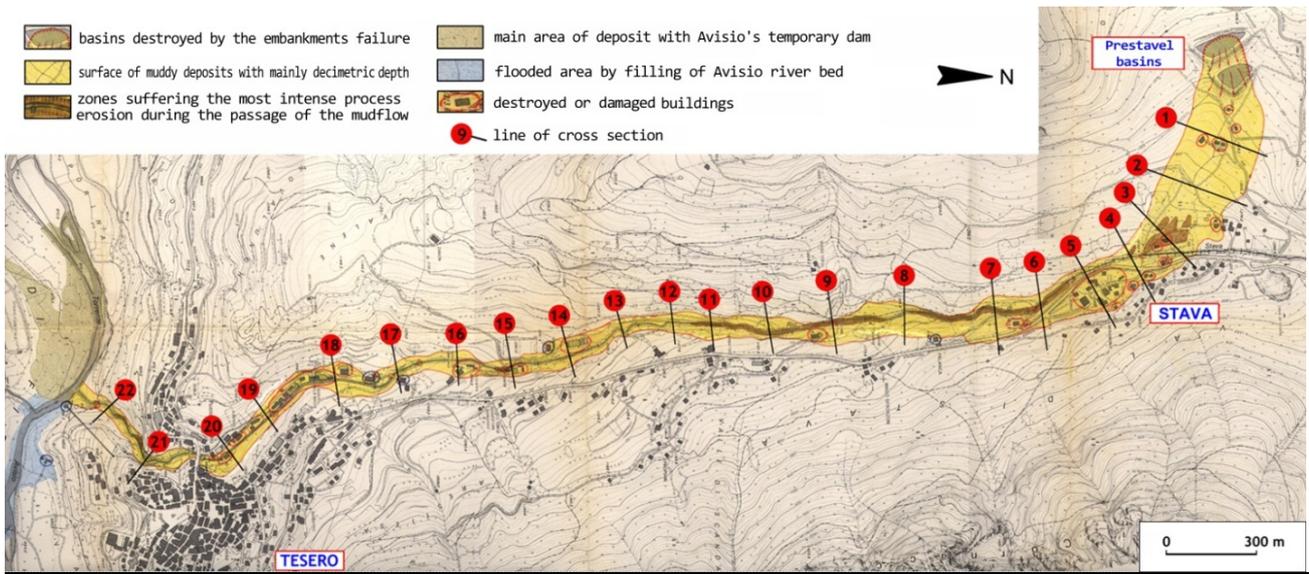
in radius), which considerably increased its thickness on the opposite side. Specific trigonometric measurements registered a maximum difference in height of about 19 m compared to the minimal thickness found on the right side of the valley (Govi and Luino, 2003). Stava, therefore, suffered the most devastating effects; it was completely razed to the ground (Fig. 11, sections 4 and 5 and Fig. 12).

Fig. 11. Mudflow path of 19 July 1985 along the Stave Valley showing different effects observed by the geologists of CNR-IRPI, Torino during the first surveys. The locations of 22 cross-sections measured during the survey are highlighted. The original map base is 1:5000 scale (from Govi and Luino, 2003, modified).

velocity of the mudflow passage were made at selected points along the track. The velocity of the mudflow passage was estimated by measuring the mudflow height on the external bank versus the internal bank at Stava (where the mudflow entered a wide curve). Speeds ranged from 20 m s^{-1} (sections 4 and 6 in Fig. 11) to 27 m s^{-1} (sections 5 in Fig. 11). These results corresponded closely to those calculated by Takahashi (1991).

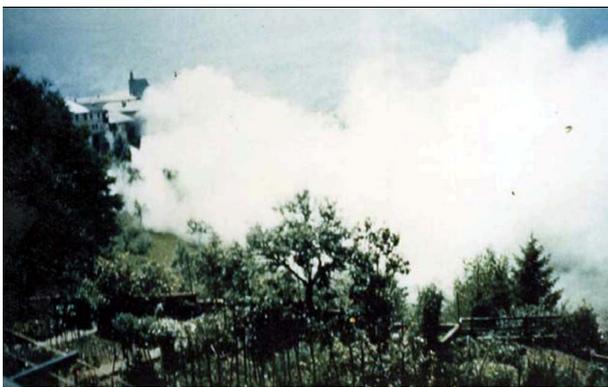
Fig. 12. The shocking moment in which the mudflow, preceded by a white cloud, reached the urbanized areas on the valley bottom of Tesero (courtesy of Fondazione Stava, 1985).

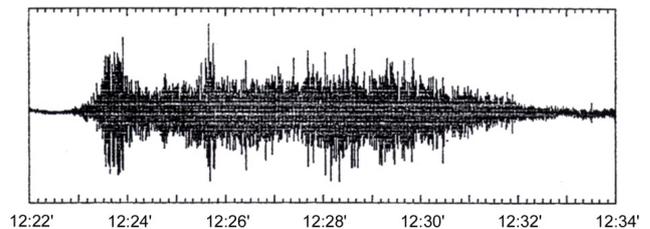
Fig. 17. Seismogram recorded at Cavalese station on 19 July 1985, from 12:22 to 12:34.

While the aftermath of the event provided evidence of how it had taken place and what its impacts were, the rapid course of events could only be roughly estimated from eyewitness accounts and field measurements at selected points. From a seismogram recorded at the nearby Cavalese station (Fig. 17), it was possible to estimate the time intervals during which the tailings basins failed, the mudflow was triggered, and its destructive passage along the Stava valley took place (Table 2). Cavalese station is located only 4.1 km from the Prestavel basins. Takahashi (1991) used the seismogram to interpret the sequence of events during the disaster and develop estimates of the velocity the mudflow attained at various points along its track. Physical measurements of the
