Site investigation of masonry buildings damaged during the 23 October and 9 November 2011 Van Earthquakes in Turkey

F. Piroglu and K. Ozakgul

Dept. of Civil Engineering, Istanbul Technical University, 34469 Maslak, Istanbul, Turkey

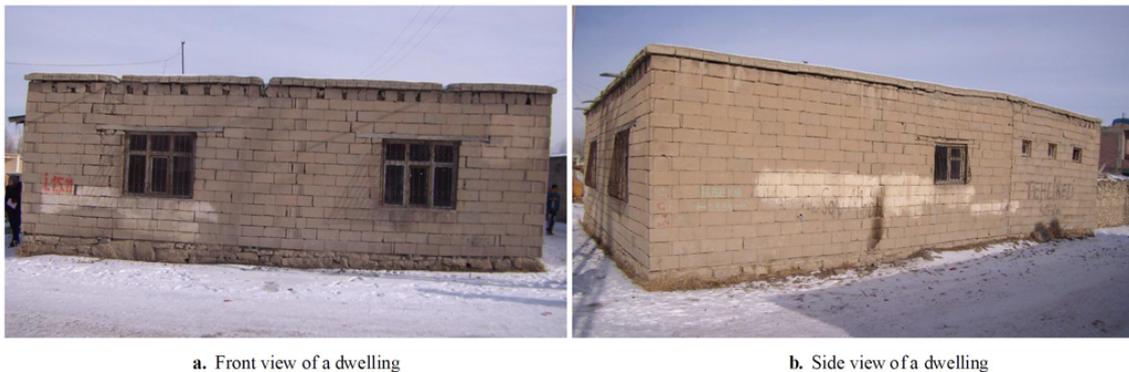
Fig. 10. Outside views of a typical unreinforced masonry building.

It was also observed that the plan lengths of the solid wall segments between the window and door openings, excluding the corners were mainly constructed more than 1.00 m, as is permitted in the first and second seismic zones (TEC, 1998, 2007) and seen in Fig. 10. In the code (TEC, 1975), it is stated that this length should be more than 0.8 m and also more than 1/4 of the maximum length of the openings which are on both sides of the solid wall segment. Plan length of the solid wall segments should be set more than 1.5 m between the corner of a building and nearest window or door openings in the first and second seismic zones (TEC, 1975, 1998, 2007). It was observed that this requirement was mainly fulfilled in most of the masonry buildings, as seen in Figs. 10, 15 and 16.

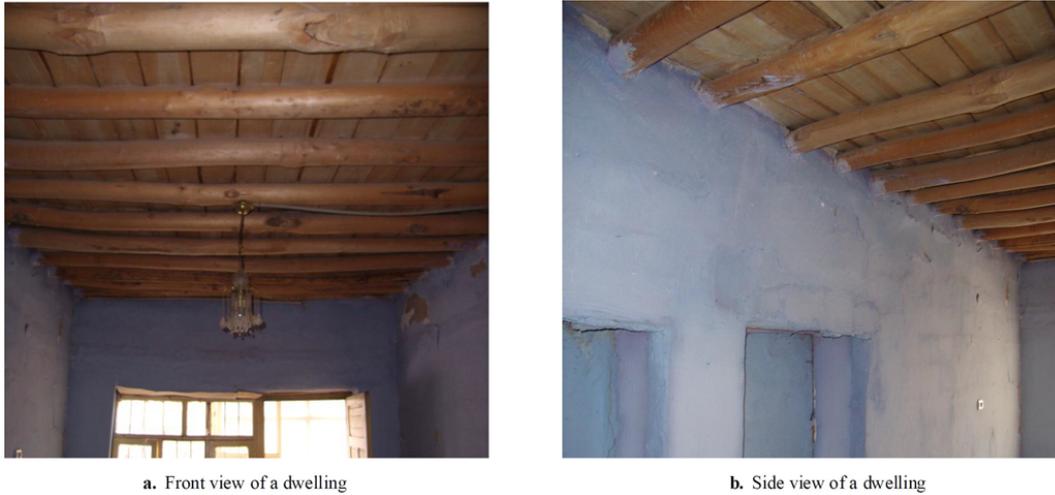
Fig. 11. Views from the interior of the traditional roof system with wooden sheathing.

In these buildings the roofs which are expected to act as a diaphragm were constructed as traditional heavy, flat roof systems by using thick mud or earth layers supported on wooden logs, as given in Figs. 11 and 12. The wooden log ends were directly supported on the width of the walls along their lengths without using any type of connections. And, to improve the seismic resistance of the bearing walls and also to provide the distribution of the loads acting on the masonry walls, it was observed that the roof band beams were not built at the roof level on top of the walls. The logs were typically sheathed with timber planks nailed perpendicular to the direction of the logs. The timber sheathing was also plastered by a thick mud layer made of straw and clay. These heavy roof systems are vulnerable to strong ground motions which cause larger seismic forces as well as larger lateral displacements; however, it is noticeable that the increased friction resistance due to the weight of the roof can cause higher strength for these structures than expected (Furukawa and Ohta, 2009). It was observed that strong inertia forces developed due to the two Van earthquakes and their strong aftershocks were the main reason for the severely damaged and partially collapsed masonry buildings in this district. According to seismic codes (TEC, 1975, 1998, 2007), in adobe buildings, soil roofs should not be constructed in the first as well as in the second seismic zones. However, especially the poor or low income people have preferred these heavy-roofed structures because they keep warm during cold winter days as well as cool during the hot summer days.

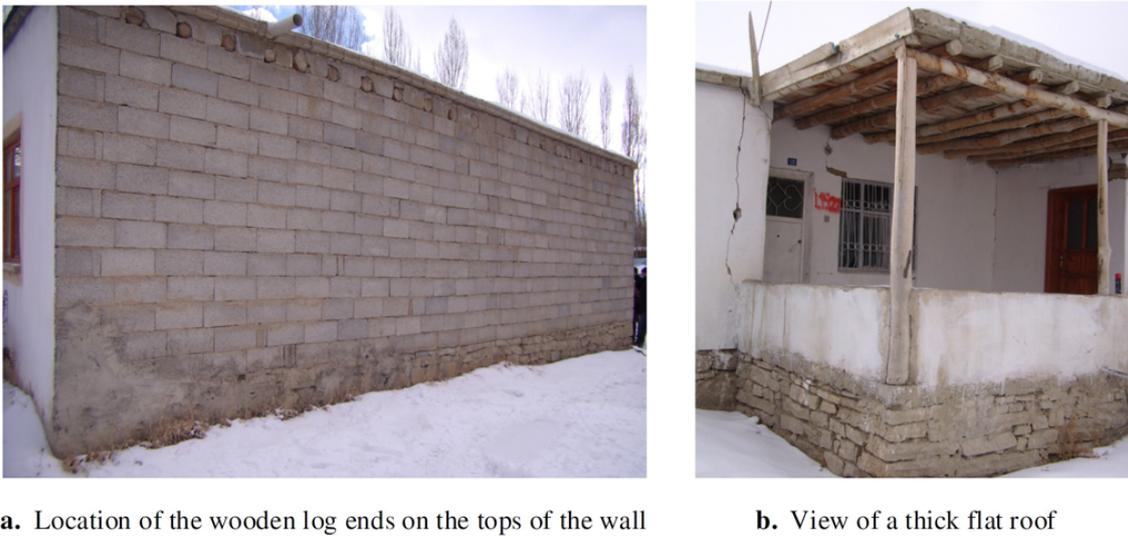
Fig. 12. Outside views of a traditional roof system.

The foundations of these buildings were mostly constructed at about 30 cm to 50 cm depths directly on the ground surface, as shown in Figs. 12 and 13, and the masonry walls were apparently built without using any plinth band beams and proper connections or anchorages on the top of the foundation. The plinth band beams should be built to prevent settlement of the building and also to provide lateral resistance and integrity to these buildings (Furukawa and Ohta, 2009). The foundations were generally laid in courses formed by intermingling of stones having non-uniform sizes and shapes and sometimes without using any mortar.

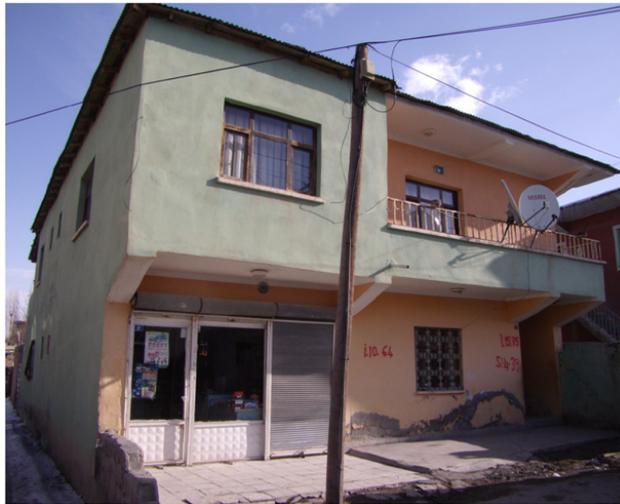
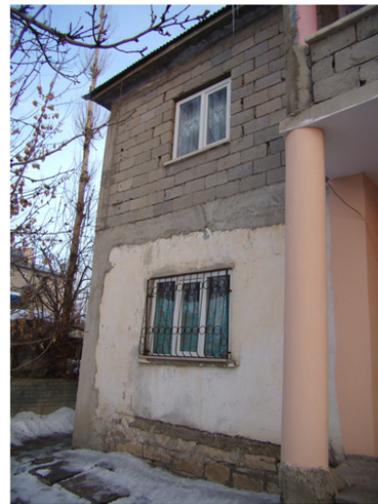
Fig. 24. Views of typical confined masonry buildings.

The confined masonry buildings were from one to three stories, commonly two stories in height, and usually had a semi-basement and an exterior staircase, as seen in Fig. 24. These buildings commonly had pitched or hipped roofs covered by clay tiles. Exterior surfaces of the bearing walls were not generally covered with plaster. Because of the lack of the plaster, the units and the mortar may be weakened and

Turkish standards (TS500, 1975, 1982, 1985). Additionally, cantilever elements such as balconies etc. should be constructed as an extension of the floor slab, with at least 1.5 m span length. It was observed that this requirement was mainly satisfied, as seen in Fig. 24a. But the continuity of the walls in vertical direction was not present, especially where the cantilever balconies were changed to living rooms in use, as also seen in Fig. 24a.

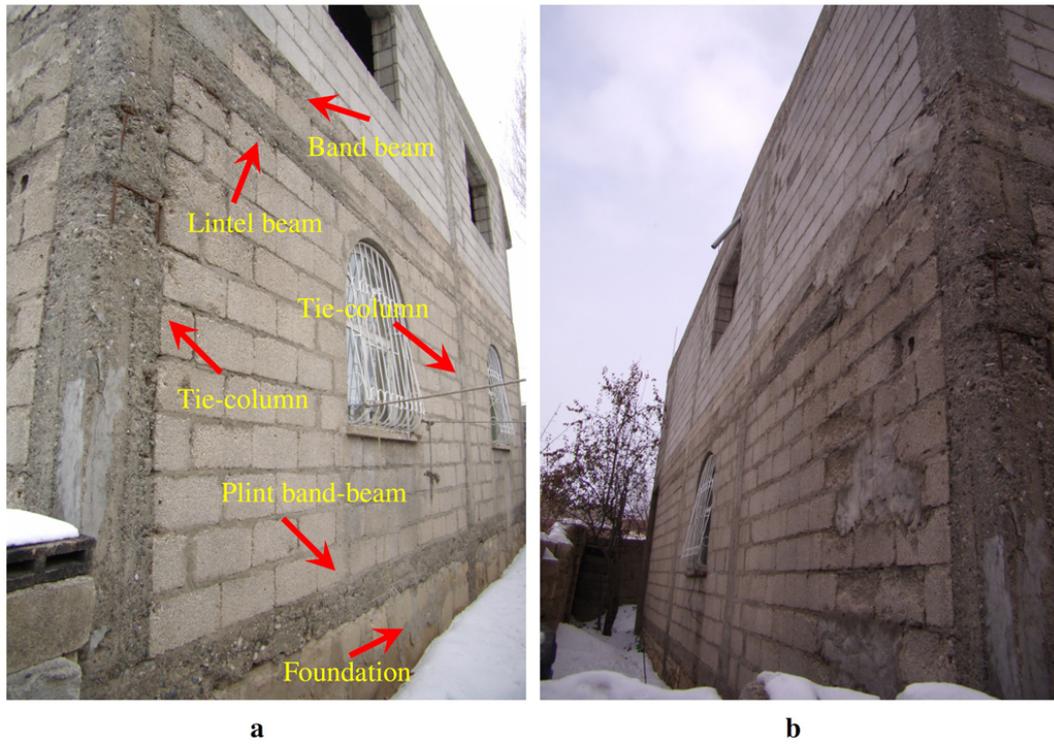
Fig. 25. Views of a typical confined masonry building and its structural members.

In the confined masonry buildings constructed in this region, foundations were commonly built as the coursed stone masonry footing at about 0.5 to 1.0 m depths. On the top of the foundations, reinforced concrete plinth band beams were constructed. Then, the masonry walls were firstly laid on the top of the plinth band beams. Afterwards, vertical reinforced concrete members called as tie columns were constructed at the wall intersections and ends. The tie columns were generally built, with the cross sections of 250×250 mm or 300×300 mm for the exterior columns and 200×200 mm for the interior columns, by using four 10 mm diameter longitudinal steel bars and 8 mm diameter stirrups having spacings between 400 and 600 mm. The width of tie columns was made equal to the wall thickness. In recent years 12–14 mm diameters for the rebars and 15 cm to 20 cm spacings for the stirrups have been preferred. Then, for each floor level, the reinforced concrete band beams were monolithically constructed with the floor slab on top of the walls. The cross-sectional dimensions used for the band beams were approximately equal to the width of the wall and 15 cm or 20 cm in

depth. Beam reinforcements were commonly composed of four 10 mm diameter longitudinal steel bars using 8 mm diameter stirrups, and mainly having up to 600 mm spacings. Concrete used in the columns and beams was mostly produced and poured with local workmanship without using any vibration technique. In some confined masonry buildings, it is noteworthy that the reinforced concrete lintel beams which were placed above the door openings were circumferentially continued along the walls of the buildings, as shown in Figs. 25 and 26. The floor slabs are monolithically
