The 27 May 1937 catastrophic flow failure of gold tailings at Tlalpujahua, Michoacán, Mexico

Abstract. On 27 May 1937, after one week of sustained heavy rainfall, a voluminous flood caused the death of at least 300 people and the destruction of the historic El Carmen church and several neighborhoods in the mining region of Tlalpujahua, Michoacán, central Mexico. This destructive flood was triggered by the breaching of the impoundment of the Los Cedros tailings and the sudden release of circa 16 Mt of water-saturated waste materials. The muddy silty flood, moving at estimated speeds of 20–25 m s⁻¹, was channelized along the Dos Estrellas and Tlalpujahua drainages and devastated everything along its flow path. After advancing 2.5 km downstream, the flood slammed into El Carmen church and surrounding houses at estimated speeds of ~7 m s⁻¹, destroying many construction walls and covering the church floor with ~2 m of mud and debris. Revision of eyewitness accounts and newspaper articles, together with analysis of archived photographic materials, indicated that the flood consisted of three muddy pulses. Stratigraphic relations and granulometric data for selected proximal and distal sam

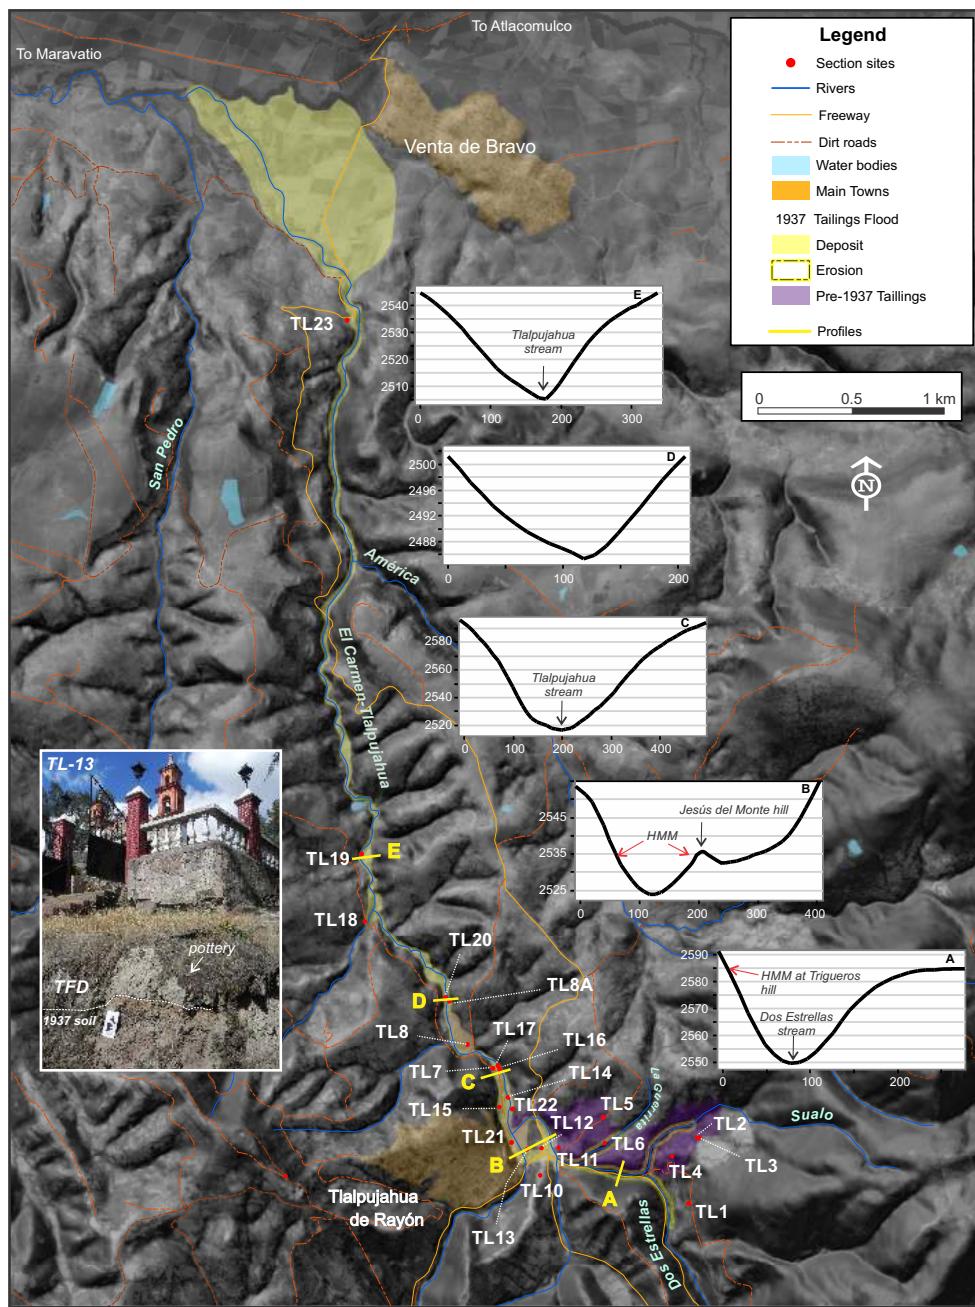
Twenty-three stratigraphic sections were measured along the path extension of the TFD (Fig. 8). From 10 of these sections, we sampled 14 specimens to perform granulometric analyses from -8 to $+12\varphi$ grain sizes (Fig. 9). The correlation of these sections suggested that the deposit mainly consists of one massive layer. However, at some locations the deposit shows three (TL01) or two beds (TL08 and TL14) (Fig. 10a–c). At locations between San Jesus del Monte (TL13) and El Carmen church (TL01) the deposit is soft and loose, but beyond El Carmen church it is partly indurated and contains void spaces in all sections.

Figure 8. Shaded relief map of the MDOT displaying the location of Tlalpujahua and Venta de Bravo villages, the extension of Los Cedros tailings in 1937, and the present extension of the 1937 flood deposit. Red circles are stratigraphic sections measured during this study. Insets are cross profiles indicating the shape of the flow channel and some flow indicators as high-mud marks.

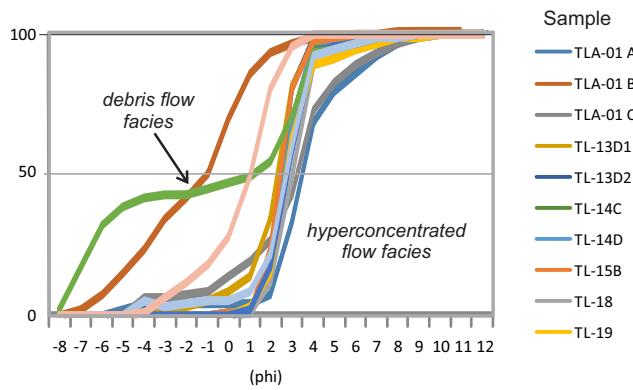
church), 2.8 m at site TL16 (0.8 km downstream), and 40 cm at the farthest location (TL-23) (Fig. 8). As a whole, the deposit is massive, matrix-supported (> 56 %), and composed of sandy to clayey particles (Fig. 9, Table 3). These characteristics indicate that the deposit had an unimodal granulometric distribution with the main mode shifting from 1 to 4φ (Table 3) and good sorting ($0.55\text{--}1.35\sigma\varphi$). The structure, texture, and grain size characteristics of TFD suggest it corre-

sponds to a hyperconcentrated flow deposit (Fig. 9). In some sections, however, the deposit may contain scattered gravel to boulder-size fragments, as in section TL-01B (up to 40 %) or at section TL-21 (43 %) (Table 3). In these sections, the granulometric distribution of TFD is bimodal, with a coarse mode (-5 to -3φ) not shown at other locations, a fine mode (1.8 – 4φ), and medium sorting (5.2 to $1.1\sigma\varphi$). The structure, texture, and grain size characteristics of the deposit at these specific locations allow us to classify them as debris flow deposits.

**Figure 9.** Cumulative curves of the TFD deposit at different distances from the source. Most of the deposits are fine-grained (hyperconcentrated flow deposits), while a few exposures contained boulder- and gravel-sized particles set in a silty matrix (debris flow deposits). See Fig. 8 for locations of samples.

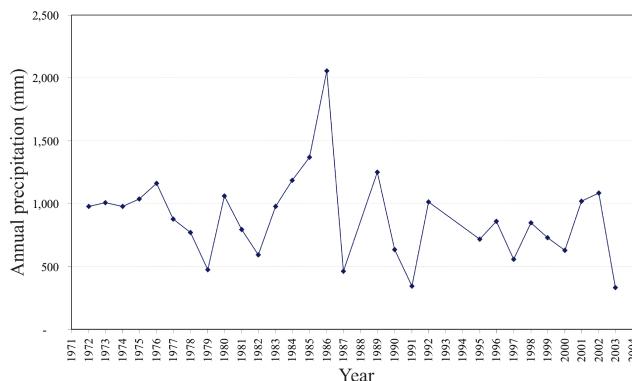
Figure 13. Timeline showing the year 1986 with extreme precipitation recorded in the region of MDOT. Data from the 15183-El Oro meteorological station from Corona Chávez et al. (2010).

Unfortunately, no local weather stations existed around the MDOT before the failure. The first station (15183-El Oro), which became operational in 1972, is relatively close to the Los Cedros metallurgical plant (Fig. 5). This station has a continuous rainfall record from 1972 to 2002, with some small gaps in 1988, 1993, and 1994. By using descriptive statistical methods, Martínez Medina et al. (2012) concluded that the MDOT showed an average precipitation of 900 mm per year. These results resemble the regional rainfall weather (see Fig. 2). However, it is worth noting that, during this period, at least 2 years had atypical rainfall (exceeding > 1200 mm); one of them occurred in 1986, when the rainfall exceeded 2000 mm (Fig. 13). With this study, Martínez Medina et al. (2012) concluded that return periods for 1800–2100 mm rainfalls occurred every 29 years. On the other hand, there is evidence that atypical rainfall periods have caused other catastrophic debris flows along the Tlalpujahua-Americas stream, as has been attested by at least two historical floods (older than 1937) observed in the stratigraphic record (site TL-14). One of them had a coarser granulometry than the 1937 flood and contained broken glass and blocks from an old bridge destroyed by this debris flow, suggesting that previous events along the Tlalpujahua-Americas stream have had larger magnitudes. By considering the time recurrence of the most recent extreme rainfall event (in 1986) and the sedimentological record, we may expect that an atyp-

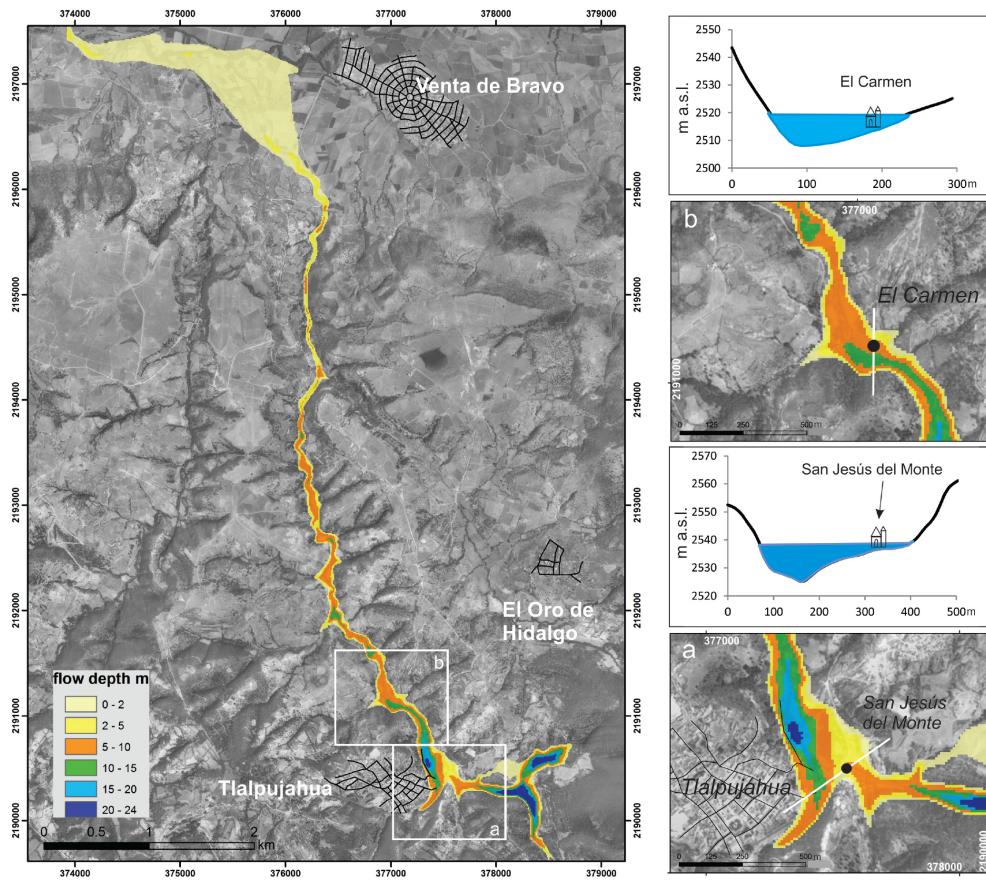
Figure 15. Map showing the maximum depth of the simulated flow and topographic profile at (a) Jesus del Monte and (b) El Carmen churches to illustrate the maximum inundation limits.
