# Design and installation of a Prototype Geohazard Monitoring System near Machu Picchu, Peru

**Abstract.** The town of Machu Picchu, Peru, serves the >700 000 tourists visiting Machu Picchu annually. It has grown threefold in population in the past two decades. Due to the limited low-lying ground, construction is occurring on the unstable valley slopes. Slopes range from <10° on the valley floor to >70° in the surrounding mountains. The town has grown on a delta formed at the confluence of the Alcamayo, Aguas Calientes and Vilcanota Rivers. Geohazards in and around the town of particular concern are 1) large rocks falling onto the town and/or the rail line, 2) flash flooding by any one of its three rivers, and 3) mudflows and landslides. A prototype early warning system that could monitor weather, river flow and slope stability was installed along the Aguas Calientes River in 2009. This has a distributed modular construction allowing components to be installed, maintained, salvaged, and repaired by local technicians. A diverse set of candidate power, communication and sensor technologies was evaluated. Most of the technologies had never been deployed in similar terrain, altitude o

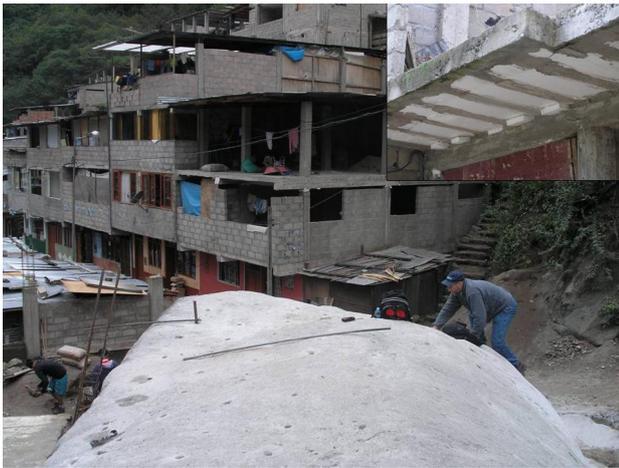
**Fig. 2.** Construction and siting practices are informal. A typical view of multistoried houses under construction. The basic plan is a concrete slab and reinforced column structure with no load bearing walls. The ground floor often contains a shop with several floors above for family use. Inset. View of a cantilevered floor showing the non uniform consistency of the concrete and the Styrofoam boards used as space fillers.

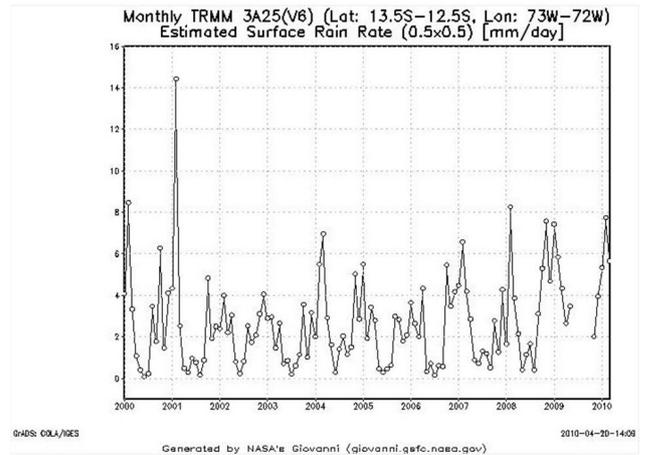
**Fig. 3.** Monthly TRMM 3A25(V6) data over MPP as time series data from January 2000 to March 2010. Data acquired using the GES-DISC Interactive Online Visualization and analysis Infrastructure (Giovanni) as part of the NASA’s Goddard Earth Sciences (GES) Data and Information Services Center (DISC).

The climate at MPP is subtropical, with the driest months of the winter season from May to August and the wettest months of the summer season from October to March (Fig. 3). The rainy months typically account for 80% of the annual rainfall average, which over the last two decades has averaged 1600 to 2300 mm. The average humidity is 77% during dry months and 91% during rainy months. At any given altitude, the variations in daily temperature are modest, and frost does not occur within the boundaries of MPP.

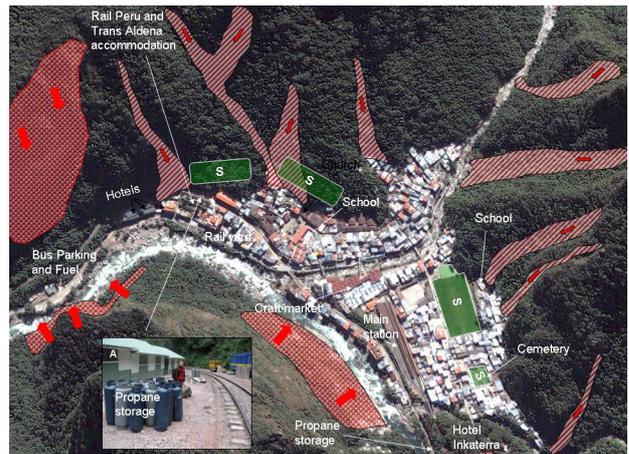
**Fig. 4.** Quickbird image showing the AC and Am Rivers. Areas prone to rock fall, toples and slides are shown as areas with a red stipple pattern. Drainage lines for floods and debris flows are shown as areas with a red stripped pattern. Designated Safe Areas (S) are shown within green boxes. Inset A shows an area where propane tanks are stored in the open. To the immediate right of the author is a rock that fell into the rail yard in 2007. The explosion and resulting destruction resulting from a ruptured propane tank would be significant.

highly susceptible to disturbance. In the opinion of the authors, more than 70% of the inhabitants of MPP live on or just beneath meta-stable slopes, and are continually exposed to the risk of large-scale slope failure (Fig. 4).

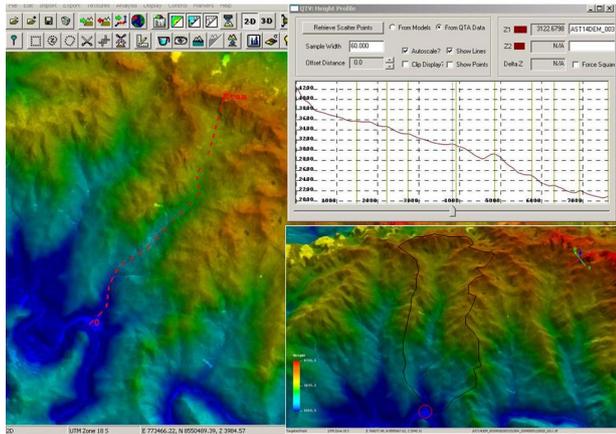
**Fig. 5.** Colorized DEM and ASTER Band 1 VNIR image used to examine height profile and mensuration data from the head of the Aguas Calientes watershed to MPP. The length of the Aguas Calientes River from the highest point to MPP is calculated to be 7.9 km. The channel profile is shown in the inset top right. Inset lower right shows a perspective view of the colorized DEM and ASTER Band 1 VNIR image. The black polygon shows the outline of the watersheds of the AC and Am which drain to and through MPP (shown in the red circle). Elevation is in meters.

The Aguas Calientes (AC) River runs through MPP to the Vilcanota River and has a catchment area of ~1400 hectares (Fig. 5). During periods of intense rain, the runoff rapidly drains through and over the colluvium and/or heavily jointed bedrock that comprise the narrow steep valley sides. Historical records dating to the 1940’s suggest that rockfalls, toples, and debris slides into the upper tributaries of the AC occur on a regular basis. On occasion, these failed materials have dammed one or more of the upper channels of the AC, temporarily reducing the flow volume in the lower channel, until such time as the accumulated water is suddenly released in a catastrophic manner as hyper-concentrated water flow, debris flow and/or mudflow. The Quechua word for this type of phenomenon is “huayco”, which is understood to describe a broad spectrum of flows either confined within or outside of normal drainage channels. At present, the last 1000 m of the AC is confined by the walls of an engineered concrete channel that bisects the western side of MPP (Fig. 6). Some portions of the channel have been periodically revised and strengthened to resist the effects of previous “huaycos”.

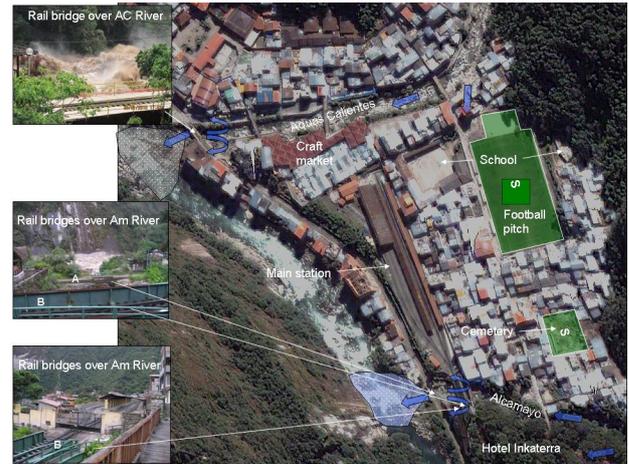
**Fig. 6.** Quickbird image of MPP showing the AC and Am Rivers. The square blue arrows show areas where the channel changes direction and overtopping has occurred historically. Note that the two “safe” areas shown in green appear to be at risk. Two rail bridges are shown as 1 and 2, upstream of which are curved blue arrows that show where a flow could back-up and overbank.

some portions of the banks have been built up and strengthened by unreinforced stone. The last portion of the channel is severely constricted by a narrow span rail bridge just above its entrance point into the Vilcanota River, to the extent that the Am overtops its channel here on a regular basis in an area adjacent to the passenger rail station and several major hotels (Fig. 6).

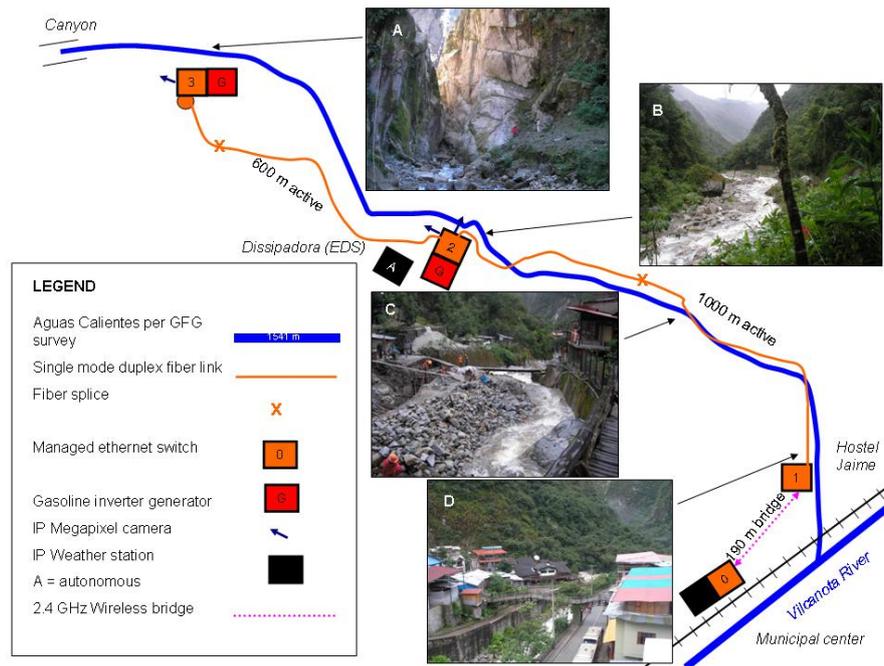
**Fig. 7.** Simplified plan of the prototype early warning system installed on 6 March 2009 along a 1541 m section of the Aguas Calientes River. Inset A shows a view upstream to a narrow granite walled canyon. Inset B shows a view downstream to the energy dissipation structure (EDS). Inset C shows a view on the edge of the engineered channel on the edge of the town. Inset D from the Hostel Jaime down to the confluence on the Aguas Calientes River with the Vilcanota River.

be protected. A wireless bridge (Client Bridge-Access Point pair, rated to 1500 m without an extended antenna, 2.4 GHz Power over Ethernet PoE) was used to test the performance from the Hotel Jaime to the Municipal Center (Figs. 7, 8). This had the advantage of being lower cost than cable in an urban setting. In practice it proved difficult to deploy in MPP due to the need for roof access on private dwellings, power and line of sight (LOS). Once installed it required negligible maintenance but could be disabled by a power failure, space-use dispute or loss of LOS due to construction. Computing power was provided by non-ruggedized laptops (Core2Duo, 2.4 GHz, 3 GB, 250 GB, 1600×1200) that were protected in a waterproof case. These laptops ran surveillance software that allowed for control, management and analysis of multiple video feeds, including motion triggered alarms and pan/tilt/zoom. Cellular phone coverage was available from two Peruvian telecommunications providers but coverage is limited and inconsistent outside MPP in the AC drainage basin. FM commercial radios worked at many locations but were often unavailable, in the wrong place or discharged. Despite its inconsistency it was necessary and useful. At the site of the EDS, an autonomous weather station was installed which had an Iridium modem for up-linking data. In this location, up-link was inconsistent on a fixed hourly schedule. Terrain shadowing was likely responsible and may be overcome either by repeated attempts (if power is available) or by

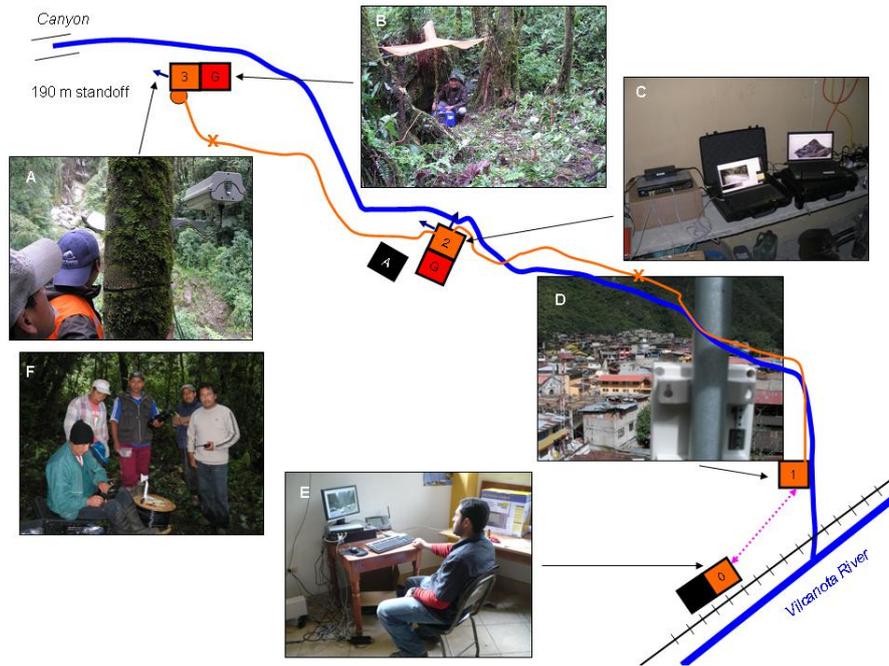
**Fig. 8.** Communication, Sensors and Power elements in the prototype early warning system. Inset A shows an IP camera mounted up on a tree platform 190 m stand-off from the narrow granite walled canyon. Inset B shows a portable generator used to power the camera in Inset A. Inset C shows an Ethernet switch and laptop located at the energy dissipation structure. The image on the screen is the feed from a camera mounted to view the flow level. Inset D shows the wireless bridge at the Hostel Jamie to the Municipal Center. Inset E shows a computer terminal at the Municipal center with an Ethernet switch. The operator is able to view feeds from an IP camera or weather station on the LAN. Inset F shows the team of municipal workers trained to set-up and maintain the equipment in the prototype warning system.

(Fig. 8) but night vision was degraded. These cameras do not work in “total” darkness but can monitor illuminated fiducials (Bulmer et al., 2007, 2009) within an otherwise dark scene. The IP-video premium camera was three times the cost of the IP-video utility camera and produced a picture quality that was visibly superior. In low light, the daylight filter retracts increasing the gain and the ability to view in faint moonlight without supplemental IR. It needed to be mounted in a heated enclosure. The IP-video precision camera was four times the cost of the utility camera, daytime vision only but permitted longer stand-offs (out to >2000 m). This was best suited for installation on a robotic base in a built structure, with panoramic windows that then enable sequential monitoring of many slopes. Video was fed to the Municipality and to portable laptops (Fig. 8). Two different weather station technologies were demonstrated (Fig. 7). The first was a commercial unit installed at the Municipal Center with a well proven record. This had sensors that measured barometric pressure, relative humidity, temperature, dew point, wind direction and speed, rainfall, time and included a solar radiation shield. Power options were solar/battery/PoE. Connection was established via wireless (900 MHz), Ethernet cable (LAN) to a computer and the Internet. For deployment up in the AC basin, the second weather station technology was custom designed and built to be autonomous, portable,

The primary objective of the technology demonstration was to show that geohazard risk can be monitored continuously along the AC River. A set of suitable technology was configured as a working prototype with a modular design that was initially able to collect data as much as 2000 m up-river from the Municipal Center. This was demonstrated and conveyed to the community on 6 March 2009, and a local team (Fig. 8) continued to operate it on an intermittent basis until mid-

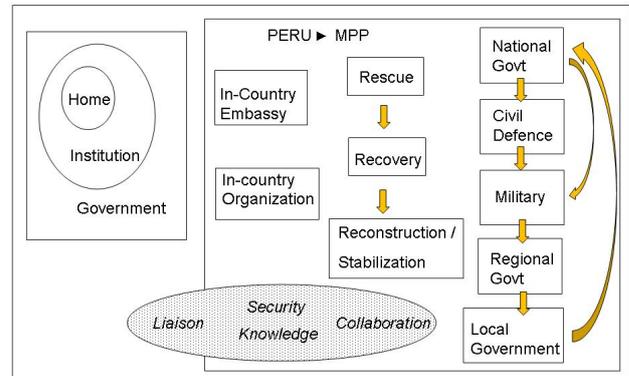
**Fig. 9.** A schematic representation of the operating space of the GFG in working on the Machu Picchu project.
