# Seismic safety assessment of unreinforced masonry low-rise buildings in Pakistan and its neighbourhood

K. A. Korkmaz

**Abstract.** Pakistan and neighbourhood experience numerous earthquakes, most of which result in damaged or collapsed buildings and loss of life that also affect the economy adversely. On 29 October, 2008, an earthquake of magnitude 6.5 occurred in Ziarat, Quetta Region, Pakistan which was followed by more than 400 aftershocks. Many villages were completely destroyed and more than 200 people died. The previous major earthquake was in 2005, known as the South Asian earthquake ( $M_w=7.6$ ) occurred in Kashmir, where 80 000 people died. Inadequate building stock is to be blamed for the degree of disaster, as the majority of the buildings in the region are unreinforced masonry low-rise buildings. In this study, seismic vulnerability of regionally common unreinforced masonry low-rise buildings was investigated using probabilistic based seismic safety assessment. The results of the study showed that unreinforced masonry low-rise buildings display higher displacements and shear force. Probability of damage due to higher displacements and shear forces can be directly r

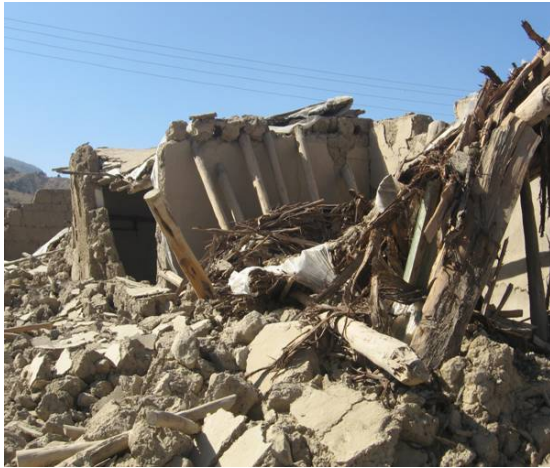
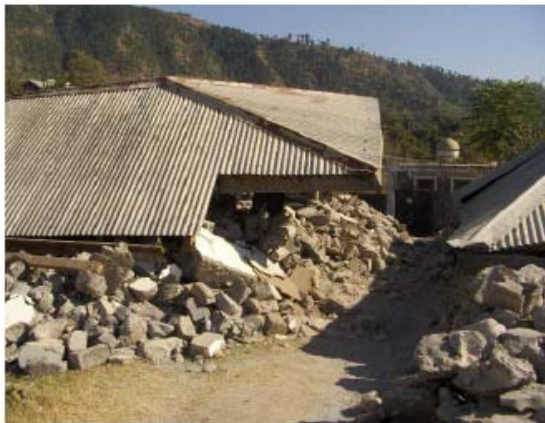
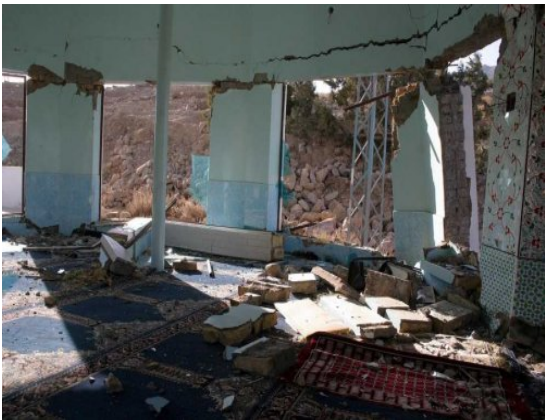
**Fig. 6.** Various damages after the earthquake (Naseer et al., 2007; Khan and Khan, 2008).

The buildings which have received the most severe damage in the recent earthquakes are mostly unreinforced stone, concrete block, and masonry buildings (see Fig. 6). Figure 6 shows some example buildings suffering such damage (Naseer et al., 2007; Khan and Khan, 2008). Performances of stone masonry schools, colleges, universities, old hospitals and official buildings were very bad during the earthquakes. Old age, poor construction and materials, and improper design were among the main factors for bad performance. Damages suffered by the masonry buildings could be explained by diagonal shear failure, combined in and out-plane effects, flexure failure of pier, failure of building corners, separation of orthogonal walls, damages at walls and failure of external masonry and parapet walls (Amjad et al., 2007).

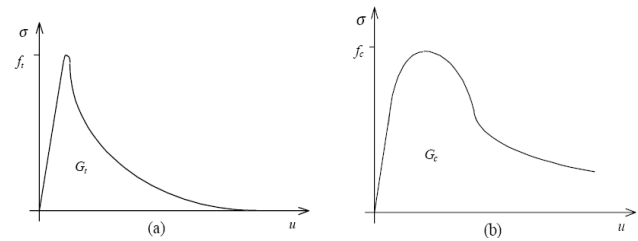
**Fig. 7.** Typical behaviour of quasi-fragile materials under uniaxial loading and definition of the fracture energy (a) tension loading (b) compression loading (Alvarenga, 2002).

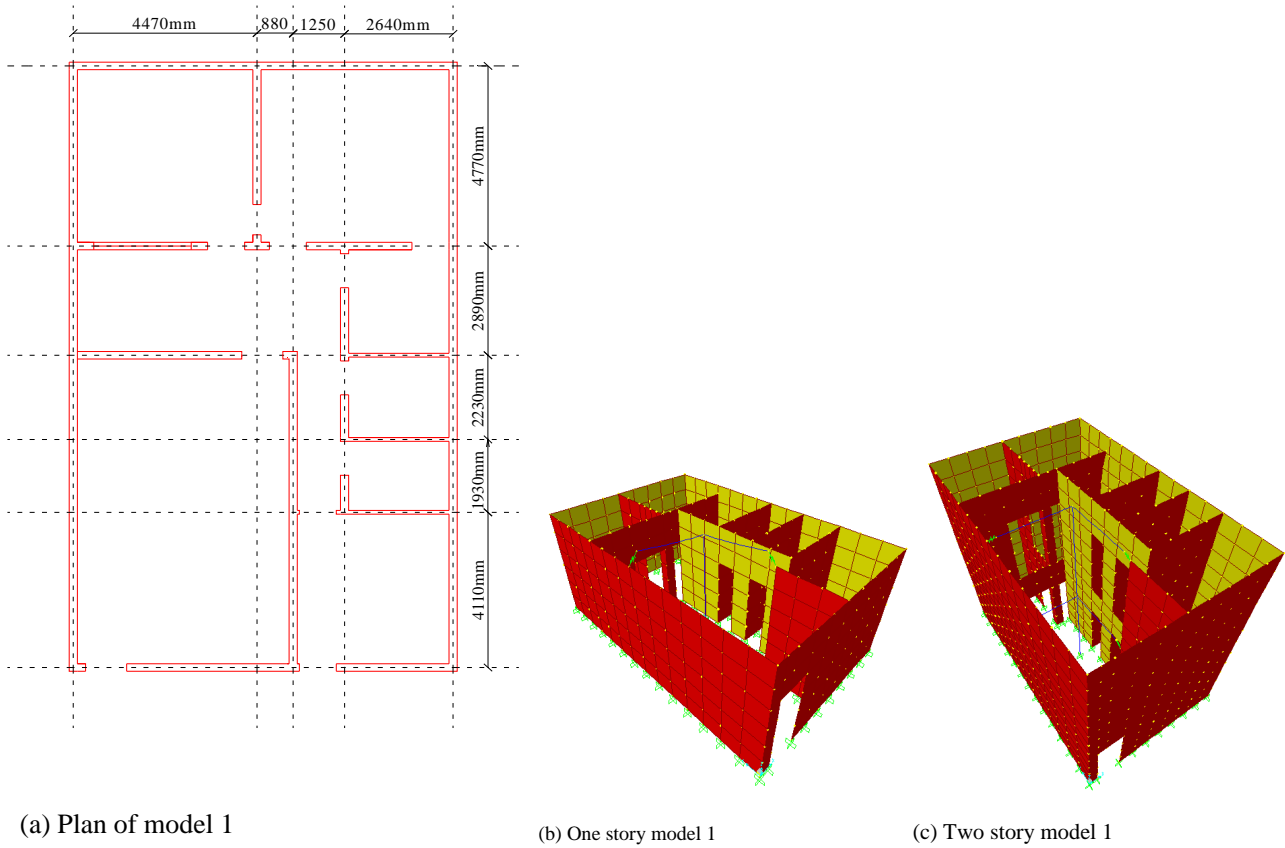
Fig. 8. Plan and 3-D view for one and two-story of Model 1.

To demonstrate the construction type and determine a path for seismic safety assessment for the region, four different representative buildings were modelled similar to the real examples. The existing building types in the region were adopted from the literature and real examples (Naseer et al., 2007). Models shown in Figs. 8 and 9 were nonlinearly investigated via nonlinear time history analyses (Wilson and Habibullah, 1998). As depicted in Figs. 8 and 9, the plan areas of typical masonry buildings in the region are close to these values. Material properties are given in Table 2. Material properties are defined according to the stone masonry material which is commonly used for construction in the region. Masonry constructions subjected to seismic events can present damping ratios around 8%–10% (Rivera, 2008). In the present study, damping ratio was taken as 8%.

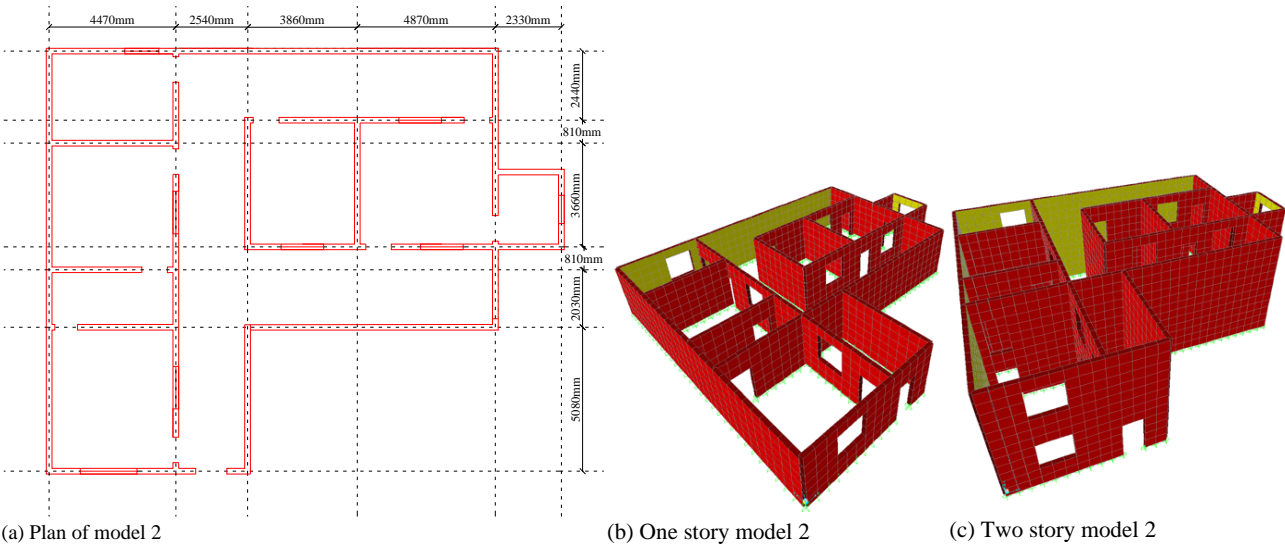
Fig. 9. Plan and 3-D view for one and two-story of Model 2.

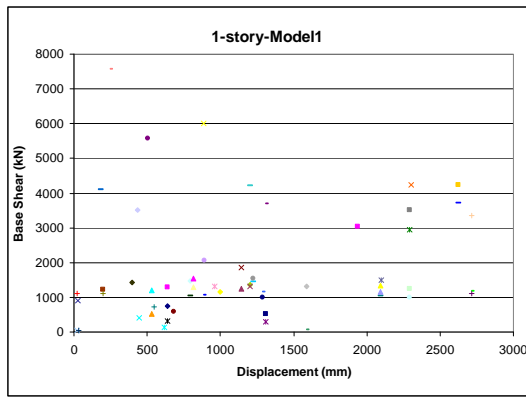
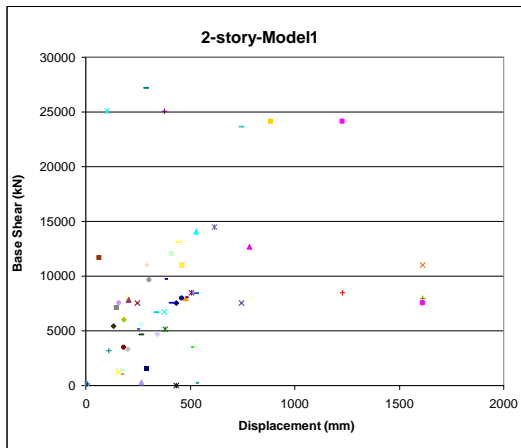
Fig. 10. Time history analysis results for Model 1.

(a) One story Model 1

(b) Two story Model 1

To obtain a set of performance estimates for representative buildings, a series of nonlinear time history analyses were conducted (Wilson and Habibullah, 1998). An extraordinarily important step for application of time history analysis is the selection of the earthquakes. For each model, 60 different ground motion data were selected. Since, local data is not available for the region, the earthquake data was chosen from all over the world. Non-linear dynamic analyses were performed considering tensile strength, tensile fracture energy and damping. In total, 240 time history analyses were conducted for evaluation. Table 3 lists the peak ground accelerations (PGA) and peak ground velocity (PGV) of the records. The time history results are given in Figs. 10 and 11.

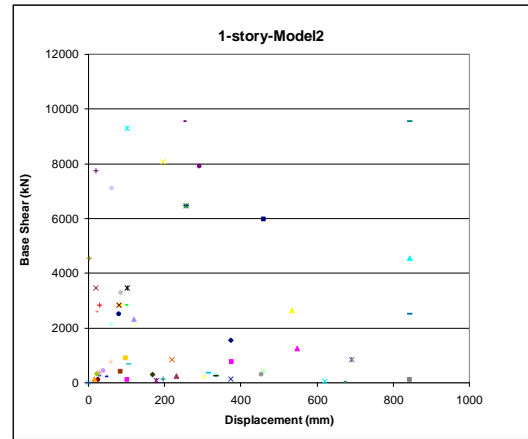
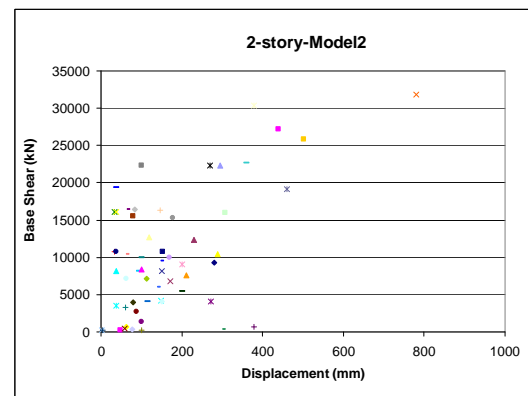
Fig. 11. Time history analysis results for Model 2.

(a) One story Model 2

(b) Two story Model 2

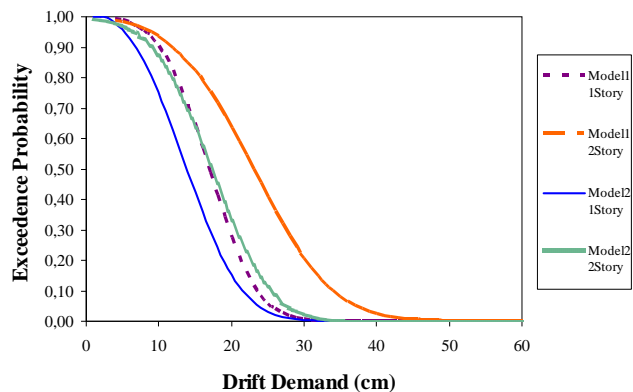
Fig. 12. Probabilistic seismic safety assessment.

developed based on analysis results and simplified probabilistic modelling. For each building, the mean and standard deviation values of these maximum drifts were assumed as parameters of normal distribution functions. According to Cornell et al., a log-normal distribution for the statistical description of the building response would be a reasonable assumption (Cornell et al., 2002). By using the distribution functions, probability of exceeding the different drift levels was computed for each model (Park et al., 2009). These distribution functions gave the probabilistic drift demand curves (see Fig. 12). Using these drift demand curves, probability of exceeding different displacement capacity thresholds (displacement limits) chosen from displacement capacity curves for each model were estimated.
